From: "Tandy C. Walker" <tandyw@flash.net>  
 To: "Lollar, James" <jlollar@cableone.net>  
 Date: 3/27/2009 8:57:21 AM  
 Subject: 64a Sailplane Unfortunate Problem Discovered

### *Comet Sailplane Project*

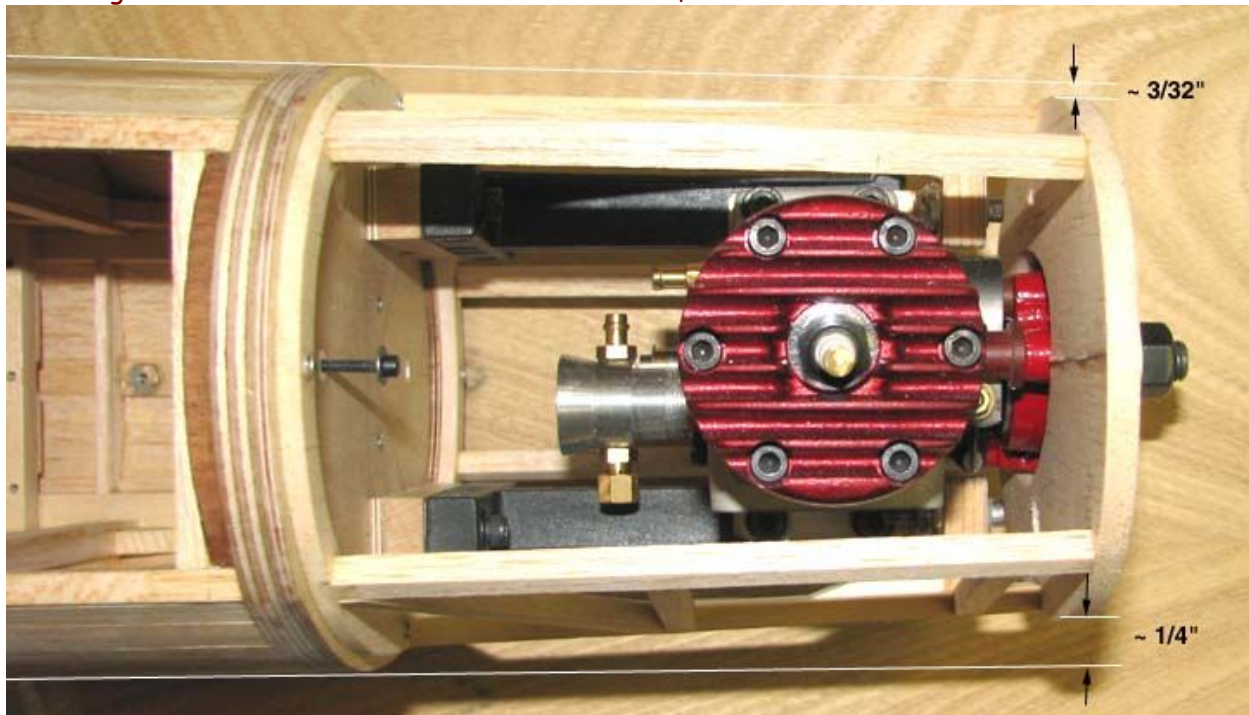
I have uncovered an unfortunate problem on the Sailplane. However, I am only going to share this with you and three others, but not the entire distribution list because I am embarrassed. The problem has been there from the moment I first mounted the engine, but I failed to recognize it. Last night I suddenly became aware that the slope of the cowl side lined up with the slope of the fuselage on the left side, but for some reason was much steeper on the right. With the shape of the elliptical fuselage, this was not apparent until I got the cowl framed up. After making a series of measurements, I found that the actual engine mounting was skewed to the left as shown below! %\$#@& .

My error was in assuming that the engine mounting automatically aligned thrust line with the fuselage's axis of symmetry, which it did not. I did some experimenting this morning and found that the proper thrust line alignment can be achieved with a small plywood shim behind the left engine composite mount. While this is much of a correction, it destroys the pristine fit of the cowl frame. I am not just sure what the individual error contributors are, but taken collectively they are more than I can tolerate. So the only thing I can do is to start over and build a new cowl frame. :O< I will try to dismantle the existing cowl frame later on this morning and see if I can salvage the rear bulkhead as it is the most complex cowl piece that interfaces with the fuselage's firewall.
