From: Tandy Walker [tandyw@flash.net]
Sent: Monday, January 11, 2010 12:07 PM
To: Undisclosed-Recipient: ;@smtp105.sbc.mail.mud.yahoo.com
Subject: 43 Speed 400 Cloudster - Wing Tip Vertical Rise Accuracy

Speed 400 Cloudster Project

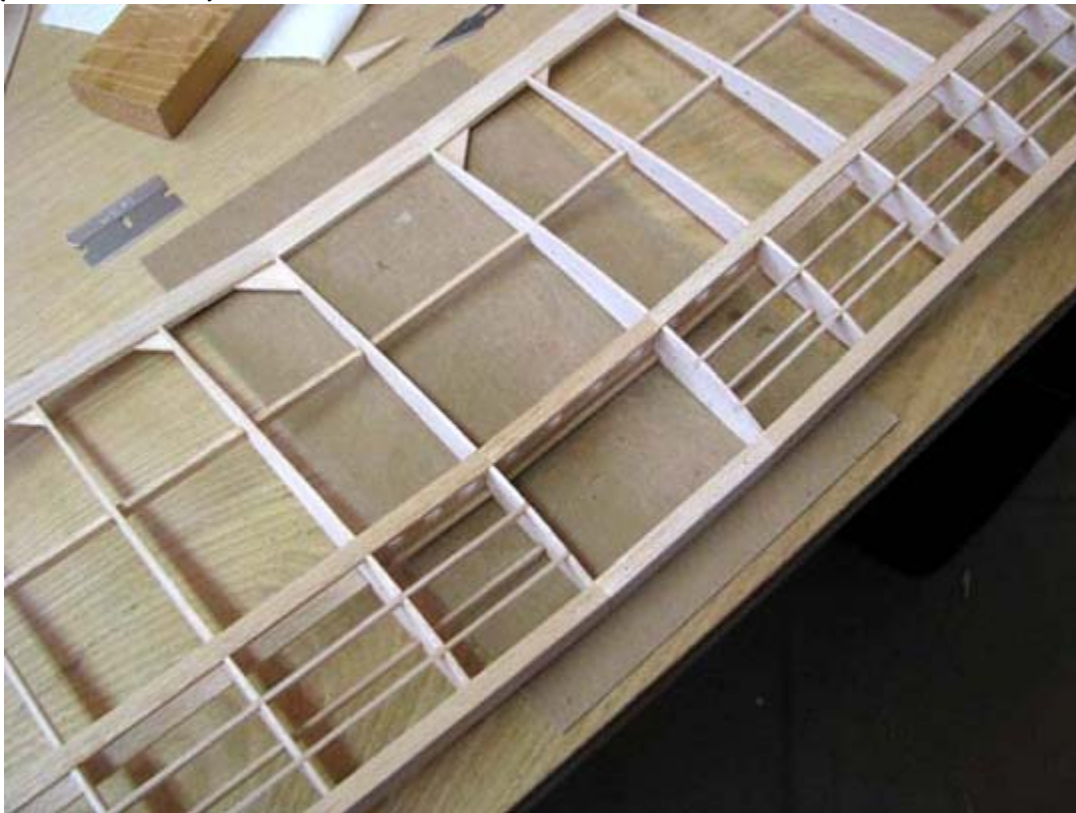
Before starting work on recessing leading edge, it is instructive to measure and compare the "as built" overall vertical rise of each wing tip with the design value while the temporary leading edge is still in place. The wing's inner panel end R1 rib replacements were glued in place, including the portion all the way forward to the temporary leading edge as shown below. Notice that the three turbulator spars are extend to these end R1 ribs as well and the trailing edge dihedral joint was reinforced with two larger 1/16" gussets (0.6" on a side) as shown below.

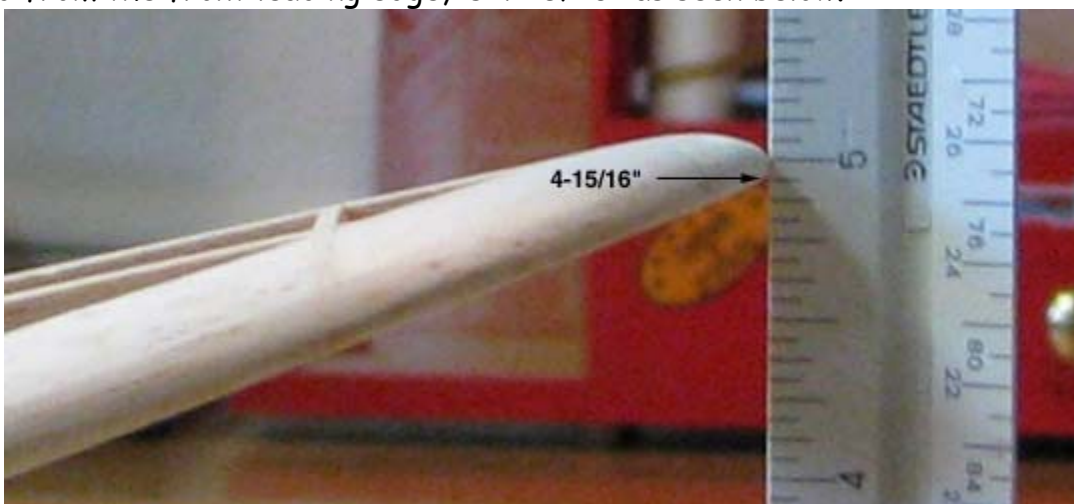
The vertical rise measurement of the lower edge of the left wing tip off the work table, as viewed from the front leading edge, is $4\text{-}15/16$ " as seen below.

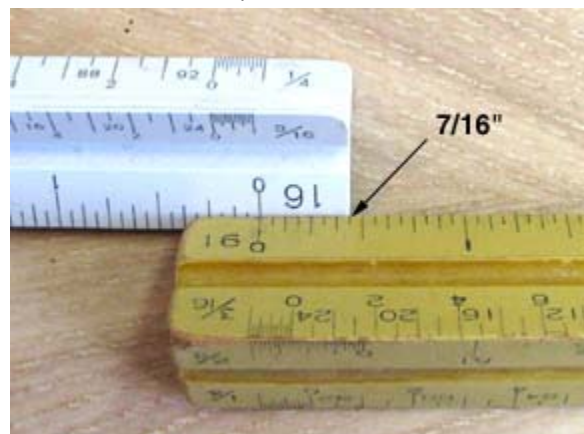
This however is not the true measurement because there is a $7/16$ " (0.438 ") blank section at the end of the scale as shown below. The true measurement is $(4.938 + 0.438) = 5.376$ ". Therefore, left wing tip rise is slightly under the design value by $5.376 - 5.461 = -0.085$ ", which is only a 1.6% overall error.

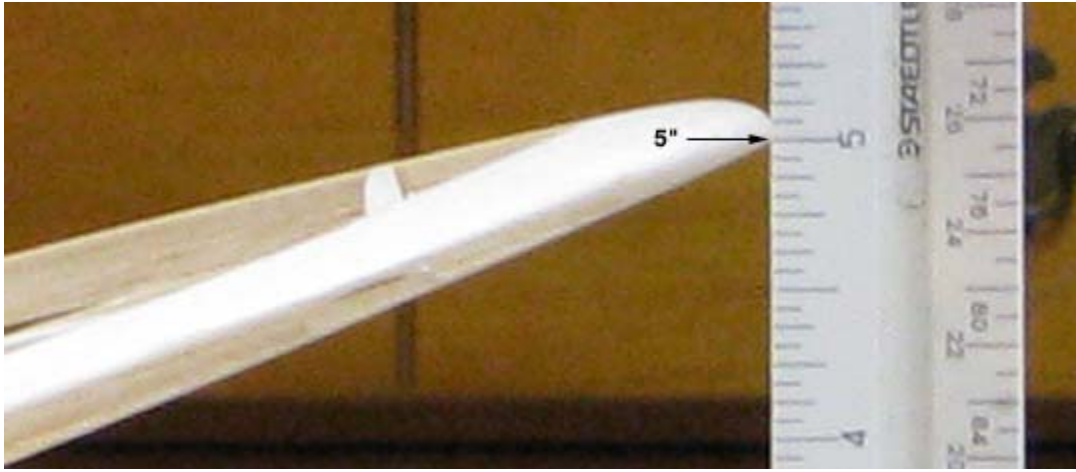
The vertical rise measurement of the lower edge of the right wing tip off the work table, as viewed from the trailing leading edge, is 5" as seen below, which is $5+0.438 = 5.438$ ". The right wing tip rise is slightly under the design value by $5.438-5.461 = -0.023$ ", which is only a 0.4% overall error.

These errors are well within practical building tolerances for balsa. I am pleased and probably very lucky that these errors turned out to be so small.....Tandy
