Subject: 75 Lancer 850 - Joining the Two Sides (Part 4)

Report No. 75
 New Cyclone Lancer 850
 February 28, 2018

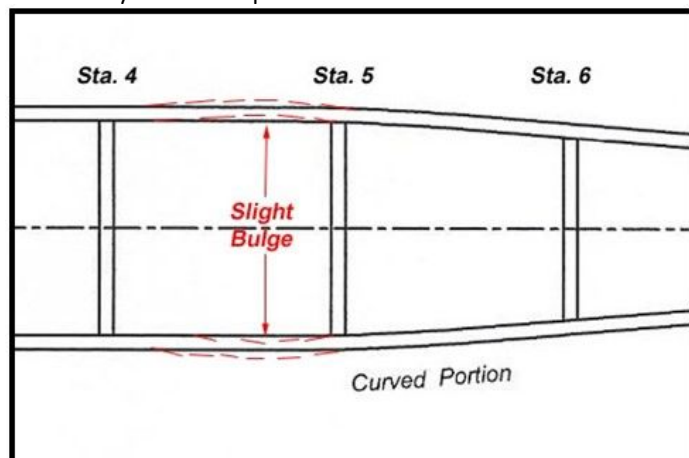
This morning when the clamps and aluminum angles were removed on each side, I discovered a slight bulge between Sta. 4 and Sta. 5 on both bottom longerons as illustrated below. The top longerons did not bulge because they were restrained by the inside spruce doublers.

To eliminate the bulging, the aluminum angles were clamped with plastic clamps on either side of the forward fuselage's bottom longerons. A Quick-Grip clamp was clamped on the aluminum angles just slightly aft of Sta. 5. Then a second Quick-Grip clamp was placed about ~ 1" forward of Sta. 5 on the aluminum angles and tightened down to squeeze down the bulging in the bottom longerons. To prevent the bulging, two 1/4" thick gussets were glued in the forward corners of the Sta. 5 cross member as shown below. Then an additional 1/4" sq. cross member was glued in at the ends of the gussets also shown below. The glue was allowed to thoroughly dry all morning.

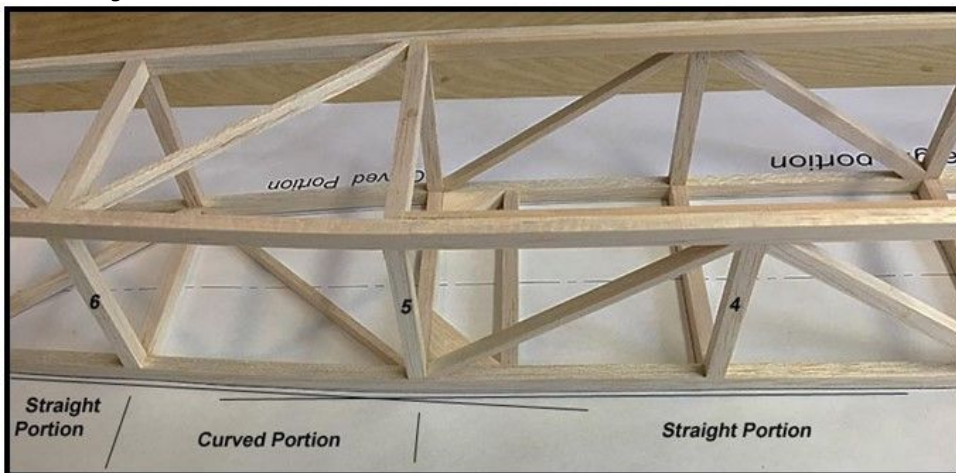
Check No. 1

The frame was placed on the top view drawing to check the bottom longeron bulge between Sta. 4 and Sta. 5. As you can see on this view from the right side, the two gussets and the additional cross member completely eliminated the bulges.

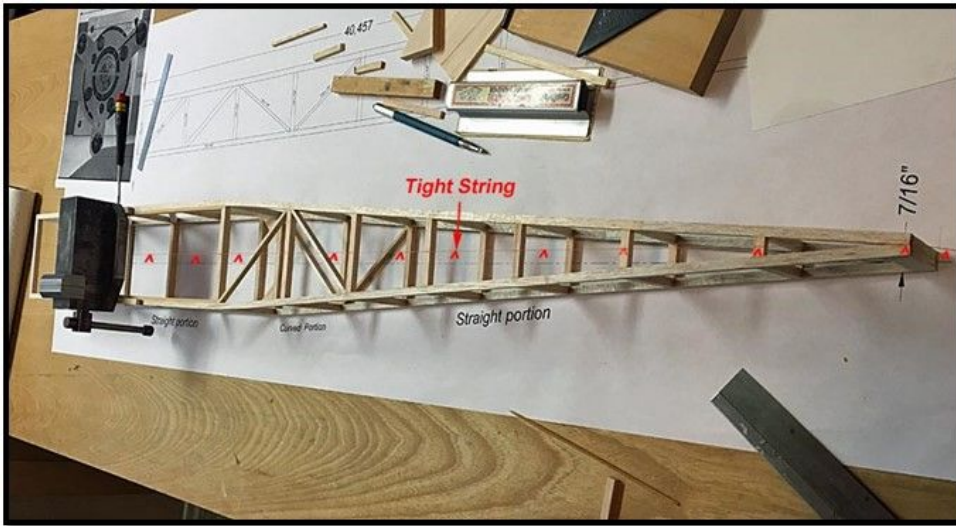
Check No. 2

With the frame weighted down on the top view drawing, a tight string was used to check the symmetry of the two sides. The tight string was centered on the first cross member in front and stretched to the center of the tail post as shown below. An inspection of the string showed it was aligned with the center marks on cross members at Sta. 3 and Sta. 5. This verified symmetry of the two sides as did the frame's match with the top view ACAD drawing.

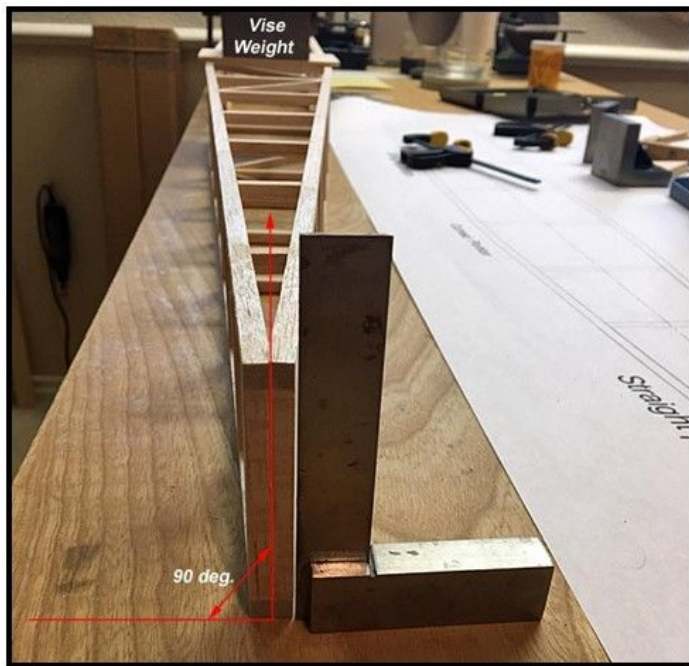
Check No. 3

The last check was to make sure the aft end of the frame (the tail post) is vertical. This was done by weighting the frame down in front with the small heavy steel vise and then placing a metal square close to the tail post. As you can see, the tail post is vertical, which verifies that there is no twist in the fuselage's frame. Also notice how straight the longerons are.....Tandy
