From: ["Tandy Walker" <rdb435021@icloud.com>](mailto:rdb435021@icloud.com)
 To: ["Tandy Walker" <rdb435021@icloud.com>](mailto:rdb435021@icloud.com)
 Date: 4/6/2018 2:32:46 PM
 Subject: 106 Lancer 850 - Vertical Tail Construction (Part 3)

Report No. 106
New Cyclone Lancer 850
April 6, 2018

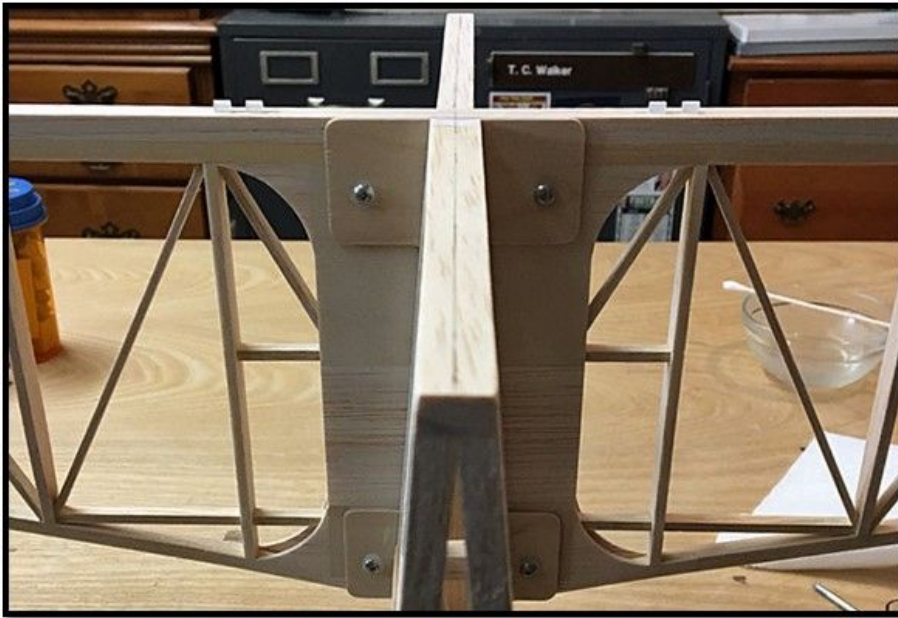
It was at this point I discovered that center line of the fin trailing edge did not line up with the fuselage tail post's center line as the picture below shows! &^%\$@#* However, it wasn't clear which one was causing the misalignment.

Since the axis of the rudder hinge line must be absolutely straight, it will be necessary to go back now and rework the fuselage's aft structure. The left side of fuselage's tail post will be built up in a taper from 0" at the top to a 1/16" at the bottom and right side will be removed from 0" at the top to a 1/16" at the bottom. This build up modification will also be carried forward on the longerons and vertical members one to two bays and then feathered in. As large as this model is, the modification should not be too noticeable.....Tandy

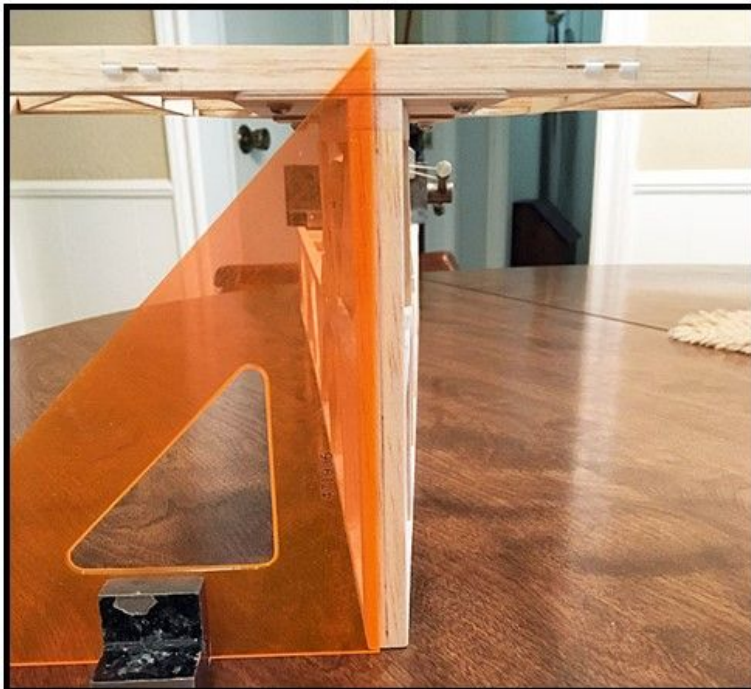
Then the orange triangle was placed on the dinette table with its top aligned with the center line at the base of the fin's trailing edge as shown below. This revealed that the tail post had somehow gotten misaligned during the assembly of the fuselage's 1/4" sq. frame structure.

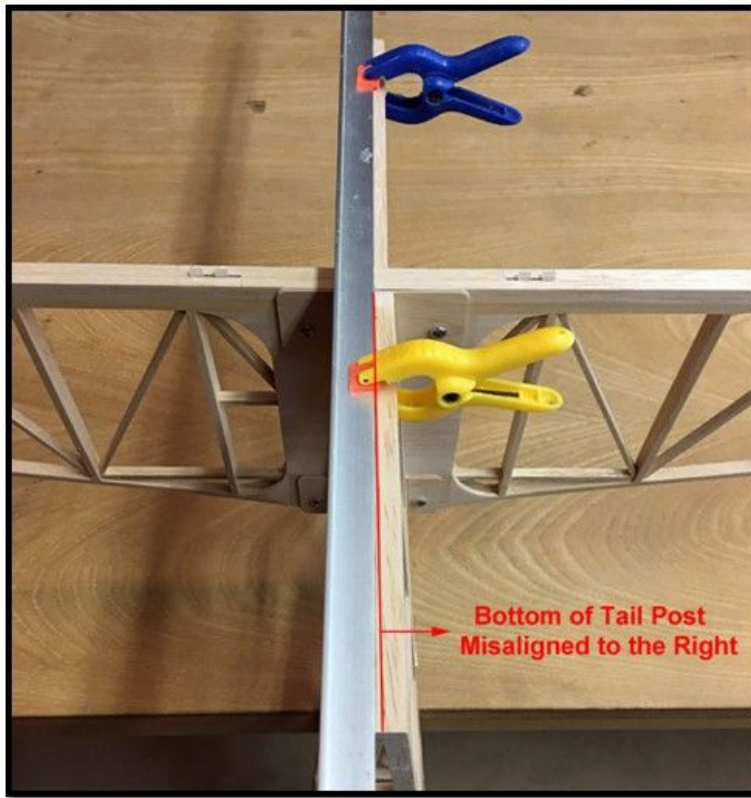
The edge of a 1/2" aluminum angle straight edge was carefully aligned with the center line of the fin's trailing edge and clamped in place as shown below. As you can see by the red line, the bottom of the tail post is misaligned to the right.

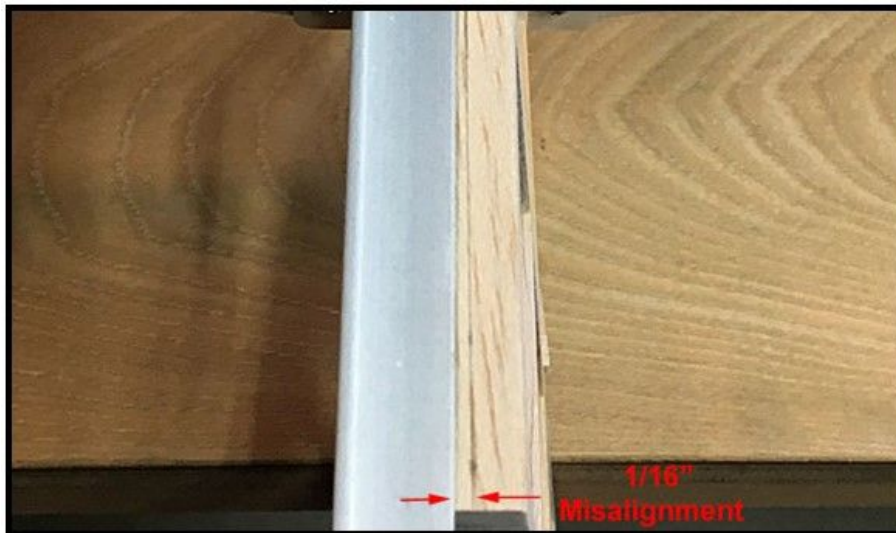
In this close up, the misalignment was measured to be $\sim 1/16$ " at the base of the tail post.
