Subject: 107 Lancer 850 - Hinging the Rudder and Reworking The Tail Post (Part 1)

Report No. 107
New Cyclone Lancer 850
April 7, 2018

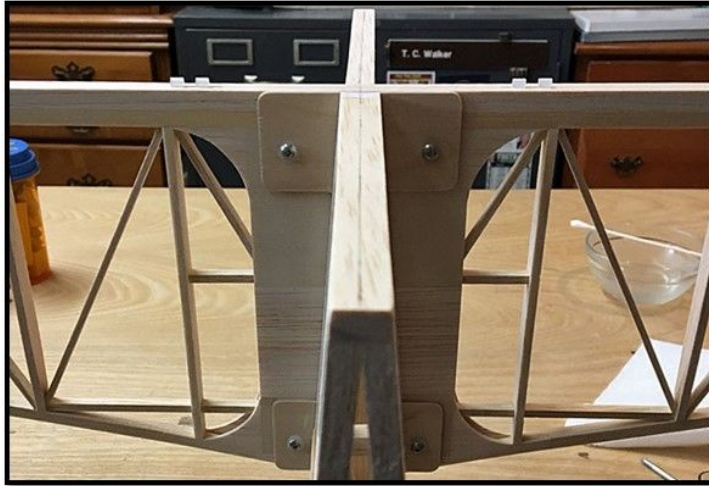
Once it was determined that the fuselage's tail post was misaligned off of vertical as shown below, it was necessary to go back and rework the fuselage's aft structure to correct the misalignmnet.

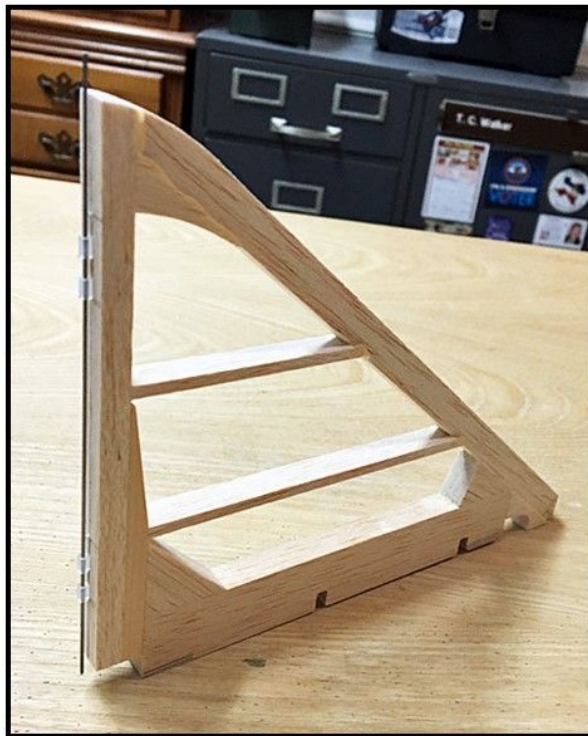
It seemed prudent to use the rudder hinged to the fin as a tool to more accurately quantify the misalignment. First the location of the two Klett hinge halves was determined on the fin's trailing edge and the hinge halves installed as shown below.

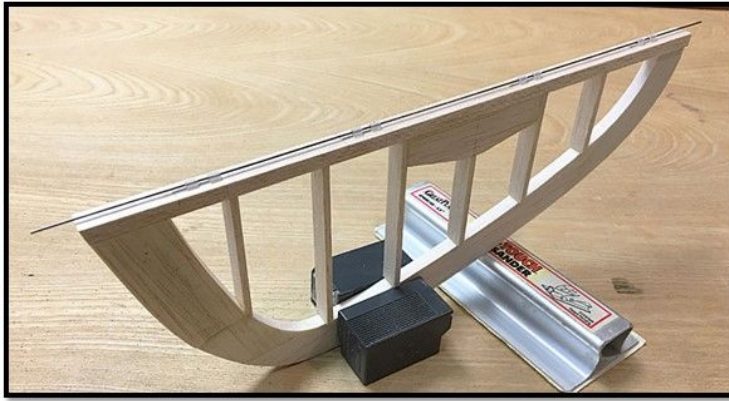
The two hinge locations were transferred to the rudder and the hinge halves installed as well as the two lower hinge halves as shown below.

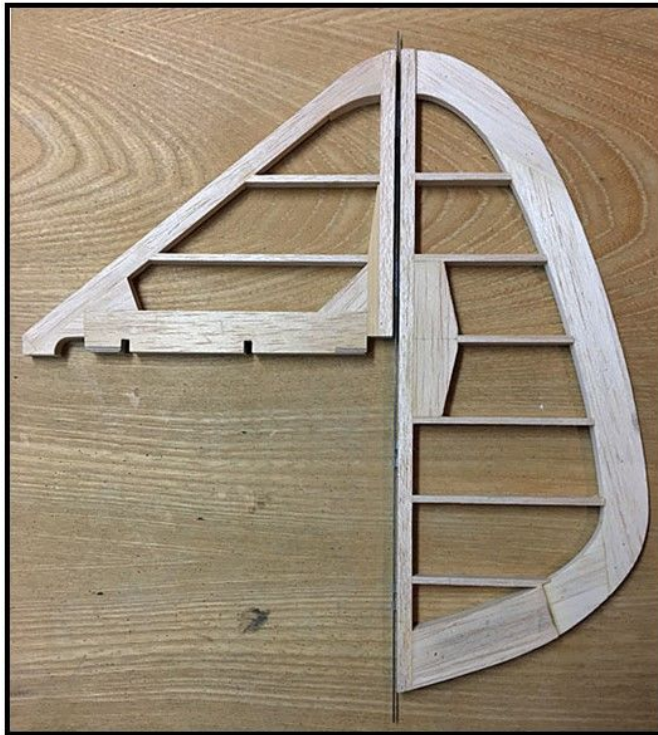
This picture shows the rudder attached to the fin with a continuous hinge pin wire.

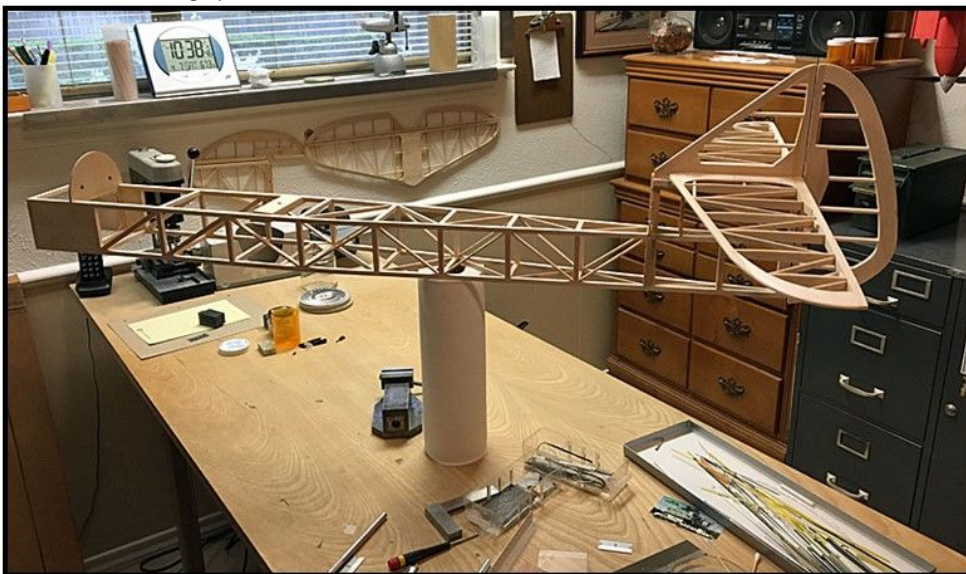
The fin was attached to the stab which was then mounted on the fuselage's stab platform. The rudder was attached to the fin with the continuous hinge pin wire as shown below.

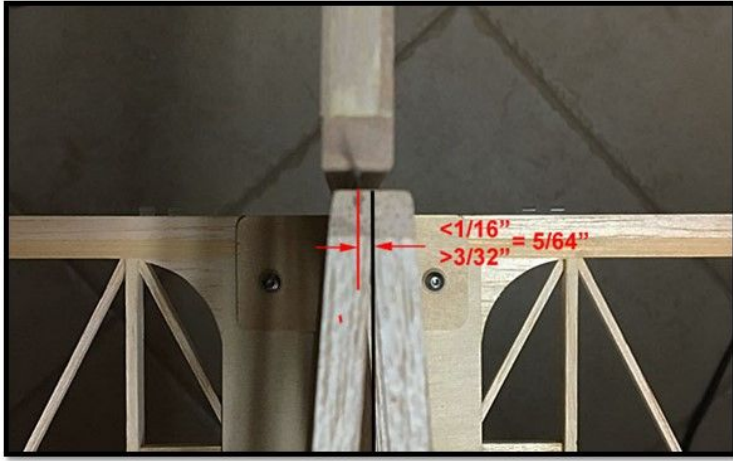
The fuselage was placed upside down on the work table and this picture was taken to show the actual location of the rudder's center line, defined by the hinge pin wire, relative to the center line of the fuselage's tail post. The misalignment turned out to be slightly greater than a $1/16$ ", but less than $3/32$ ", so call it $5/64$ ". Therefore, $3/32$ " balsa strips will be used to build-up on the left side of the fuselage.....Tandy
