From: "Tandy C. Walker" <tandyw@flash.net>
 To: [Undisclosed-Recipient:](#)
 Date: 8/21/2009 4:59:00 PM
 Subject: 160 Sailplane Balance Point Correction

Comet Sailplane Project

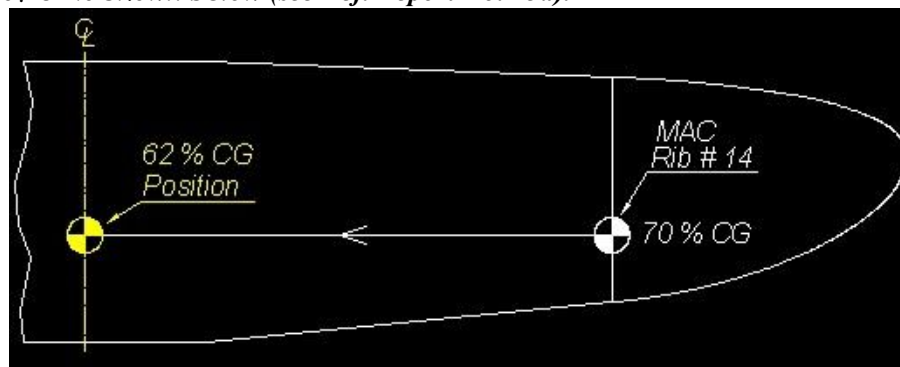
I out started yesterday morning by doing a center of gravity (CG) evaluation on the Sailplane. The balance point came out at 8.8" aft of the wing's leading edge, which is $(100 \times 8.8/13.75) = 64\%$ CG. This compares with the design CG of 62% shown below (see *Ref. Report No. 43a*).

I am not sure just how critical this 2% difference is, but I simply can not take any chances during the first flight tests with a possibility of a marginally stable airframe.

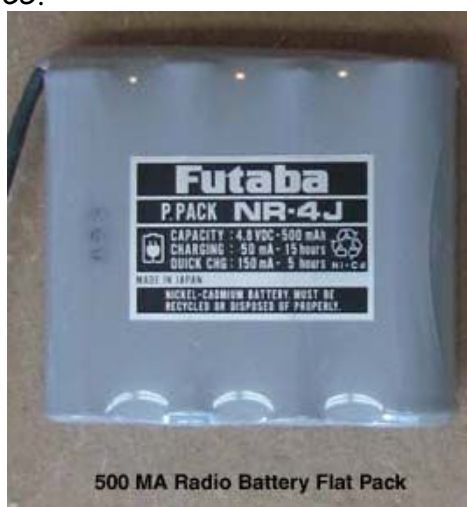
Without adding ballast weight, the radio's flight battery shown below is the heaviest single item that I have to work with to try and correct the CG.

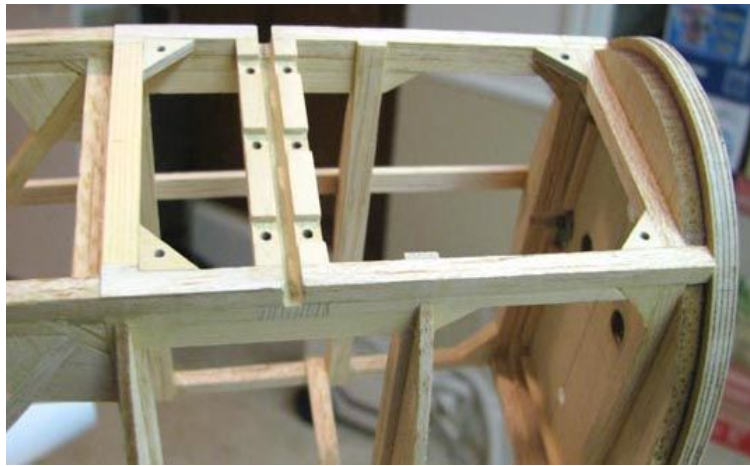
I reassembled the model and rechecked the balance point. It came out almost exactly on 8.5", which is the design CG of 62%. The good thing about this location is that there is a lot of spruce structure built into to fuselage in this area to support the rear landing gear strut as shown below.
