From: "Tandy Walker" <rdb435021@icloud.com>
To: "Tandy Walker" <rdb435021@icloud.com>
Date: 1/7/2018 4:13:51 PM
Subject: 30 Lancer 850 - Trailing Edge Gussets

New Cyclone Lancer 850

January 7, 2018

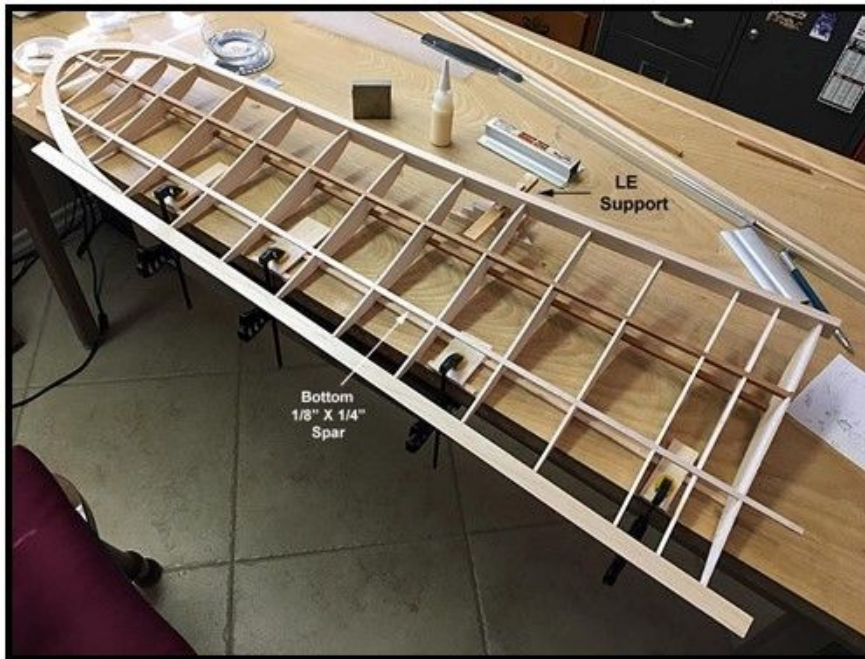
Even though the two rear spars were straight, the long 1/4" X 3/4" trailing edge had a slight waviness when I unclamped the right wing panel from the work table shown below.
