From: "Tandy Walker" <rd435021@icloud.com>  
 To: "Tandy Walker" <rd435021@icloud.com>  
 Date: 1/8/2018 9:43:09 PM  
 Subject: 32 Lancer 850 - Contouring Right Wing Tip

*New Cyclone Lancer 850*

*January 8, 2018*

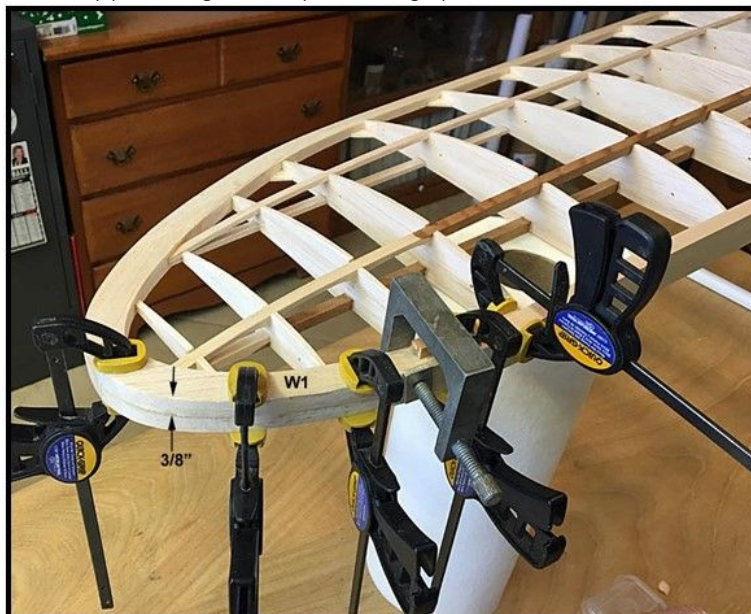
Therefore, another 3/8" W1 tip piece was glued on top of the wing tip as shown below in order cover the exposed three ribs.

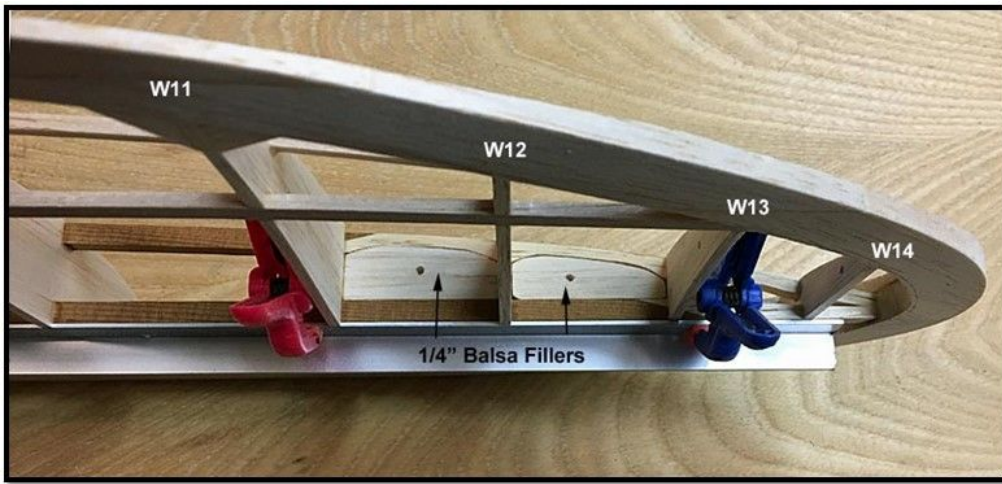
Then two 1/4" balsa filler blocks were cut out to fill in between top and bottom spar openings. These were glued in place with aliphatic glue between ribs W11-W12 and W12-W13 as shown below. Once these filler blocks thoroughly dry overnight, the bottom main spar and wing tip should remain straight. The two holes in the filler blocks are for venting between compartments.....Tandy
