Subject: 46 Lancer 850 - Dihedral Bracing (Part 1)

New Cyclone Lancer 850

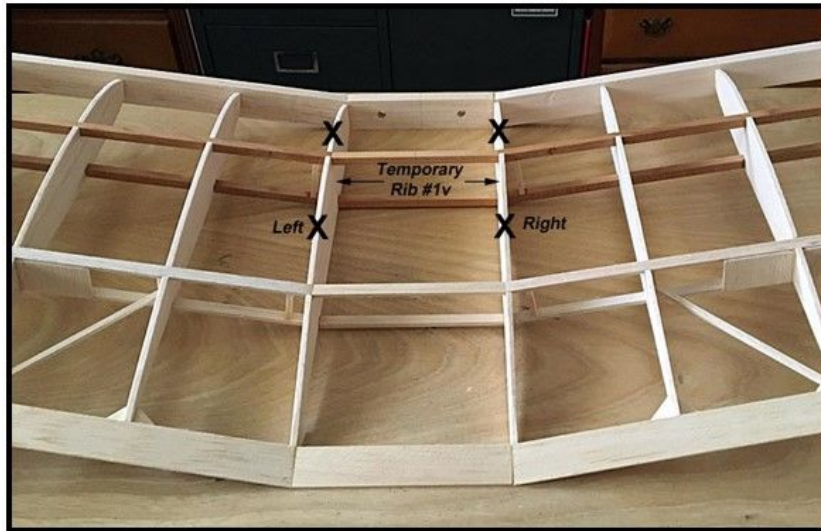
In Report No. 24, the concept of a temporary #1v rib was introduced to maintain the LE, TE, and spar positions at the wing panel root only until wing panels were attached to the center section. The left and right panel's temporary #1v ribs are shown in the picture below. The four pieces of the ribs to be removed first are marked with an "X" in order to develop a pattern for the main spar's dihedral brace.

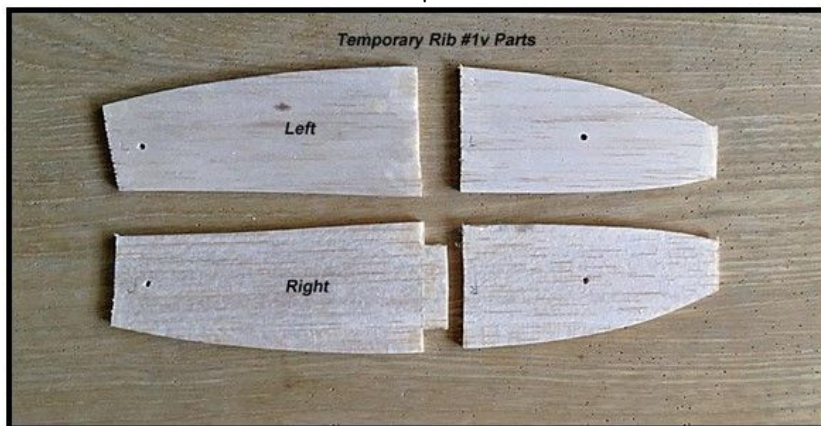
These are four pieces removed.

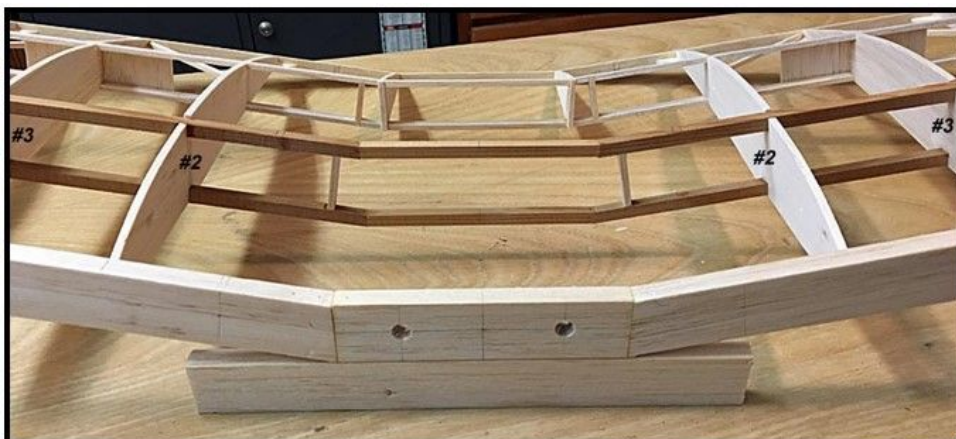
As you can see below, the removal of these pieces left the top and bottom 1/4" sq. spruce spars completely exposed between the two #2 ribs (if you remember the two #1a ribs were remove before the wing panels were joined to the center section). The 1/8" X 1/4" balsa braces were added between the top and bottom main spruce spars on either side of the center section to maintain the spar's separation now that the pieces of the #1v ribs are remove.

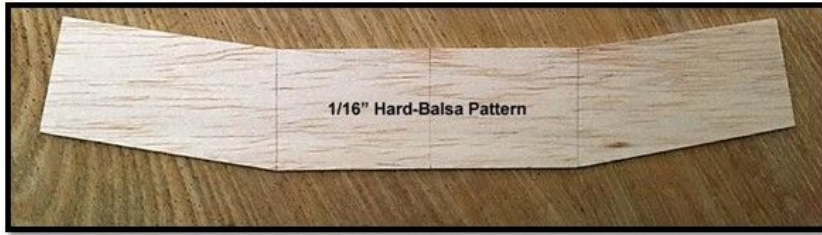
A pattern shown below was developed for the main spar's dihedral brace using a sheet of 1/16" hard-balsa.

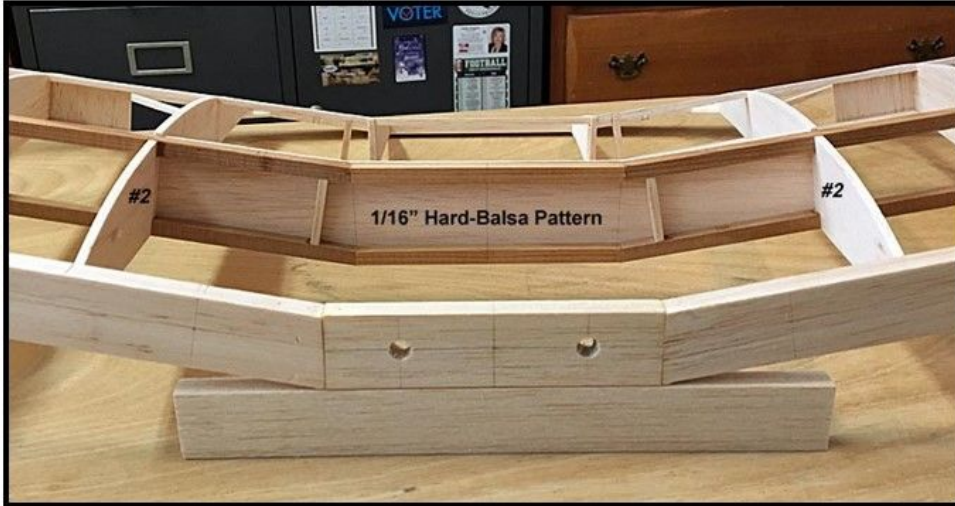
The pattern is continuous through the center section and extends out to each #2 rib as shown below. Notice that the pattern is on the rear face of main spars.

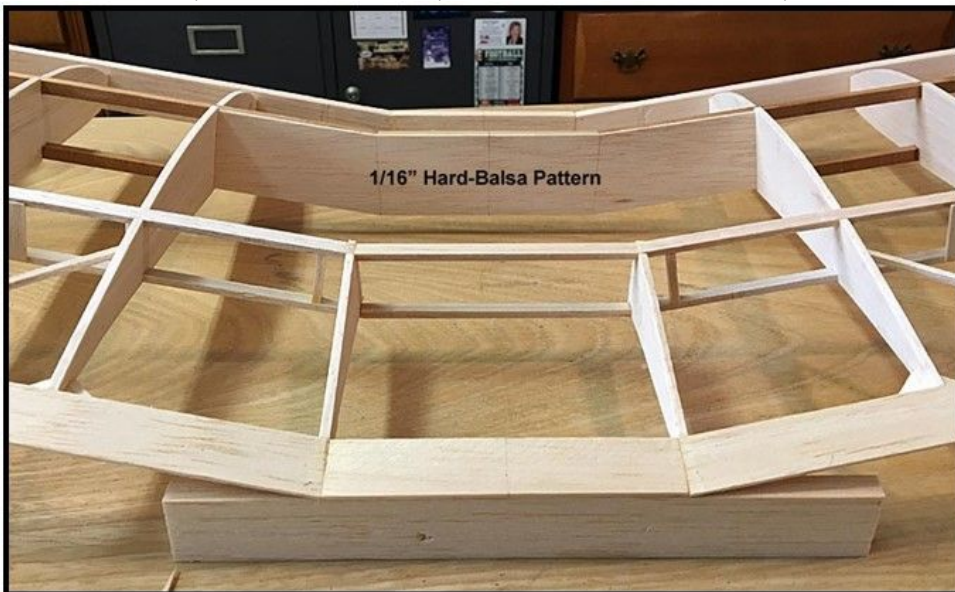
This picture shows the balsa pattern on the rear face of main spars.

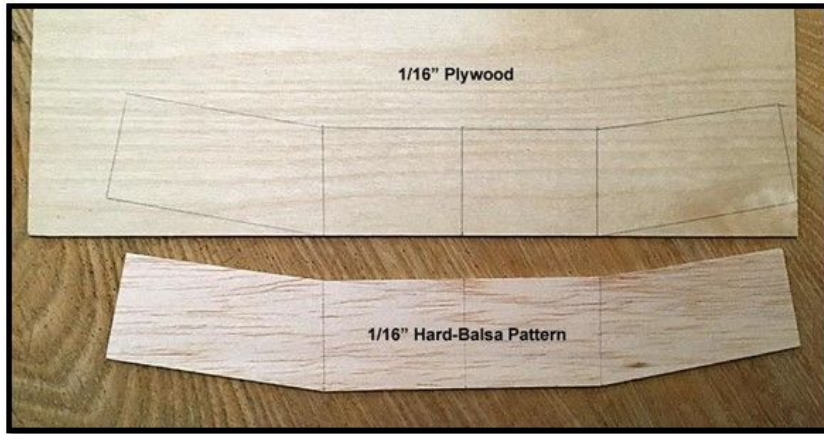
The balsa pattern was then traced onto a sheet of 3-ply 1/16" birch plywood as shown below.
