From: ["Tandy Walker" <rdb435021@icloud.com>](mailto:rdb435021@icloud.com)
 To: ["Tandy Walker" <rdb435021@icloud.com>](mailto:rdb435021@icloud.com)
 Date: 2/19/2018 9:22:18 AM
 Subject: 67 Lancer 850 - Splicing Fuselage Longeron

Report No. 67
 New Cyclone Lancer 850
 February 19, 2018

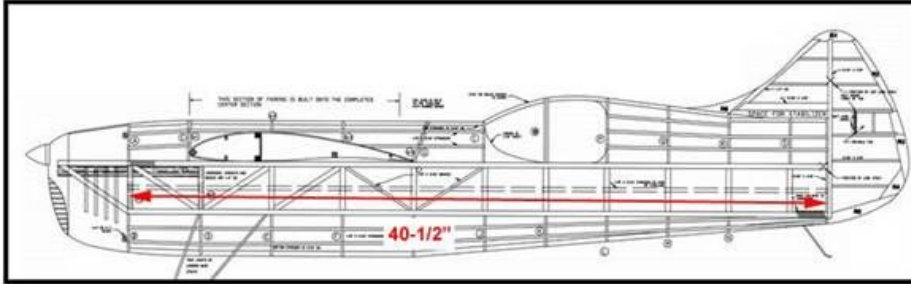
The fuselage's four 1/4" square longerons must be at least 40-1/2" long as shown below. Friday evening one of the 36" long 8 gram balsa strips was cut into four 8" segments for splicing onto the other four 36" strips.

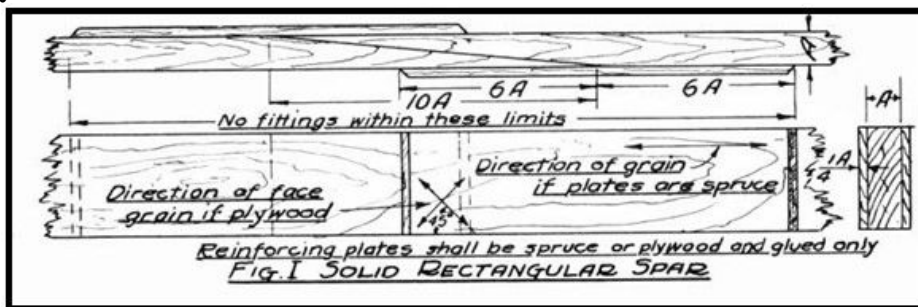
The recommended joint for splicing longerons is referred to as a "scarf" joint. The picture below taken out of an aircraft maintenance manual shows the scarf joint for an aircraft spar. The scarf joint is defined by the ratio of the spar's diagonal cut to the spar's depth. As you can see in the picture below, the ratio is 10A/1A, or simply a 10:1 scarf joint.

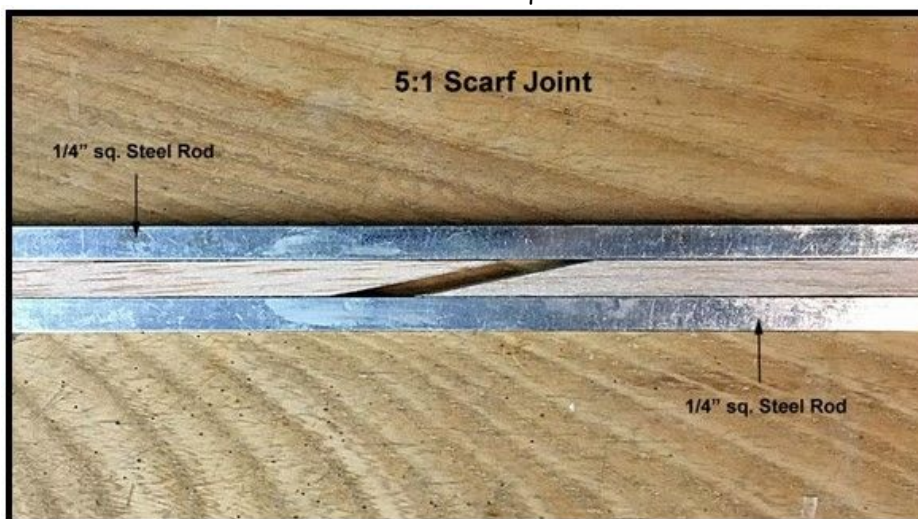
It is rather difficult to get matching cuts for a 10:1 joint by hand. Several years ago I found that a 5:1 scarf joint clamped and glued with aliphatic glue proved to be sufficiently strong enough for balsa longerons. So Friday evening I started splicing the first 1/4" square balsa longeron for the Lancer 850 fuselage. The matching cuts for the 5:1 joint are shown below between the two 1/4" square steel rods.

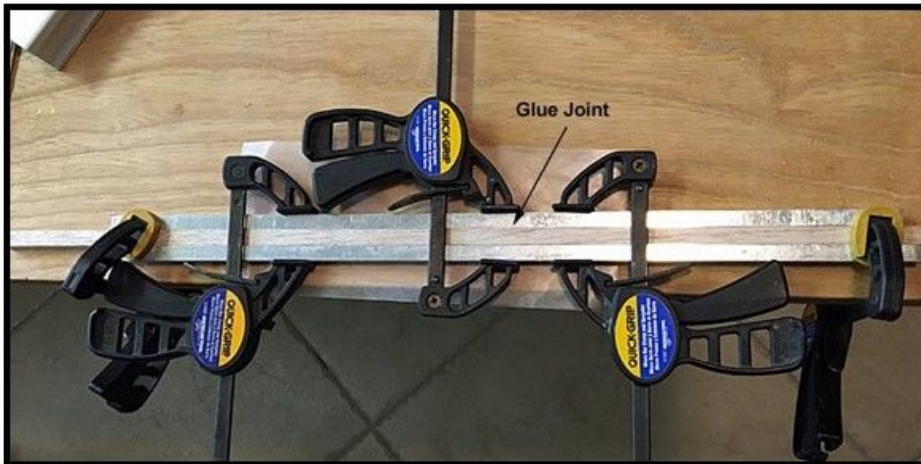
Pre-gluing consisted of forcing Titebond Extend wood glue into the grain on the face of

each cut with thumb pressure. Then a thin layer of glue was applied to 8" piece and place against the 36" piece on top of wax paper. Pressure was applied by clamping the joint between the two 1/4" square steel rods with 3 "Quick Grip" clamps. Two additional clamps were used to clamp the steel rods to the work table as shown below. Notice that the yellow rubber pads were removed for clamping the steel rods.

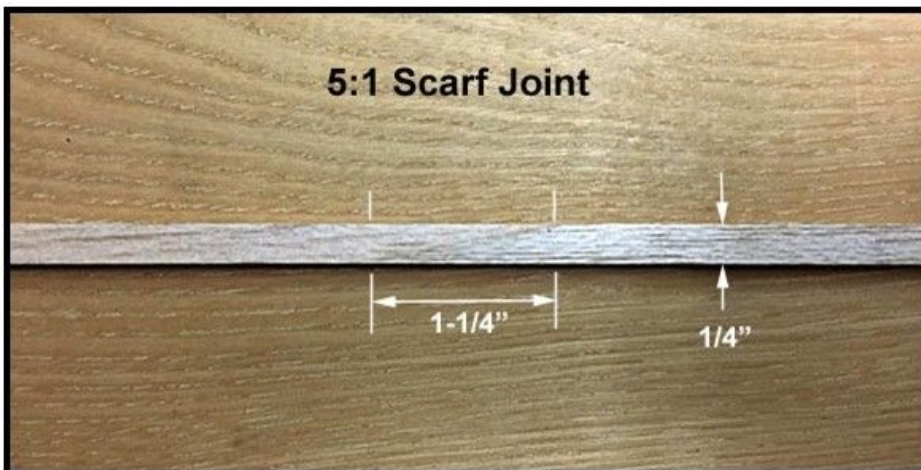
After the glue in the joint had dried overnight, the clamps were removed Saturday morning. The resulting longeron splice is shown below. Notice how tight the joint is with no gaps or voids.

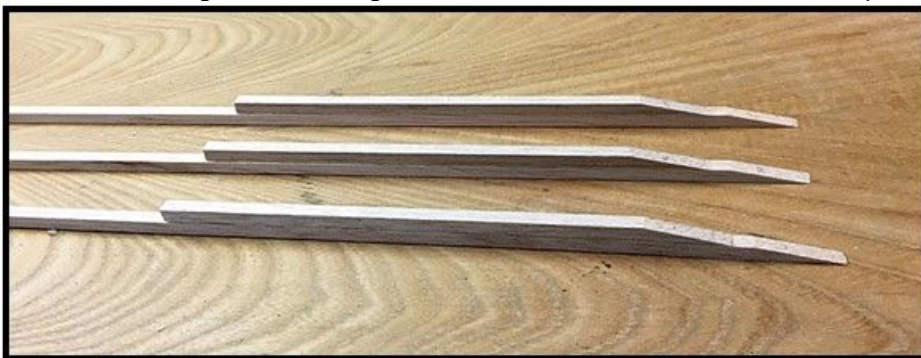
The other three longeron matching cuts shown below were also made Friday evening.

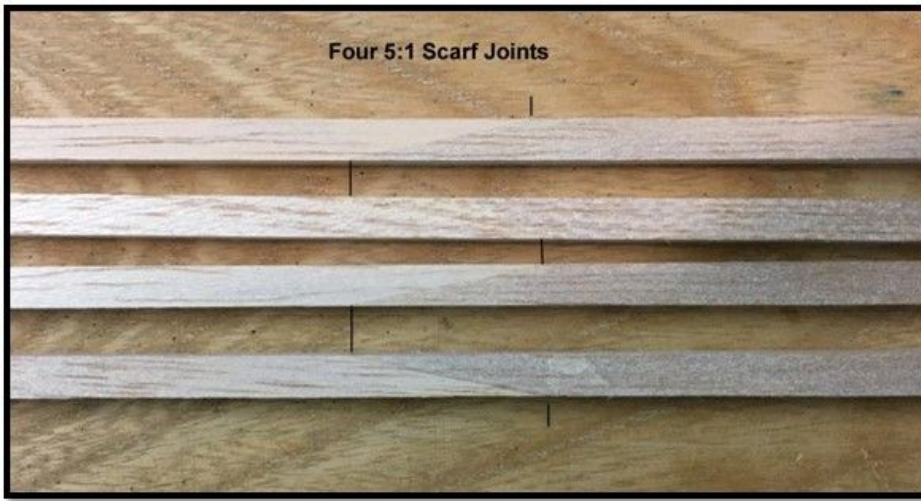
I got up early Sunday morning and jiggled up the second longeron splice before leaving for early church. I took Sue out for breakfast after church. After some 5 hours later, I removed the clamps and jiggled up the third longeron splice. Late Sunday evening, I removed the clamps and jiggled up the fourth longeron splice before I went to bed. This morning I removed the clamps on the fourth longeron. A close up of the four scarf joints are shown below.

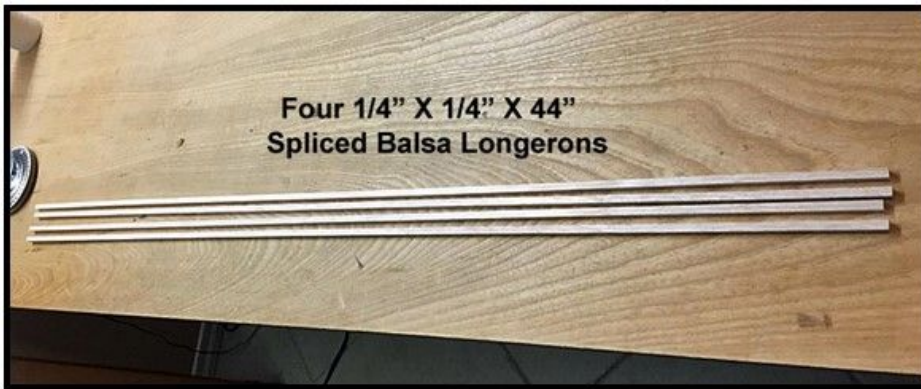
All four of the 44" spliced longerons are shown below. When I receive the PDF file for the fuselage's 1/4" square primary structure drawing from Alfredo, it will be taken to the copy center and the plan printed out. Then I can start building the structure.....Tandy
