From: "Tandy Walker" <rd435021@icloud.com>
To: "Tandy Walker" <rd435021@icloud.com>
Date: 2/25/2018 11:17:45 AM
Subject: 71 Lancer 850 - Top Longeron Spruce Doublers

Report No. 71
New Cyclone Lancer 850
February 25, 2018

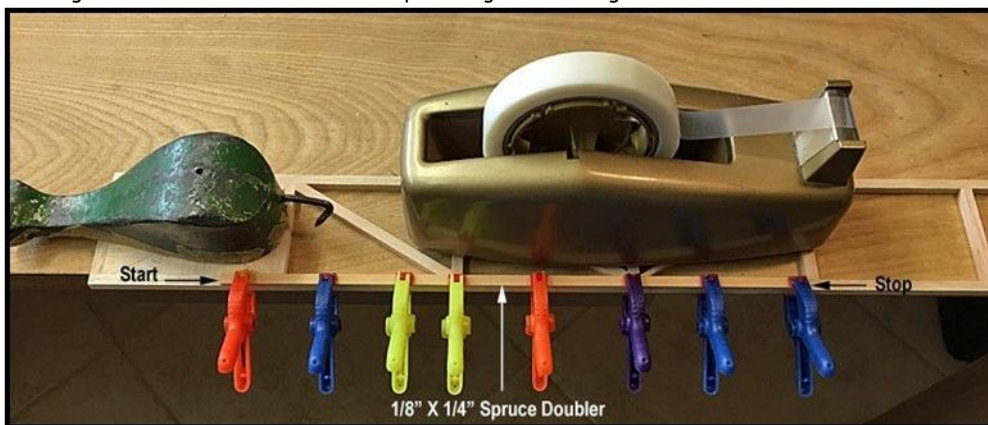
This picture shows the 1/8" X 1/4" spruce doubler clamped and glued on the top left longeron's inside face. The fuselage frame was weighted down on the work table to keep it straight while the glue dried.

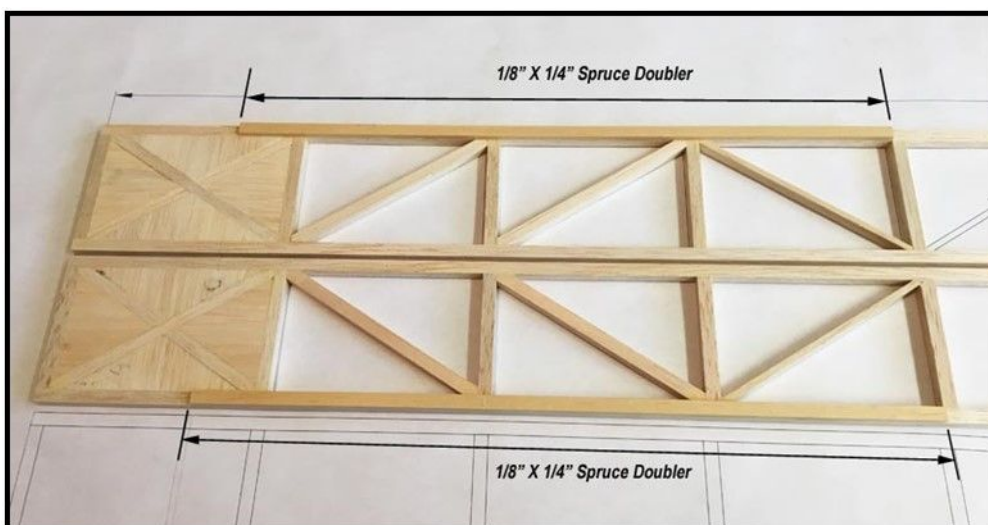
Both sides are now ready for assembly.....Tandy
