Subject: 73 Lancer 850 - Joining the Two Sides (Part 2)

Report No. 73  
*New Cyclone Lancer 850*  
 February 26, 2018

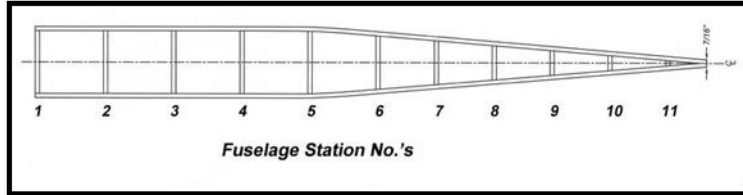
The fuselage station numbers 1 through 11 are defined in the frame's top view drawing below.

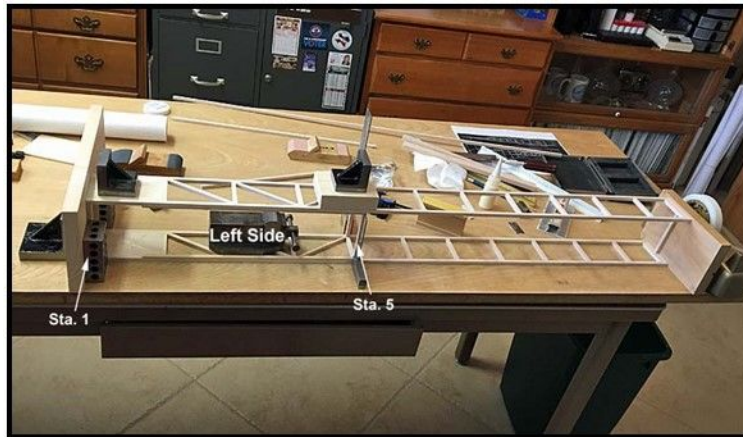
Yesterday whole series of weights, squares, blocks, and planks were used to jig the two sides together with the two cross members at Sta.'s 1 and 5 as shown below and left to dry overnight.

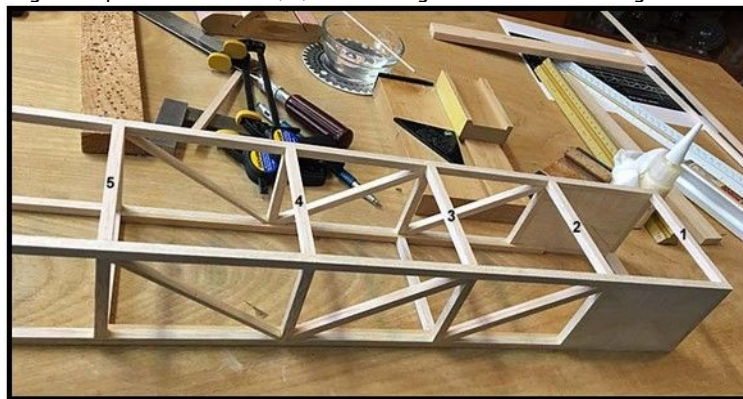
This morning 1/4" sq. cross members 2, 3, and 4 were glued on the bottom longerons as shown below.

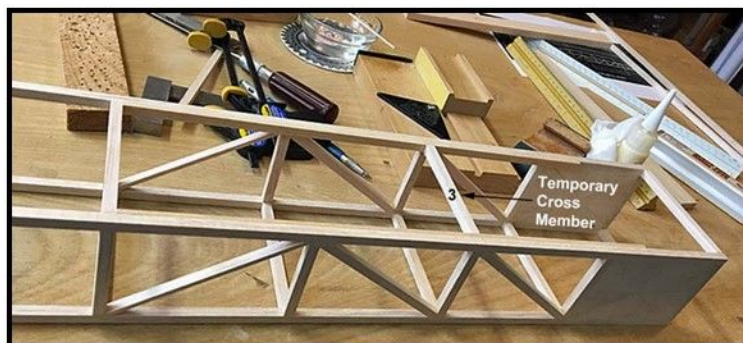
In addition, a temporary cross member was glued in between the spruce doubles at Sta. 3 on the top longerons as shown below. This cross member should minimize any bowing of the top longerons when the aft portion of the fuselage frame is pulled together and will be removed later on in the construction.

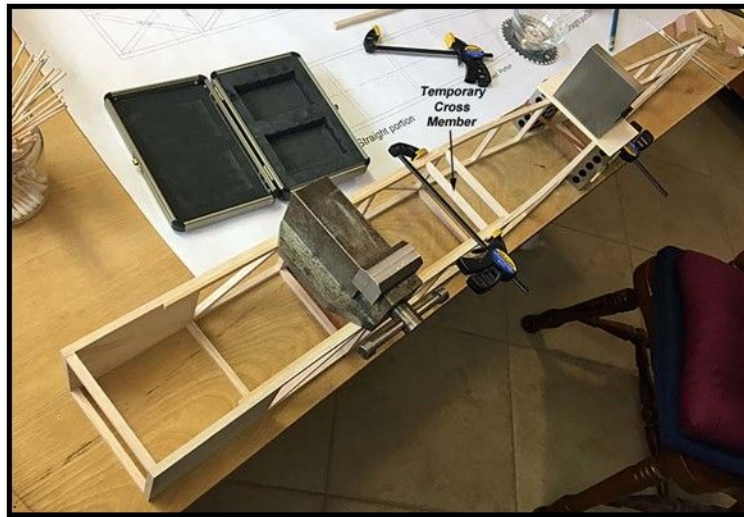
After the forward cross members were dry, it was time to bend and pull together the aft portion of the fuselage's sides. First the aft end of the two sides were tapered inside by sanding so that together their width measured 7/16" as was shown on the drawing. The sides already joined in the front were placed on the work table and weighted down with small

heavy steel vise. Another temporary cross member shown below was clamped in place, but not glued to prevent the top longerons from bowing when the aft portion of the fuselage frame was pulled together.

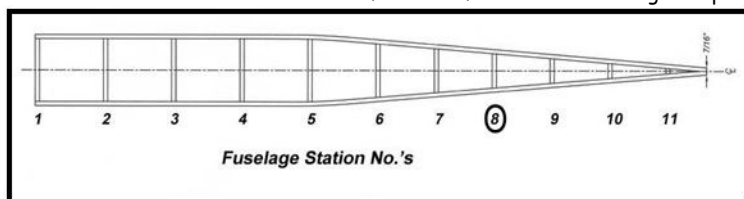
Sta. 8 shown below was selected as the first set of cross members to glue in place.

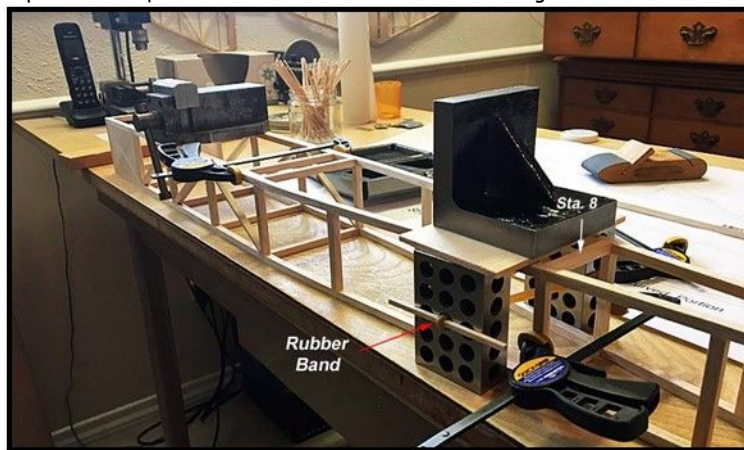
The two 1/4" sq. cross member for Sta. 8 were cut with the ends beveled to fit the slope of the sides. A Quick-Grip clamp was used to hold the sides together while the both cross members were glued in place using aliphatic glue. While the glue was still wet, precision 1-2-3 steel blocks were placed on each side and rubber banded together as shown below. The a piece of 1/8" sheet balsa was placed on top of the two blocks and a 3" steel square block was placed on top for weight. The whole purpose was keep the sides square and vertical while the cross member glue dried.

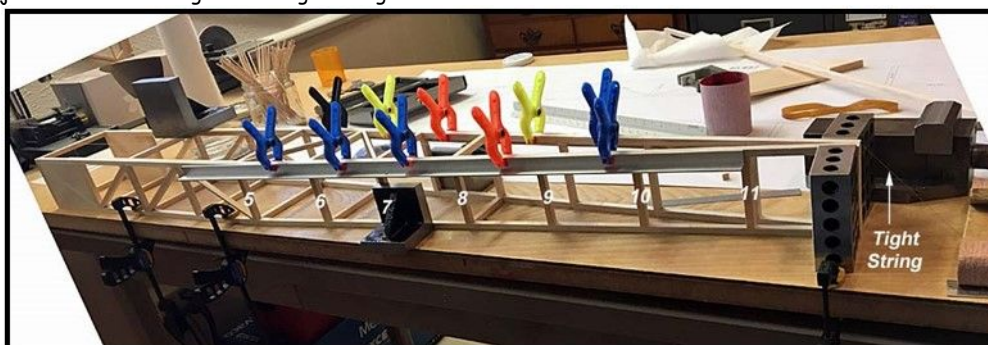
A 1/2" aluminum angle was clamped on the top longerons to hold them straight from Sta. 6 through 11 as shown below and then the sides were clamped to the work table. The pair of precision 1-2-3 steel blocks were placed up against the tail post and adjusted to center orange thread tight string.

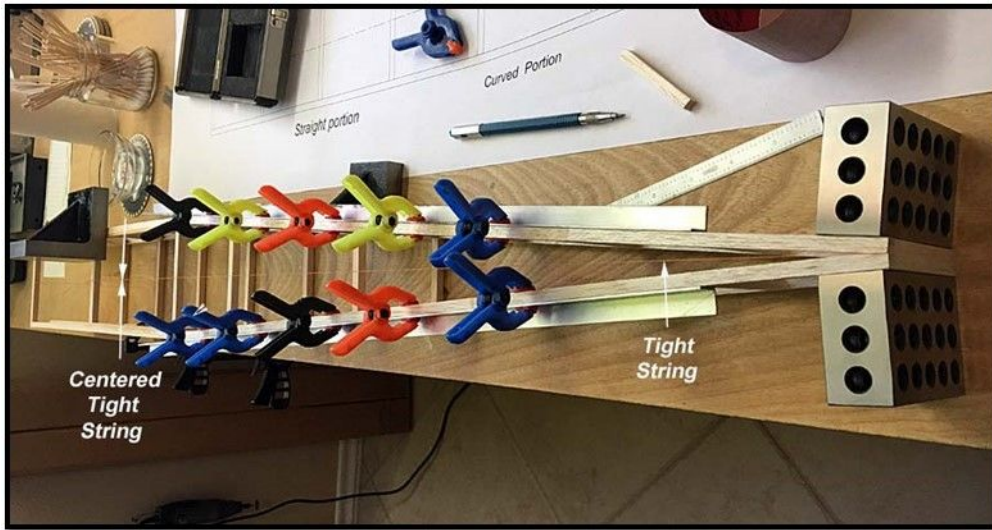
This close up of orange thread tight string shows the final adjustment of the precision blocks to line up the tail post. Only the top of the tail post was spot glued at this time.

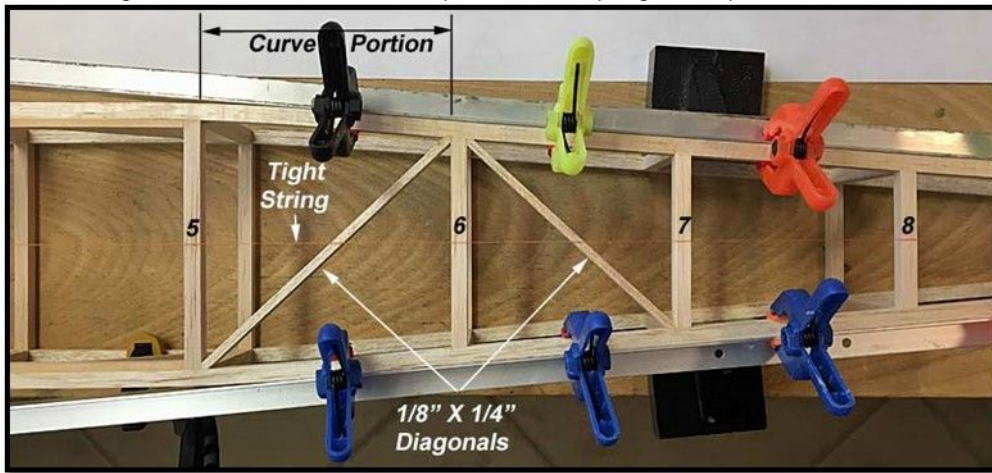
Two 1/8" X 1/4" diagonals were used to lock the curve portion of the top longerons in place as shown below.
