Subject: 80 Lancer 850 - Evaluation of Wing Alignment

*Report No. 80
New Cyclone Lancer 850
March 5, 2018*

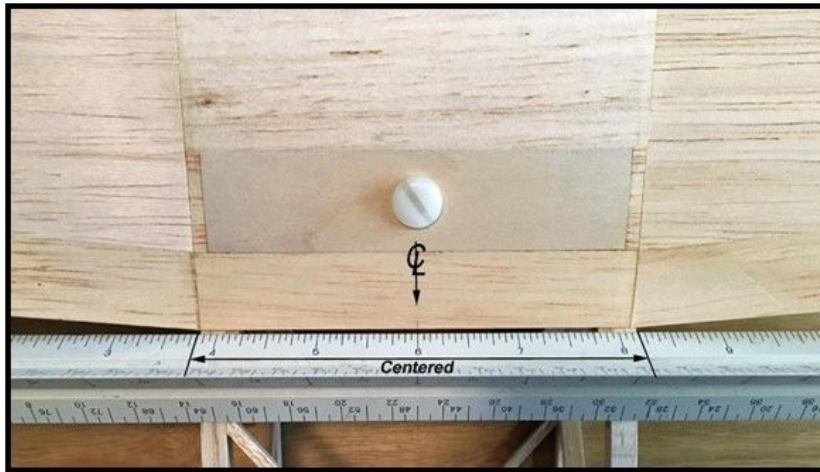
With the fuselage attachment block screwed to the bottom of the wing's center section, the wing dowels were inserted into the bulkhead C and the attachment block was pushed down between the two top longerons, but not glued, which firmly positioned the wing on the fuselage's frame. The center line of the wing center section's trailing edge was confirmed to be centered between the fuselage's two top longerons as shown below.

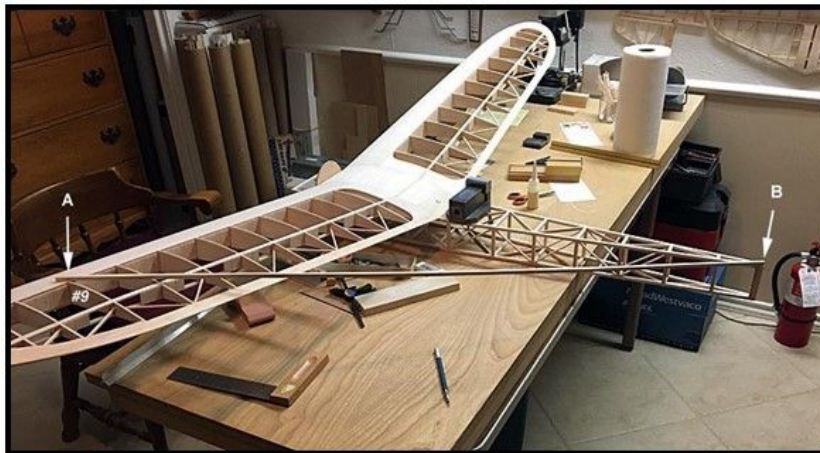
The fuselage frame was weighted down on the work table just behind the wing's trailing edge with the small heavy steel vise as shown below. A 48" long 1/4" sq. balsa strip was placed between the fuselage's tail post (Point B) and the left wing's #9 rib (Point A) also shown below.

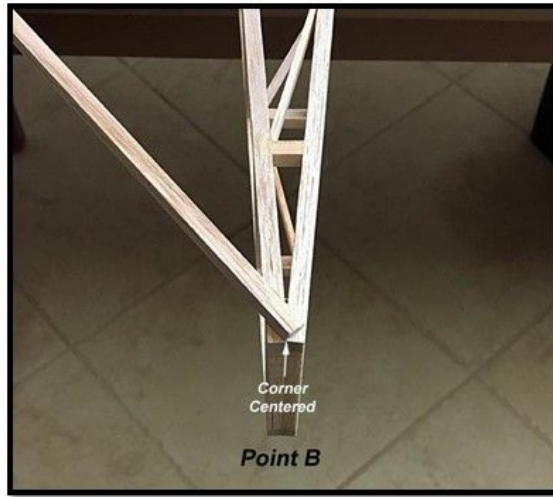
Point B

First the corner of the 1/4" strip was centered on the tail post as shown below.

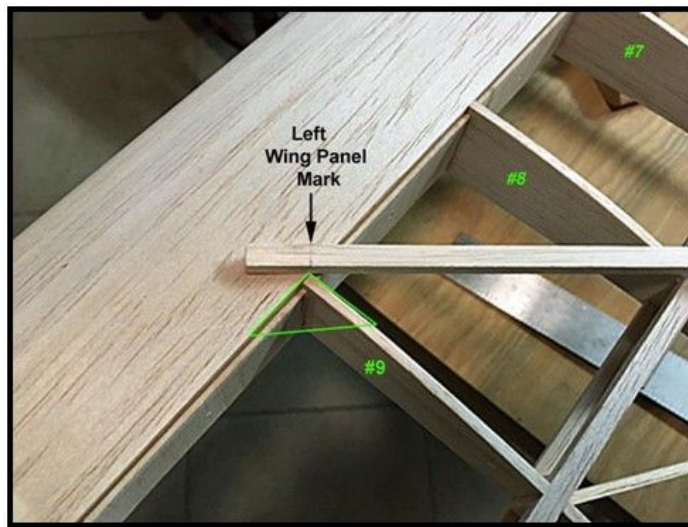
Point A

Then a mark was made on the strip where the inside face of rib #9 touched the strip as shown by the green triangle below.

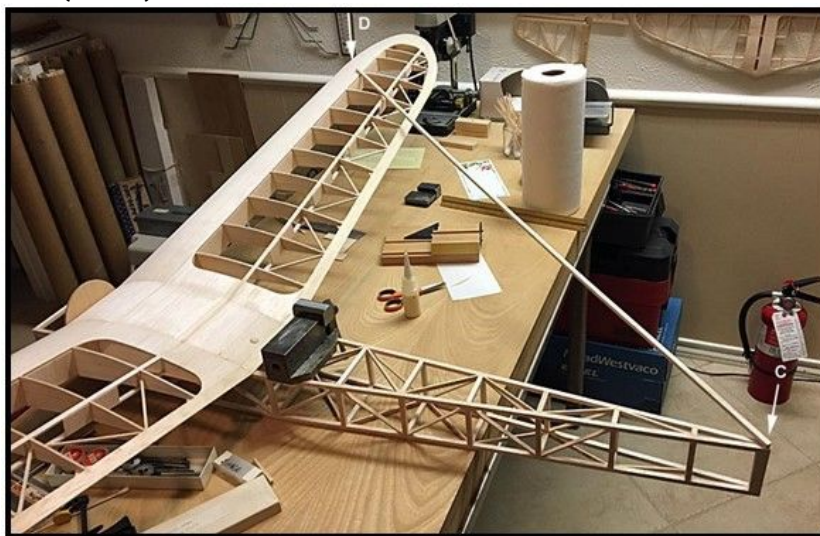
The 48" long 1/4" sq. balsa strip was then moved and placed between the fuselage's tail post (Point C) and the right wing's #9 rib (Point D) as shown below.

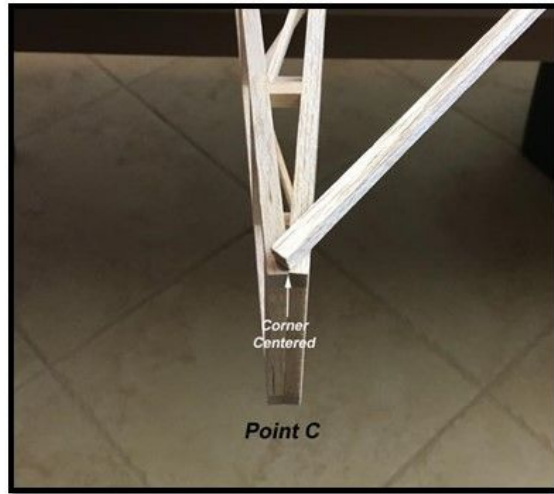
Again the corner of the 1/4" strip was centered on the tail post as shown below.
Point C

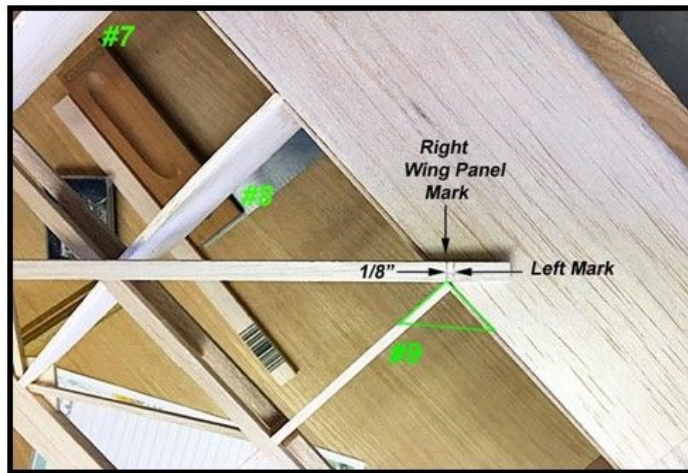
Point D

Then a second mark was made on the strip where the inside face of rib #9 touched the strip as shown by the green triangle below. The difference between the two marks was $\sim 1/8''$ as shown below. At the assembly level, getting this large wing's main spar perpendicular to the fuselage's center line to within an $1/8''$ is well within my building tolerance and certainly more than satisfactory.

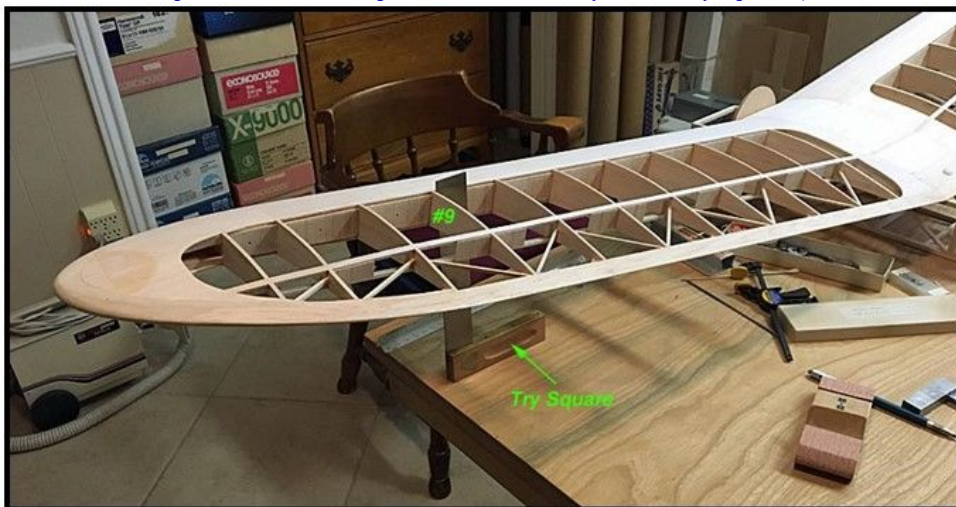
The Lancer's 83" wing span is too long to be able to measure the wing tip height above the work table. So the inside face of rib #9 shown below was selected for the measurement. A try square was placed on the work table and placed against the inside face of rib #9 to measure the height of the top of rib #9 as shown below.

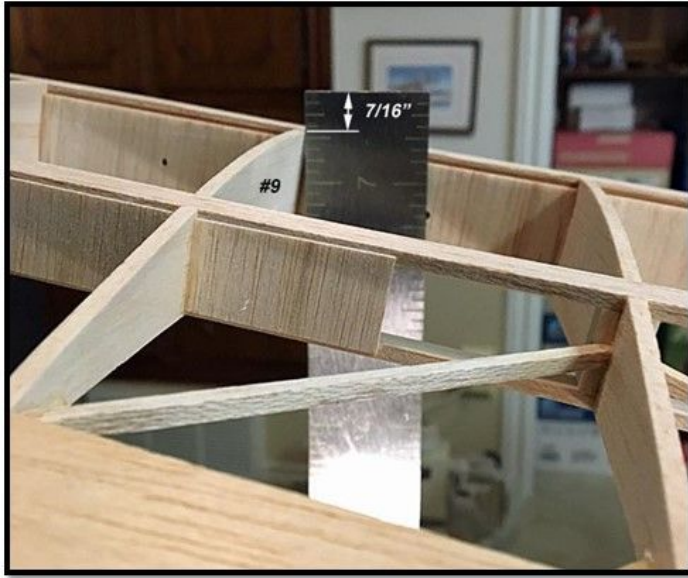
The top of the left wing's rib #9 was $7/16''$ below the end of the metal scale as shown below.

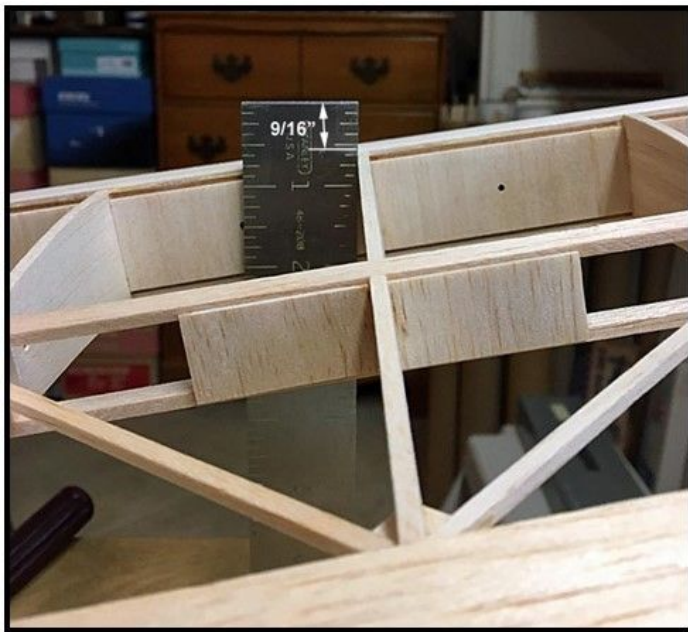
The top of the right wing's rib #9 was 9/16" below the end of the metal scale as shown below. The difference in these two heights was only ~1/8" which again is well within my building tolerance and is more than satisfactory.

Having shown the wing's alignment with the fuselage to be satisfactory, the next step will be to complete the fuselage's attachment block and permanently integrate it into the fuselage's 1/4" frame work.....Tandy
