Subject: 81 Lancer 850 - Completing Rear Wing Attachment

Report No. 81

New Cyclone Lancer 850

March 7, 2018

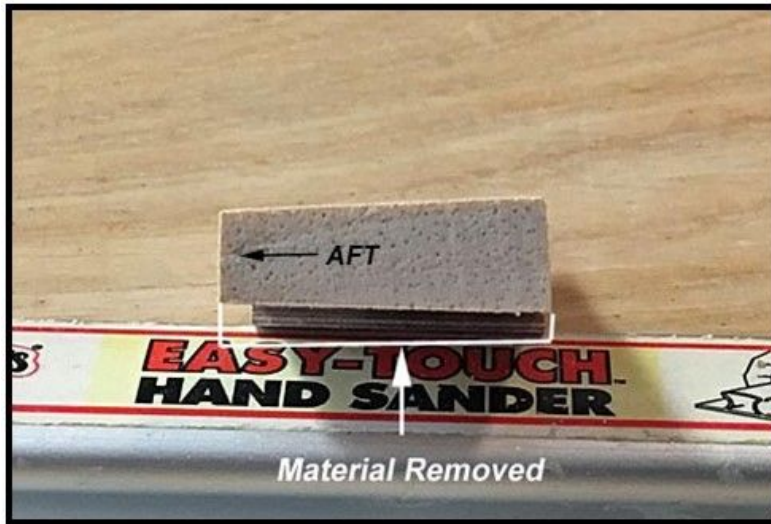
Having shown the wing's alignment with the fuselage to be satisfactory, the next step was to complete the fuselage's attachment block and permanently integrate it into the fuselage's 1/4" frame work. The bottom of the attachment block was carved and sanded down as shown below to be flush with the bottom of the top longerons.

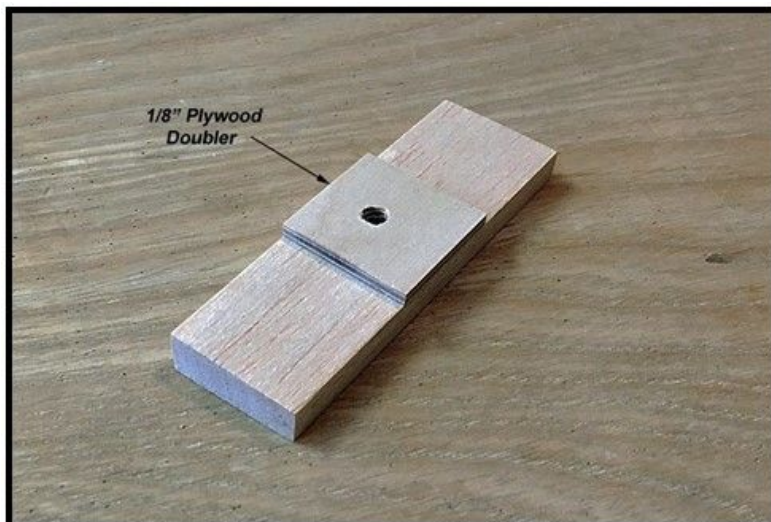
A 1-1/8" sq. plywood doubler was drilled and glued to the bottom attachment block as shown below. Then the 1/4-20 tap was run through the block and plywood to cut the threads in the doubler.

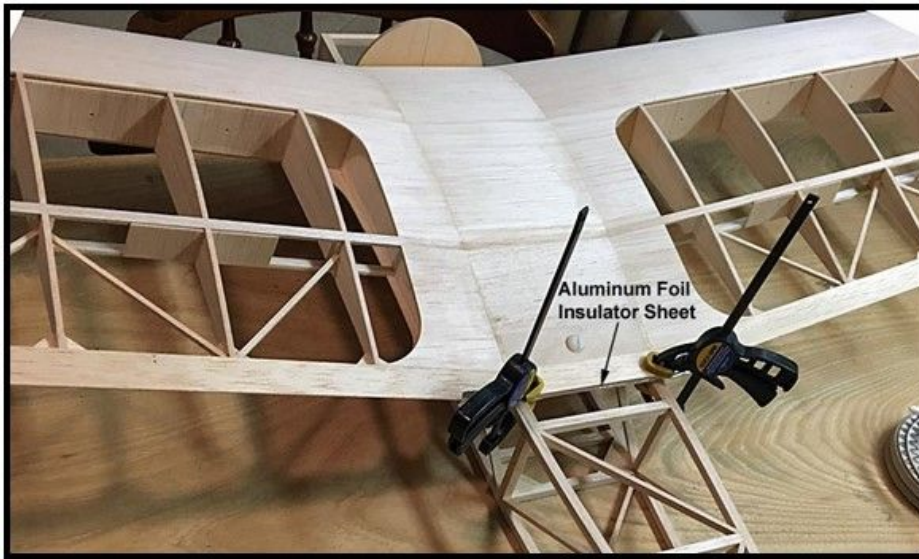
As you can see below, a piece of reversed trailing edge was placed on the center section's trailing edge and two Quick-Grip clamps were used to clamp the rear of the wing to the fuselage's two top longerons. The assembly was turned over and all of the excess glue was removed with a wet Q-Tip. Then the assembly was placed on the work table and left to dry overnight.

The ends of the attachment block were pre-glued with aliphatic glue and let dry. A sheet of aluminum foil was placed on the bottom of the wing's center section and folded over on top of the trailing edge to prevent any glue from accidentally sticking to the bottom of the wing's center section.

Next the attachment block was screwed to the bottom of the wing's center section. Aliphatic was brushed onto the insides of the longeron's spruce doublers. The attachment block was pushed down between the two top longerons and the wing was pushed forward which inserted the wing dowels into bulkhead C, slid the ends of the attachment block into the glue on the insides of the longeron's spruce doublers, and firmly positioned the wing on the fuselage's frame.

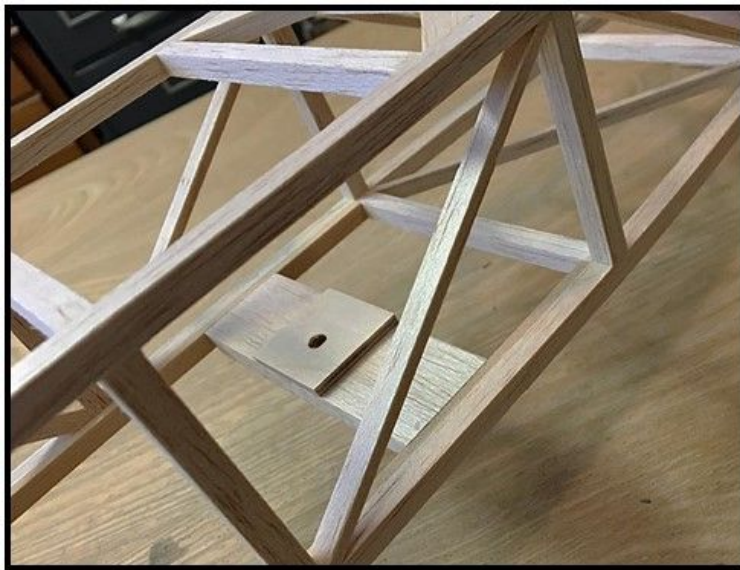
This morning the wing was removed. As you see, the butt joints of the bottom of the attachment block are in fact flush with the bottom of the top longerons.

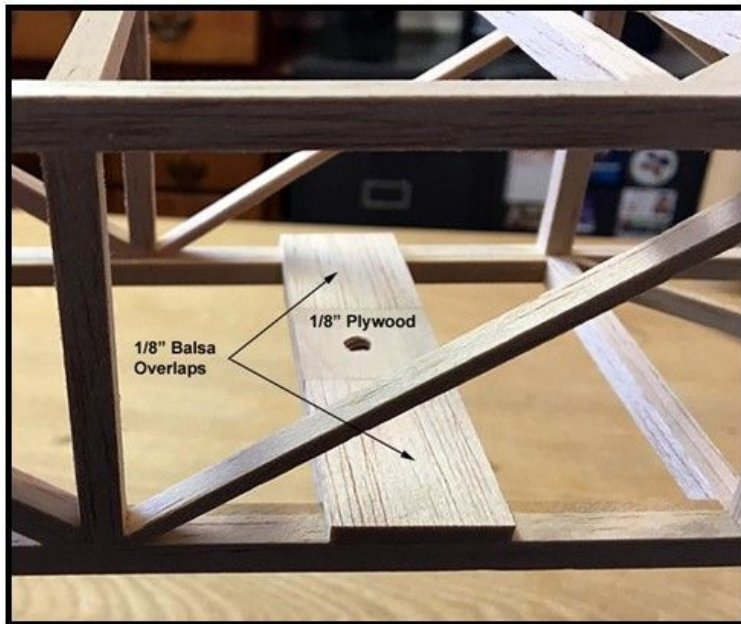
1/8" X 1-1/8" balsa doublers were glued on either side of the block and overlapped onto the longerons as shown below.

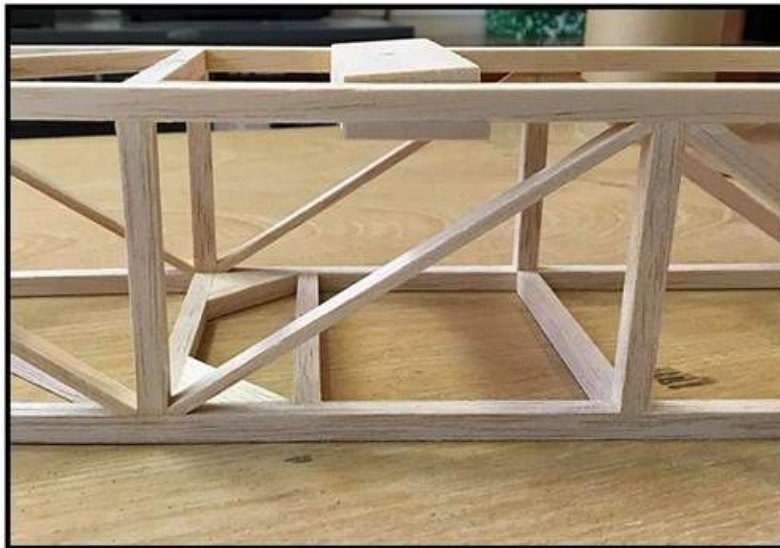
The picture below shows the attachment block glued to the top longerons. Additional support structure will be needed to transfer some of the attachment block's load down into the lower longeron, however this issue will be addressed at a later date.

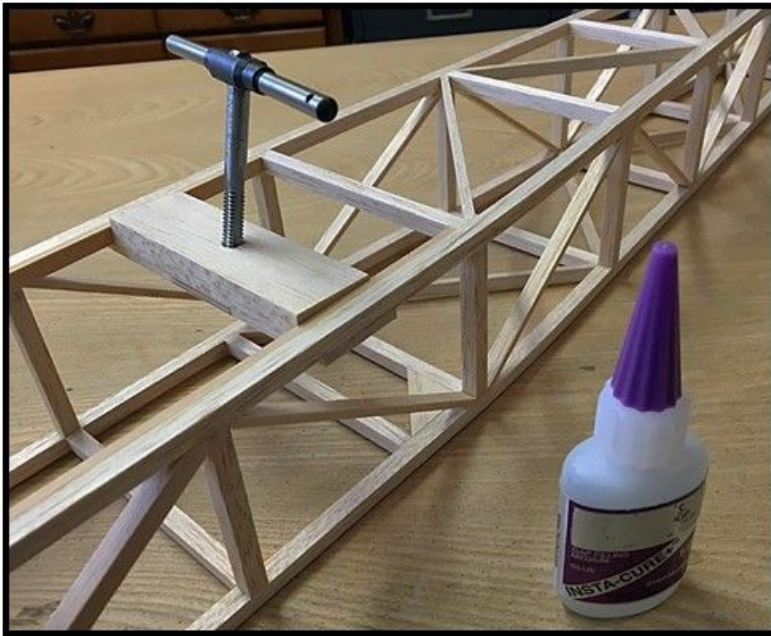
The 1/4-20 threads inside the attachment block were coated liberally with medium CA to harden the threads. Once the CA had hardened, a 1/4-20 tap was run through the threads as shown below to make sure they were clean and smooth.

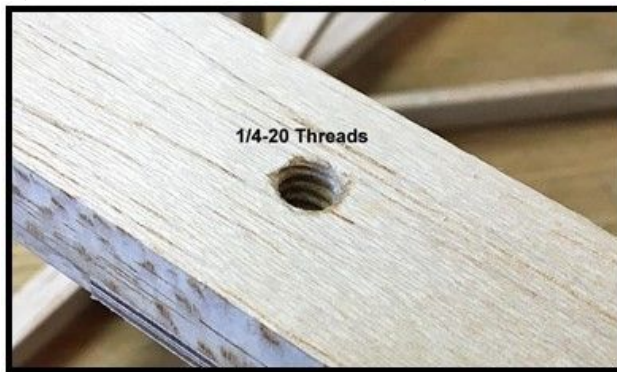
This is a close up of the harden threads in the top of the balsa attachment block.

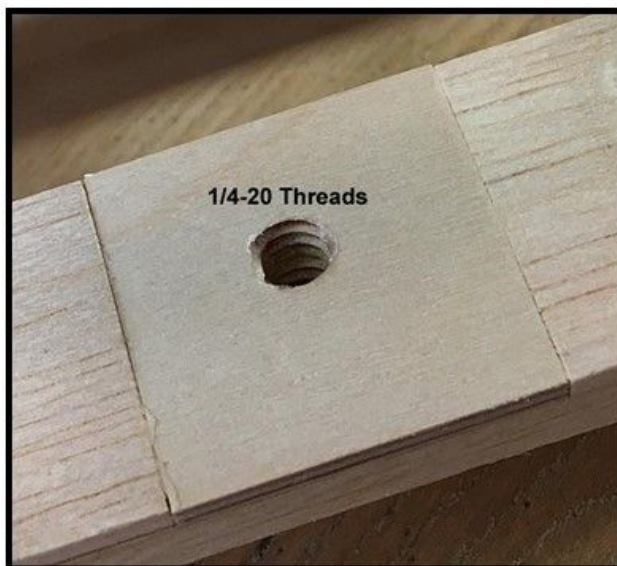
This is a close up of the harden threads in the 1/8" plywood doubler on the bottom of the attachment block.

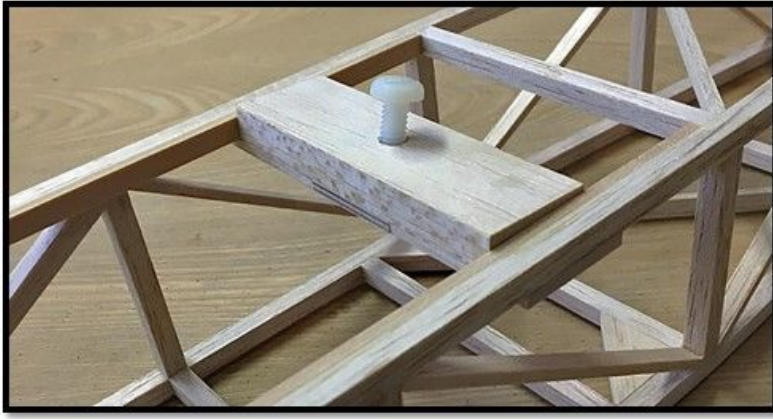
This picture shows a trial fit of the wing attachment's 1/4-20 nylon screw threaded into the attachment block. The feel of the screw verified that the threads were a good fit.....Tandy
