From: "Tandy Walker" <rdb435021@icloud.com>
To: "Tandy C. Walker Cloud" <rdb435021@icloud.com>
Date: 4/9/2018 12:18:15 PM
Subject: 108 Lancer 850 - Reworking The Tail Post (Part 2)

Report No. 108
New Cyclone Lancer 850
April 8, 2018

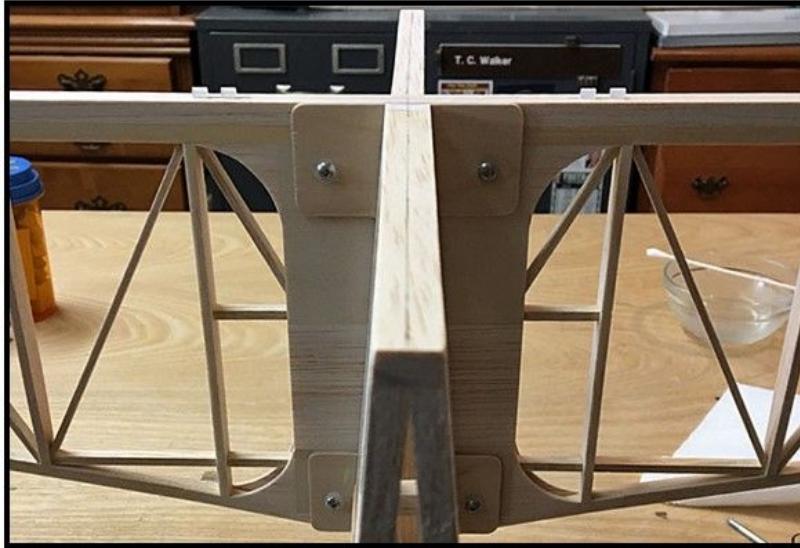
This report deals with the modifications necessary to correct the fuselage's misaligned tail post with the fin center line shown below.

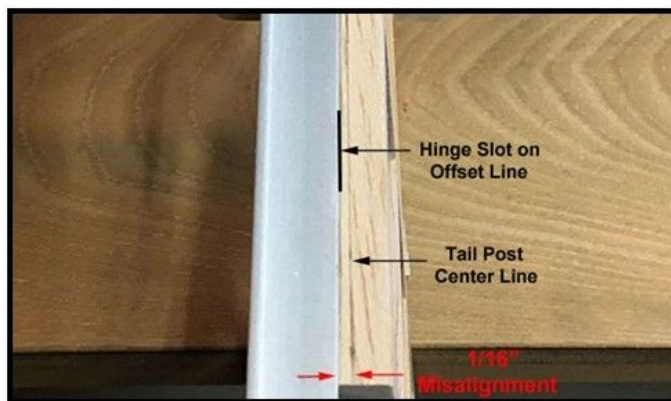
This morning the hinge slots were located on the fuselage's tail post to match those on the rudder and cut in along the offset line shown below.

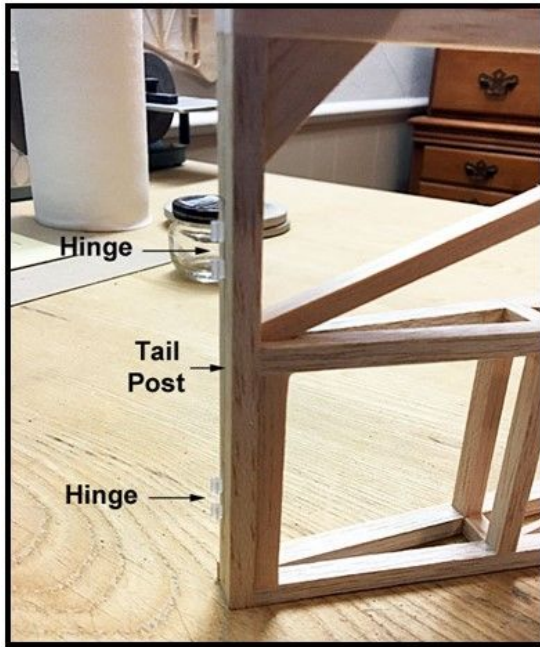
The tangs on the two hinge halves were cut down to 1/4" and inserted in the tail post as shown below.

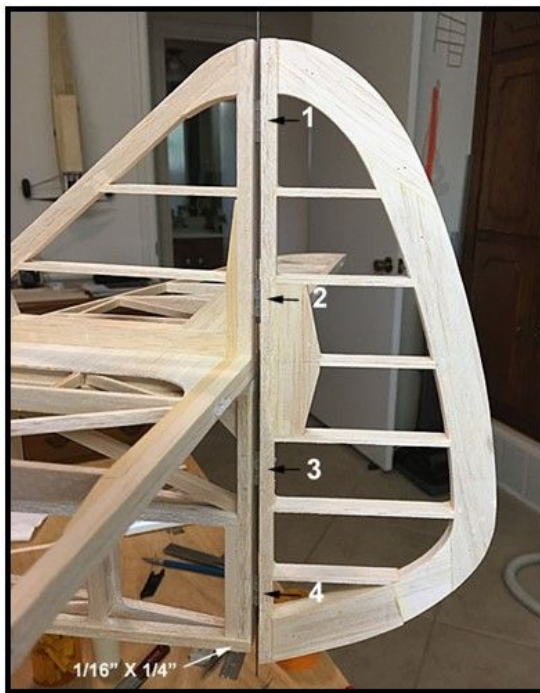
The tail assembly was mounted on the fuselage's stab platform and rudder was attached by inserting a continuous 0.031" hinge pin wire through the four hinges as shown below. A strip of 1/16" X 1/4" balsa was glued on the outside of the left bottom longeron as you can see below. As it turned out, a 3/32" piece would have been too thick.

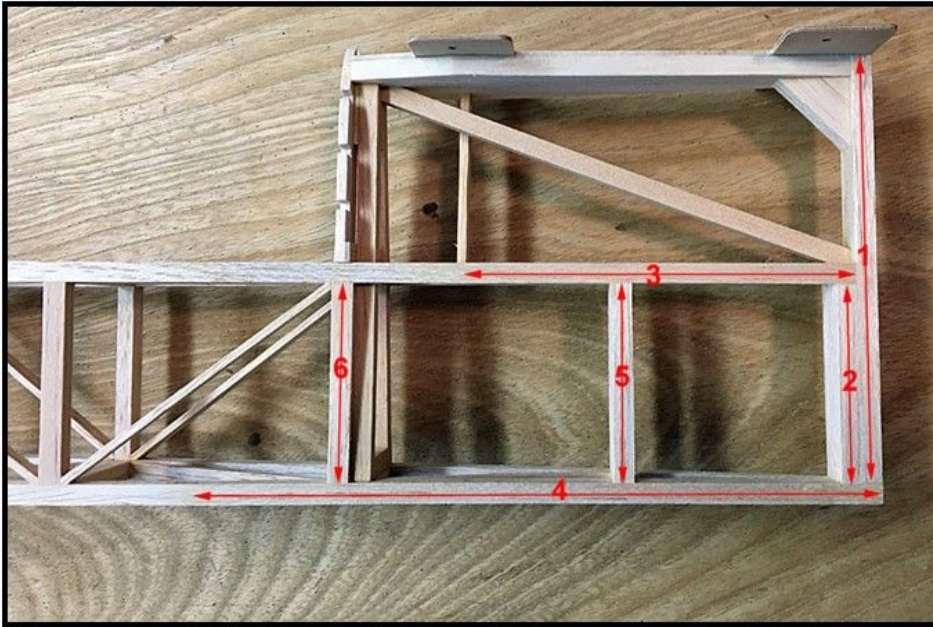
To build up the left side of the tail post, a total of six 1/16" X 1/4" strips were glued on the outside of the fuselage structure as shown in red below. By extending the strips forward (i.e., No.4), the buildup started out a 1/16" at the tail post and then feathered into the structure at the forward end, which helped to disguise the misalignment correction. Also strip No. 1 started out a 1/16" at the bottom of the tail post and then feathered into the structure at the top.

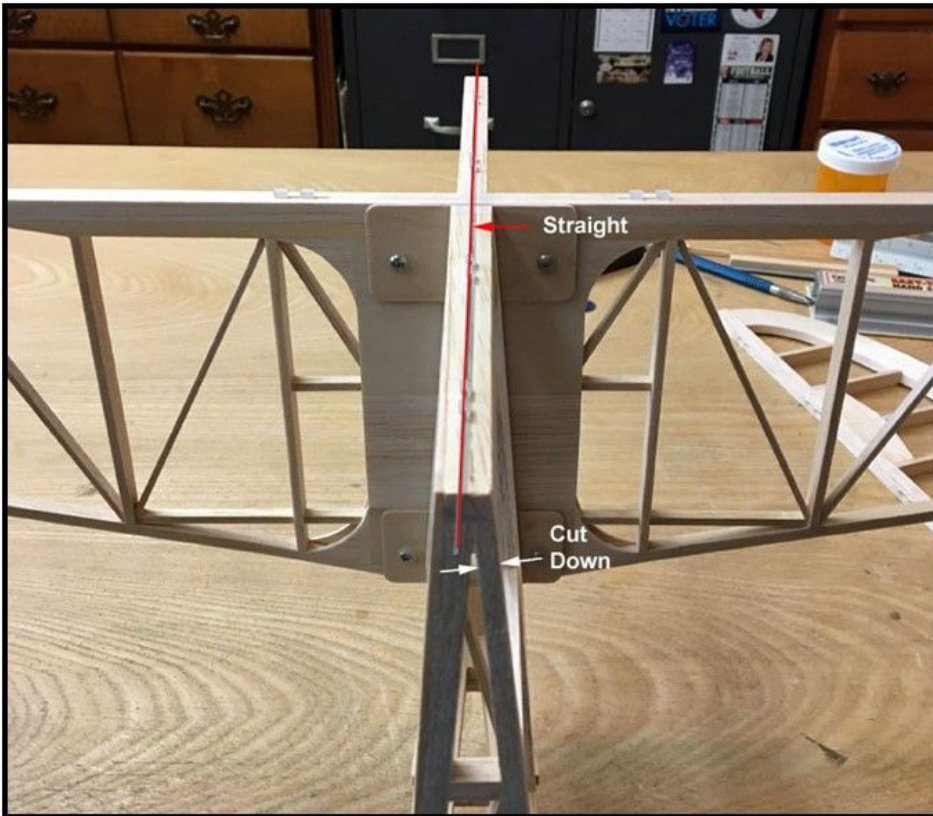
The right side of the fuselage was carved and sanded down a 1/16" at the bottom of the tail post as you can see, but not up at the top. All of these modifications successfully eliminated the tail post misalignment, which aligned it with rudder's straight hinge line as shown in red below.

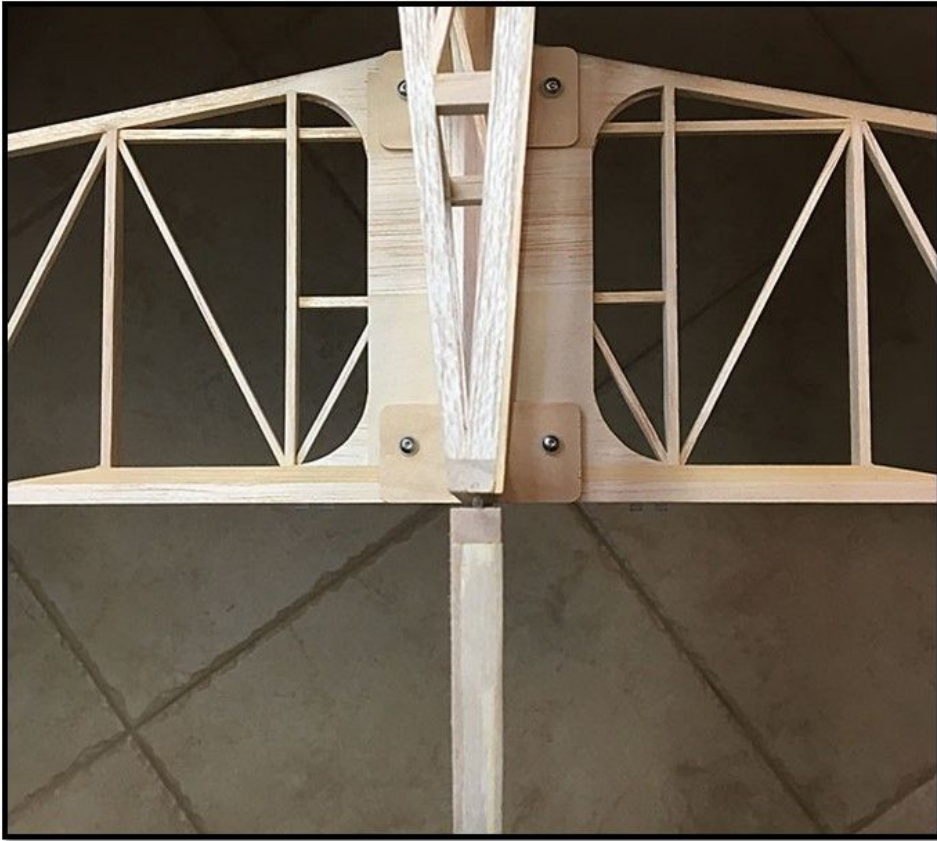
This bottom view picture shows the tail post is now correctly aligned with the rudder.
