From: ["Tandy C. Walker" <tandyw@flash.net>](mailto:tandyw@flash.net)  
To: ["Walker, Tandy C." <tandyw@flash.net>](mailto:tandyw@flash.net)  
Date: 12/31/2008 4:09:43 PM  
Subject: 24 Sailplane Elevator Construction and Hinging

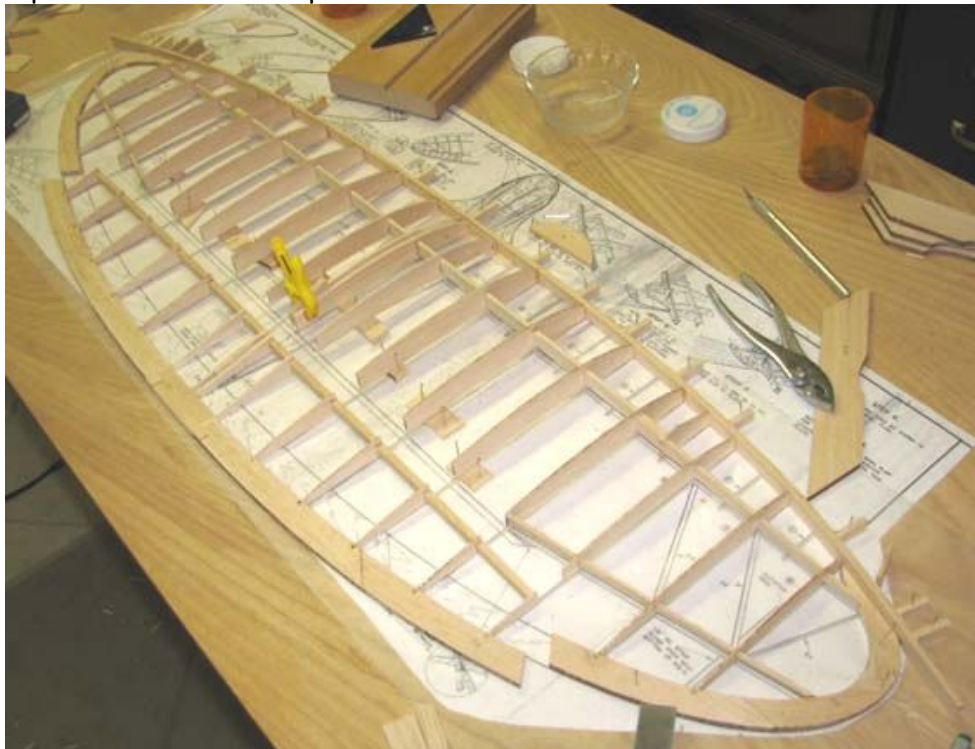
So this afternoon I have to get the model room cleaned up and the Sailplane stab put away for a while. I did want to update you guys on my stab/elevator work in progress. Remember back on the December 11th in Report No. 17, I separated the elevator portion of the stab as shown below.

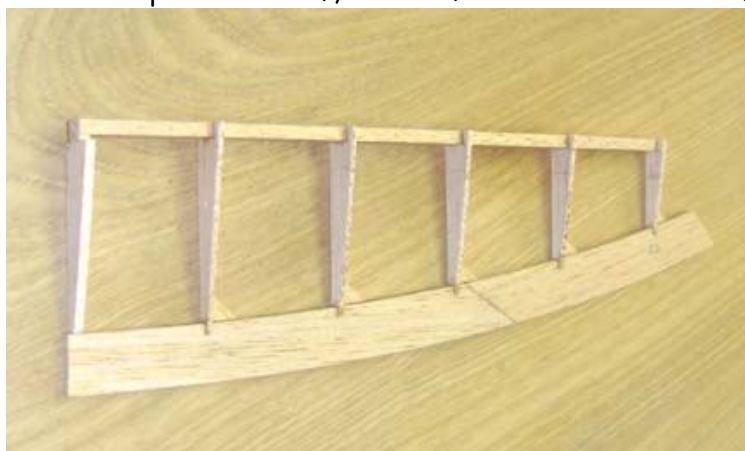
After cutting the elevator portion in half, I was left with an elevator half as shown below.

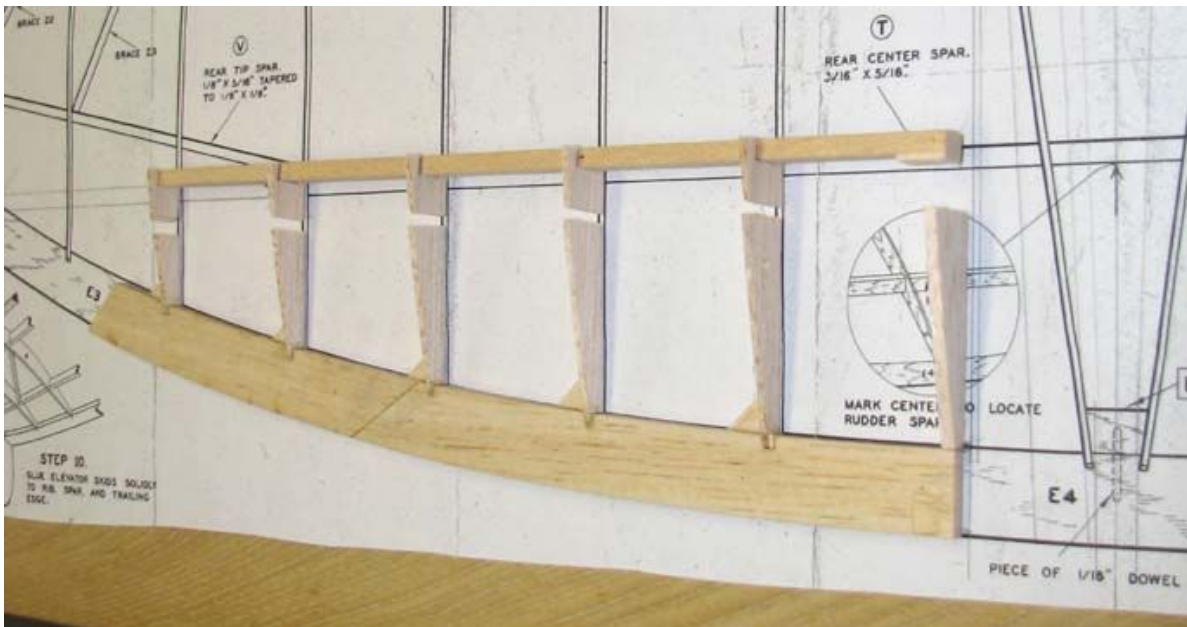
Accounting for the widths of the stab and elevator spars as well as width of the hinges, I cut off the leading edges of all of the elevator ribs as shown below.

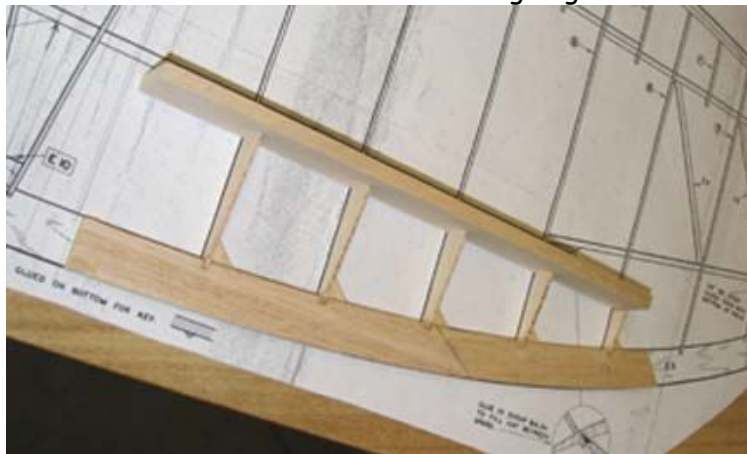
Next I installed a new 1/4" elevator leading edge as shown below.

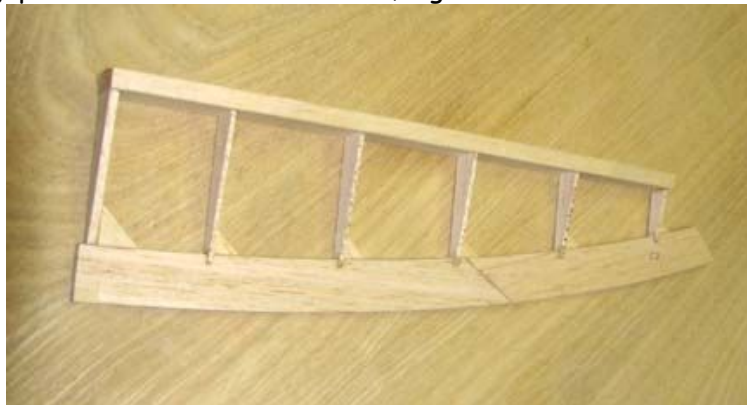
Once the gap of root rib was established, I glued in the root rib as shown below.

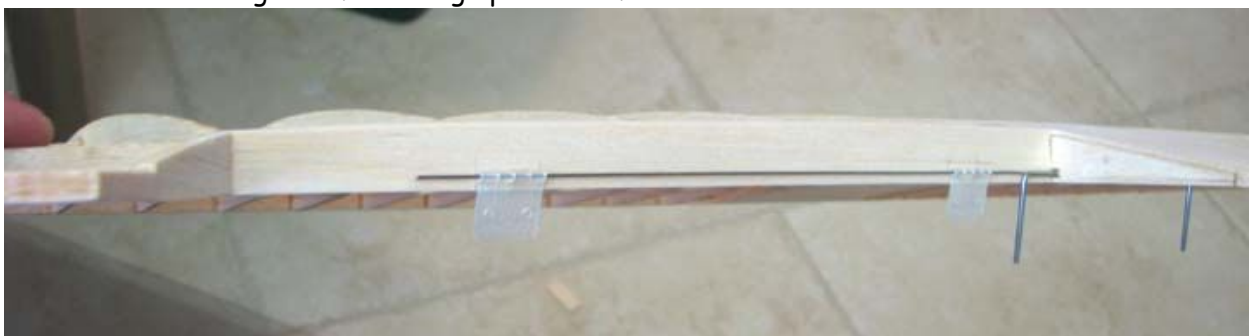
Next I installed the Klett hinges in the stab and elevator halves. The hinges on left side of the stab trailing edge are shown below along with .031" hinge piano wire.

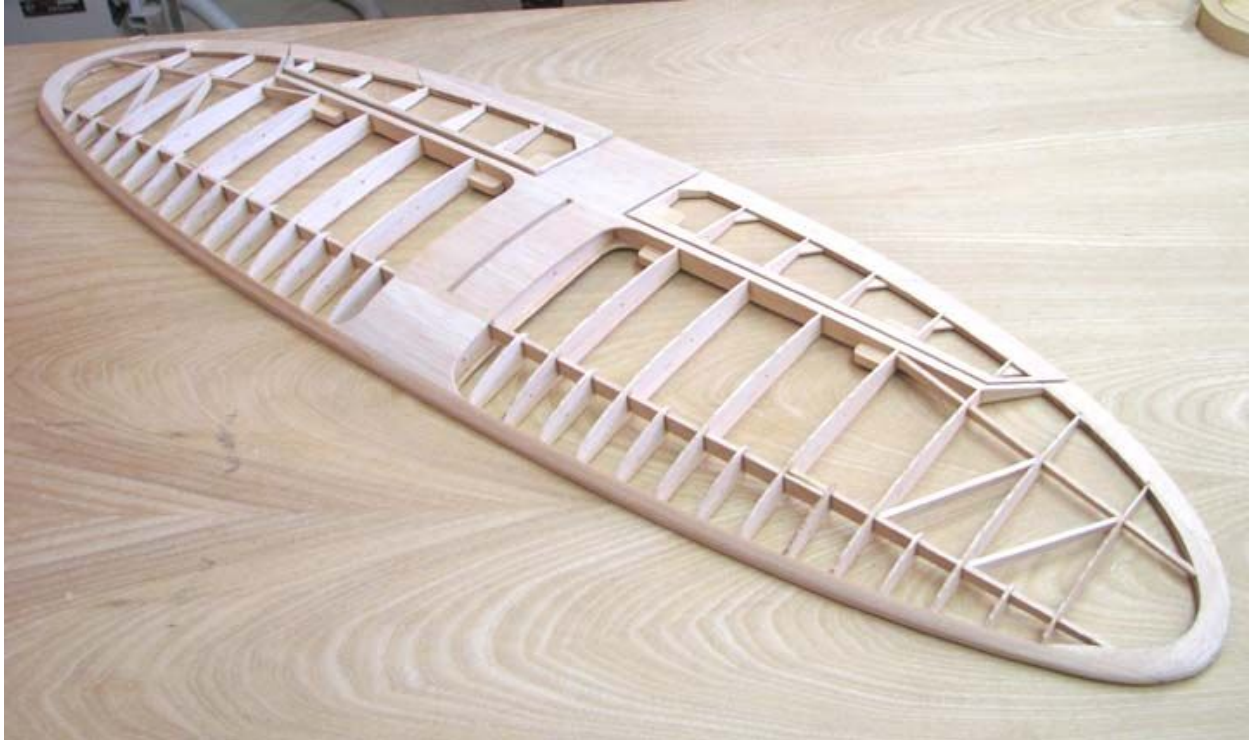
I went through a very frustrating and extremely difficult time getting each of the elevator halves properly aligned with the cut outs in the stab. I will just leave it at that because I am not sure I even have the ability to describe what all I had to go through to accomplish this task. However, the bottom line is shown in the picture below with the elevator halves installed and hinged in the stab cut outs.

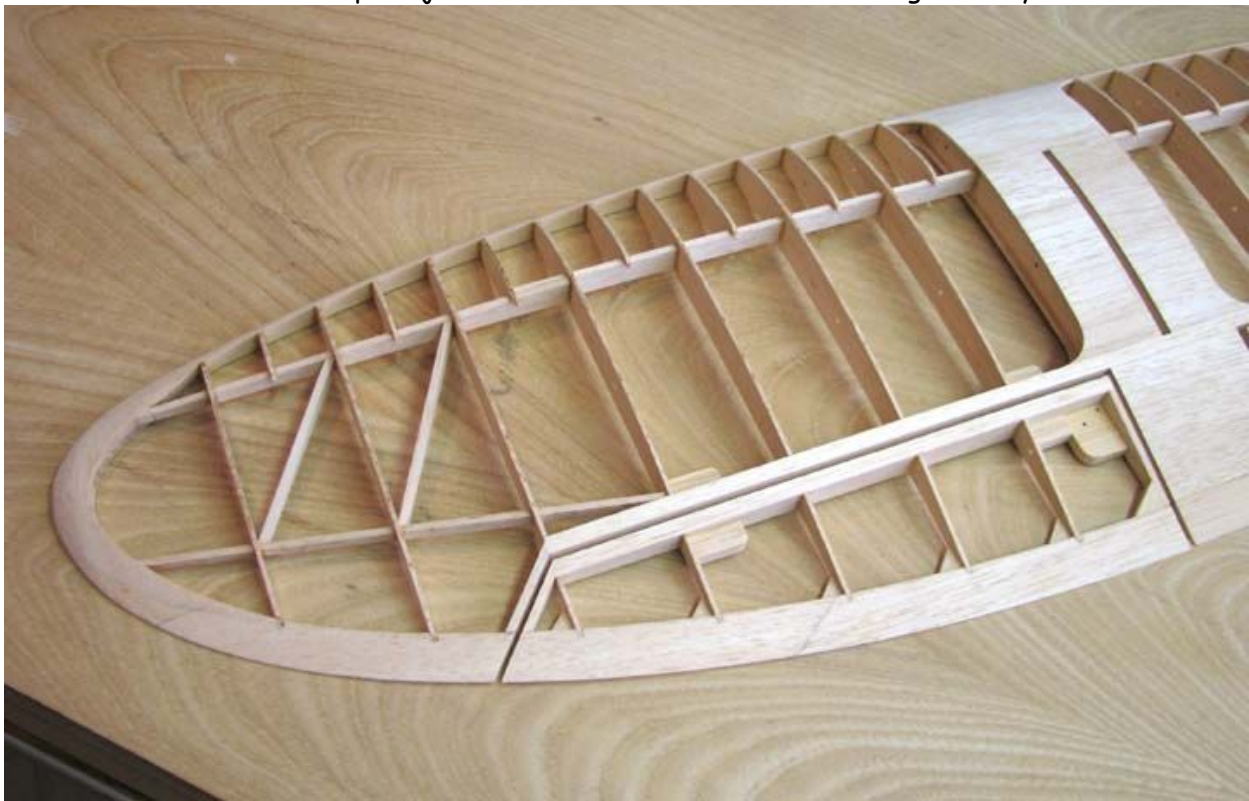
This shows the left side of the stab. The stab tip and the left side of the leading and trailing edges have been contoured and sanded to shape. I just haven't had the time to do the right side yet.

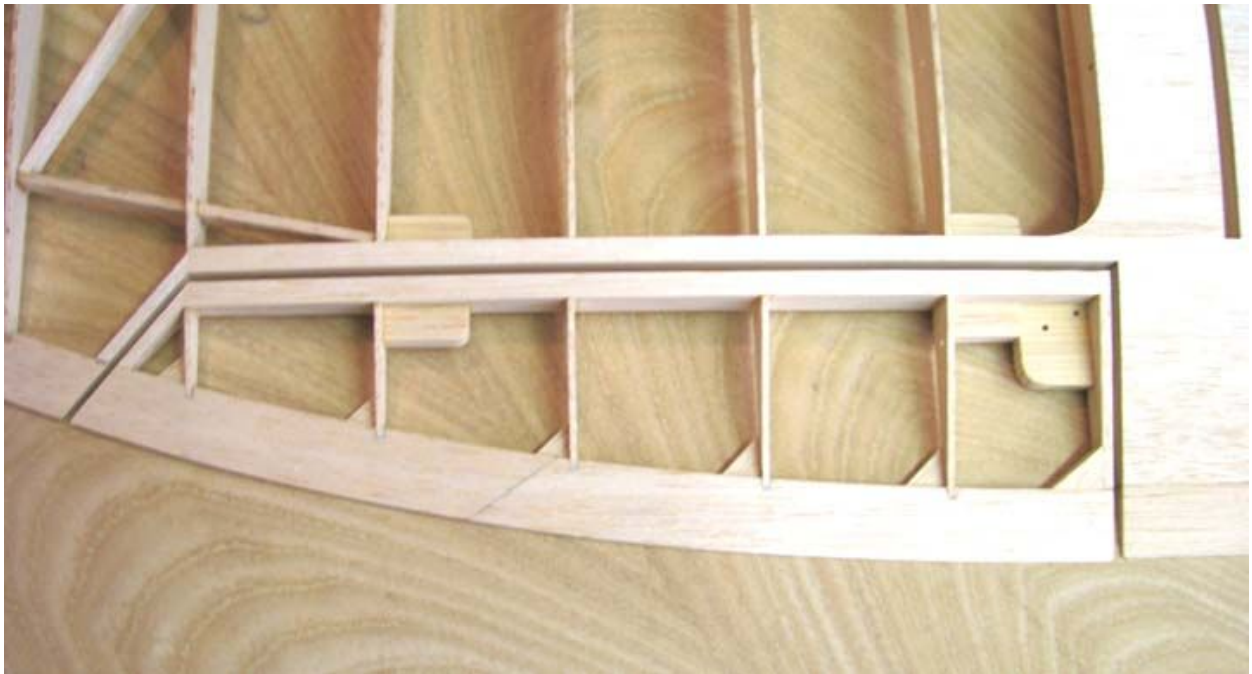
This is a close up attempting to show the gapped interface of the left elevator half in the stab cut out.

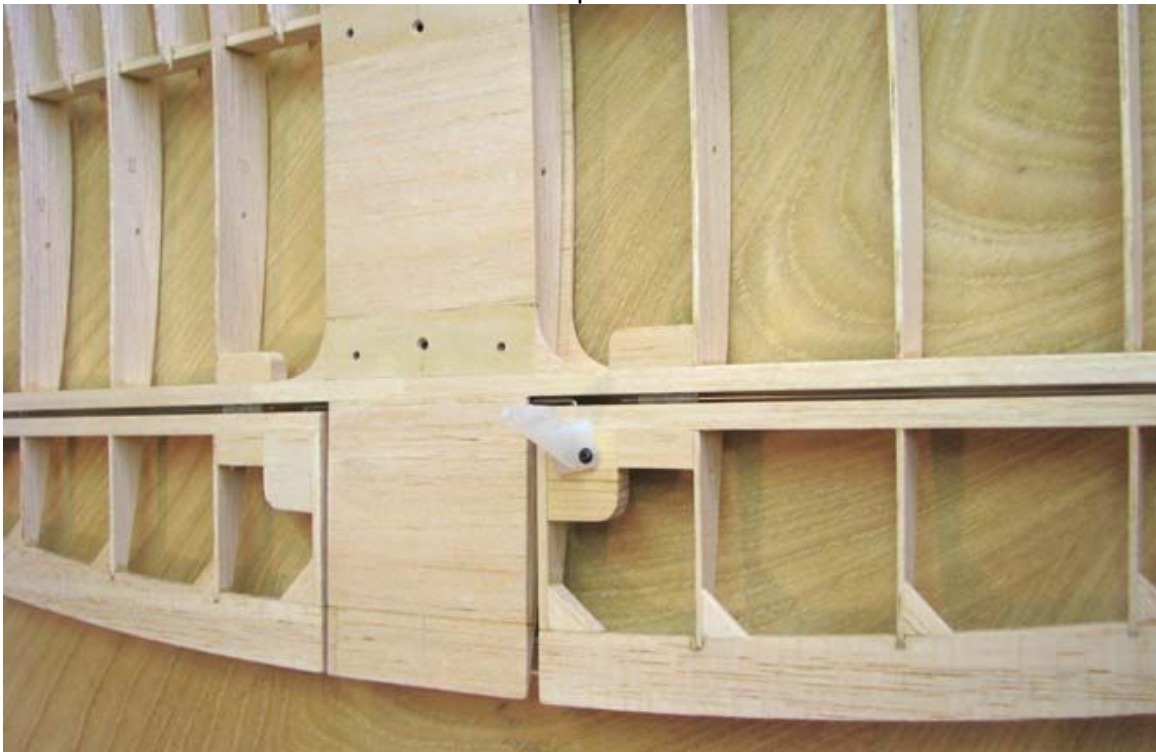
This picture of the bottom of the stab was taken to show the elevator's control horn that is mounted on a spruce block that also contains a brass tube for 1/16" piano wire elevator connector to slide into.

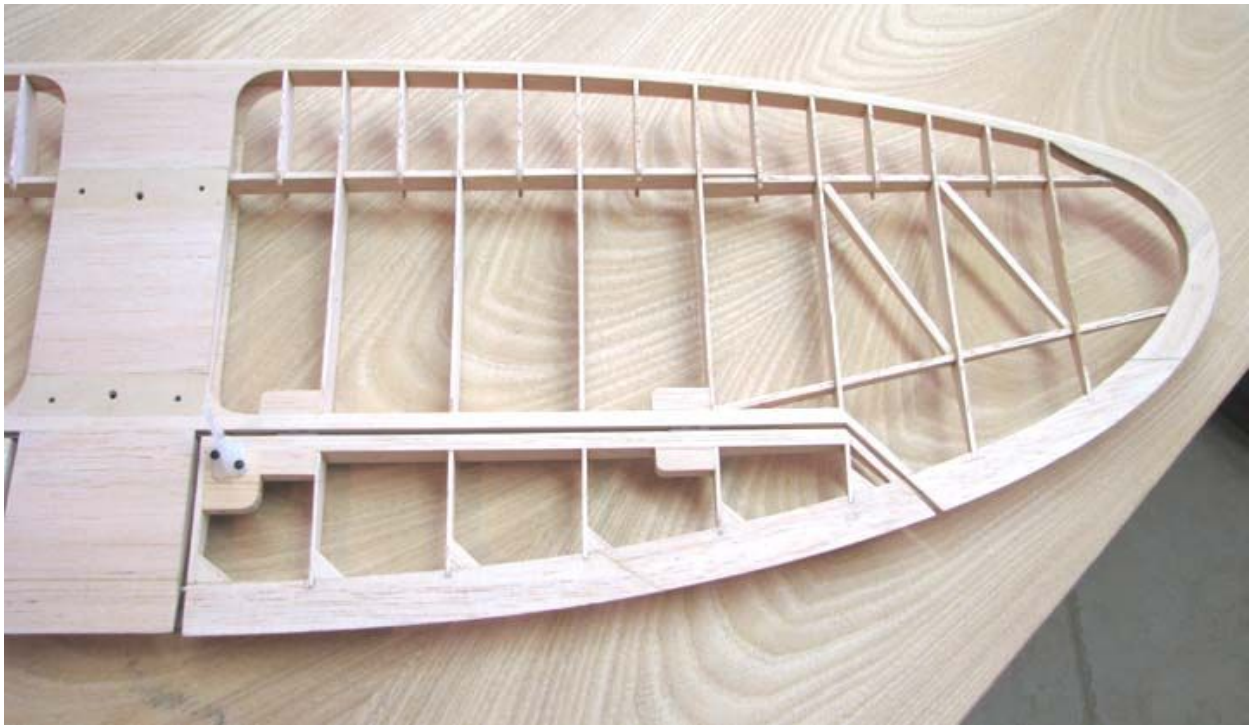
This last picture shows the entire bottom of the left side of the stab.
