From: ["Tandy C. Walker" <tandyw@flash.net>](mailto:tandyw@flash.net)
 To: [Undisclosed-Recipient:](#)
 Date: 4/29/2009 9:28:49 AM
 Subject: 87 Sailplane Pylon Construction and Integration with the Fuselage

Comet Sailplane Project

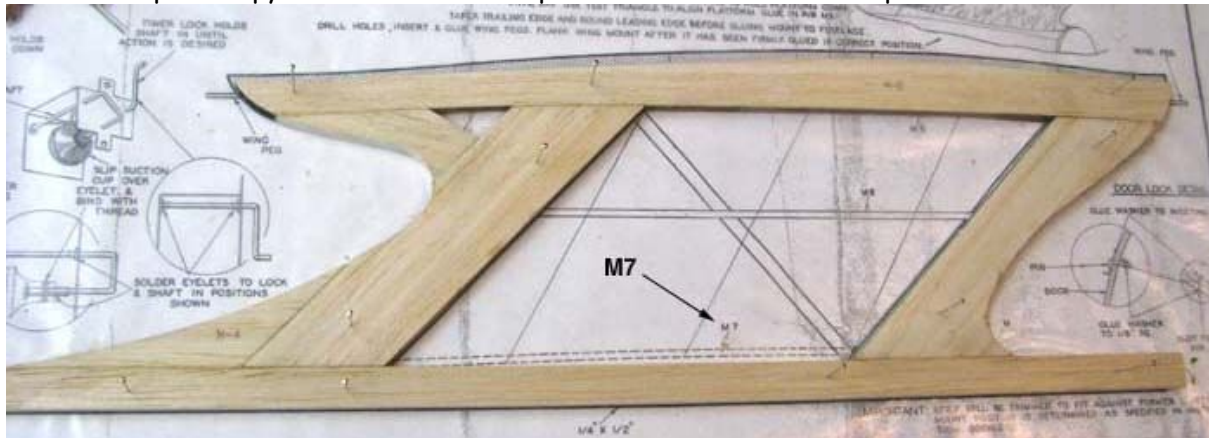
The Sailplane's pylon core is framed up out of 3/16" sheet balsa pieces as shown below.

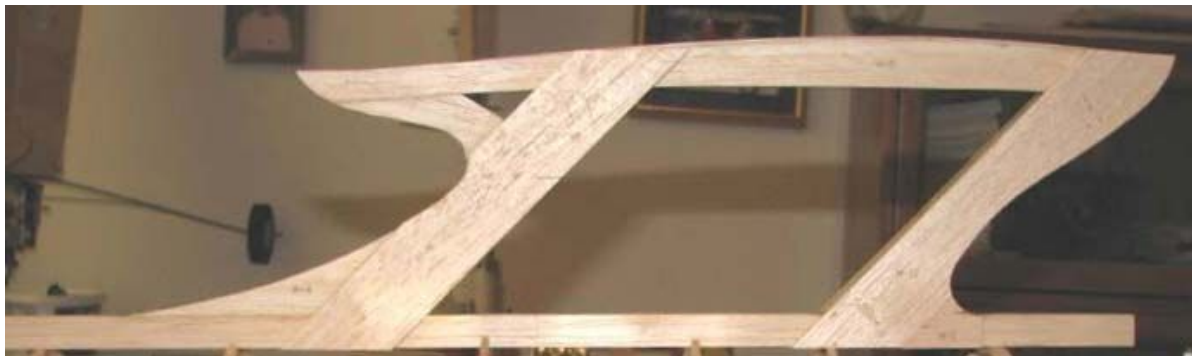
The fore and aft vertical members of the pylon core are overlaid on both sides with 3/16" doublers as shown below.

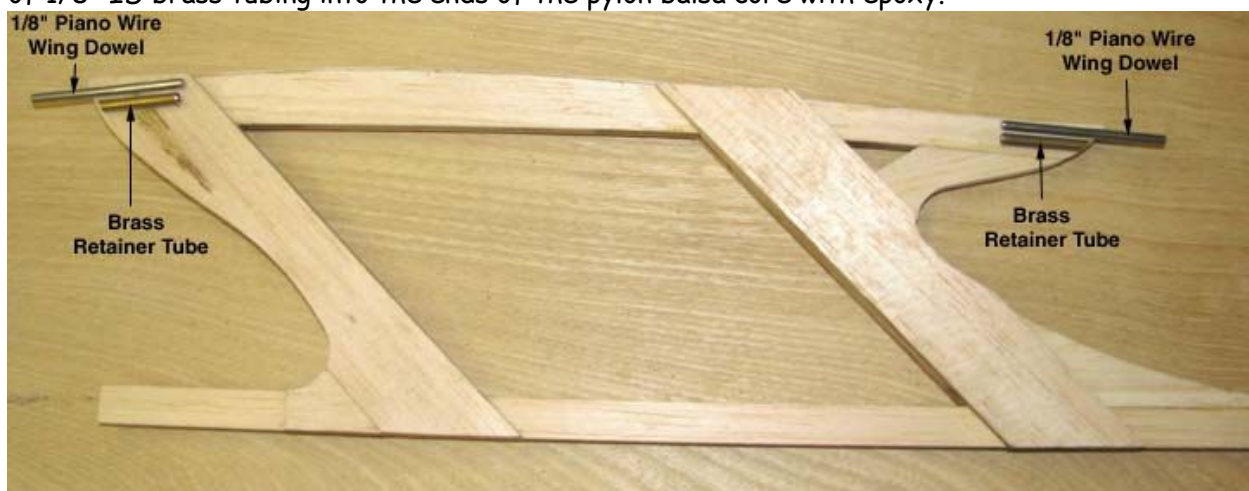
1/8" piano wire was used for the wing dowels as shown below. They were made removable by embedding pieces of 1/8" ID brass tubing into the ends of the pylon balsa core with epoxy.

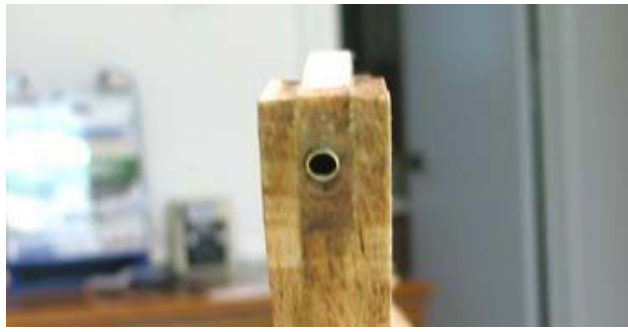
This is a picture of the front brass tube epoxied into the pylon balsa core.

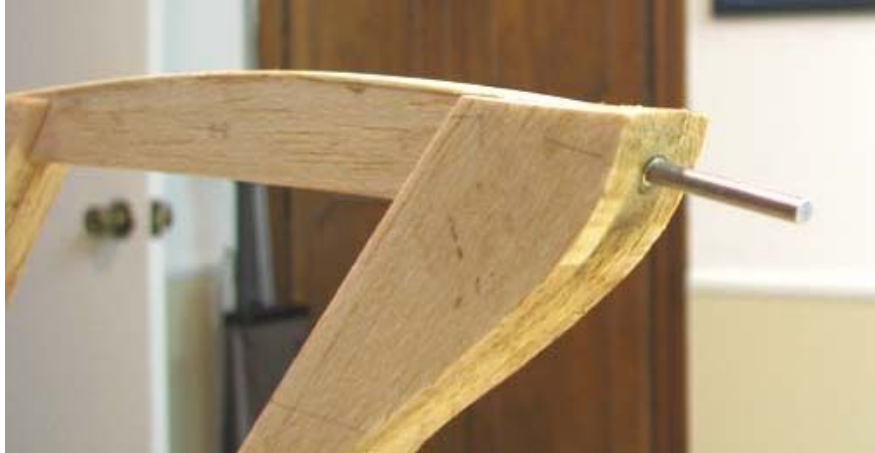
The 1/8" piano wire wing dowel is inserted into the brass tube as shown below.

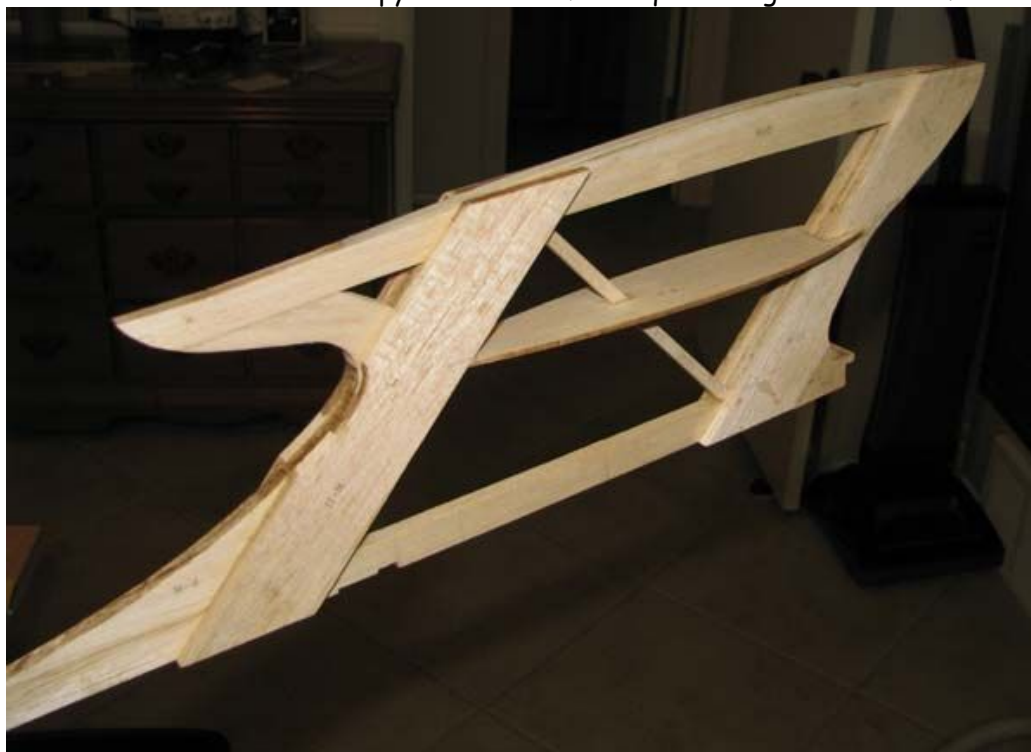
This shows the center pylon rib and 3/16" square diagonal installed.

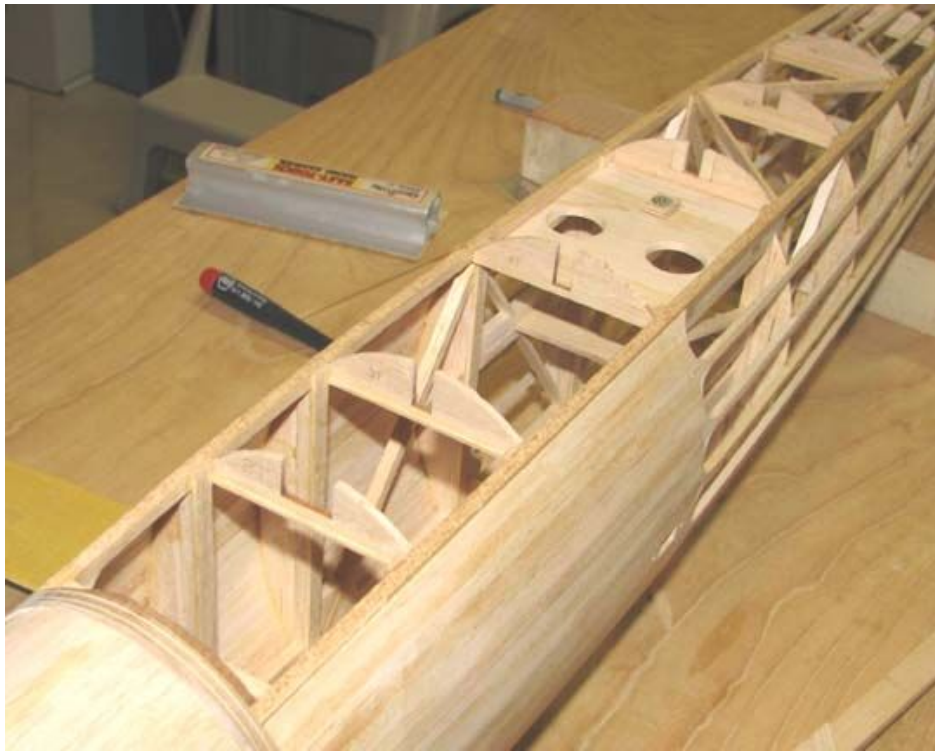
This picture shows the notches in the fuselage's five top bulkheads for the pylon frame.

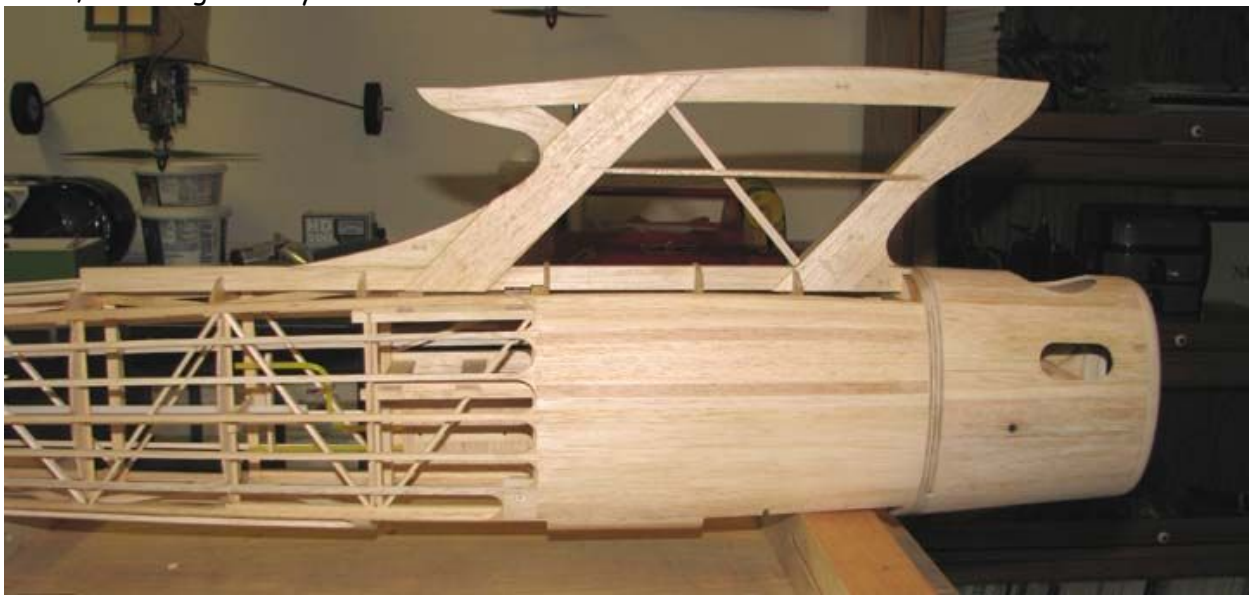
The lower pylon member was cut to length and the frame inserted into the fuselage bulkhead notches as shown below, but not glued in yet.

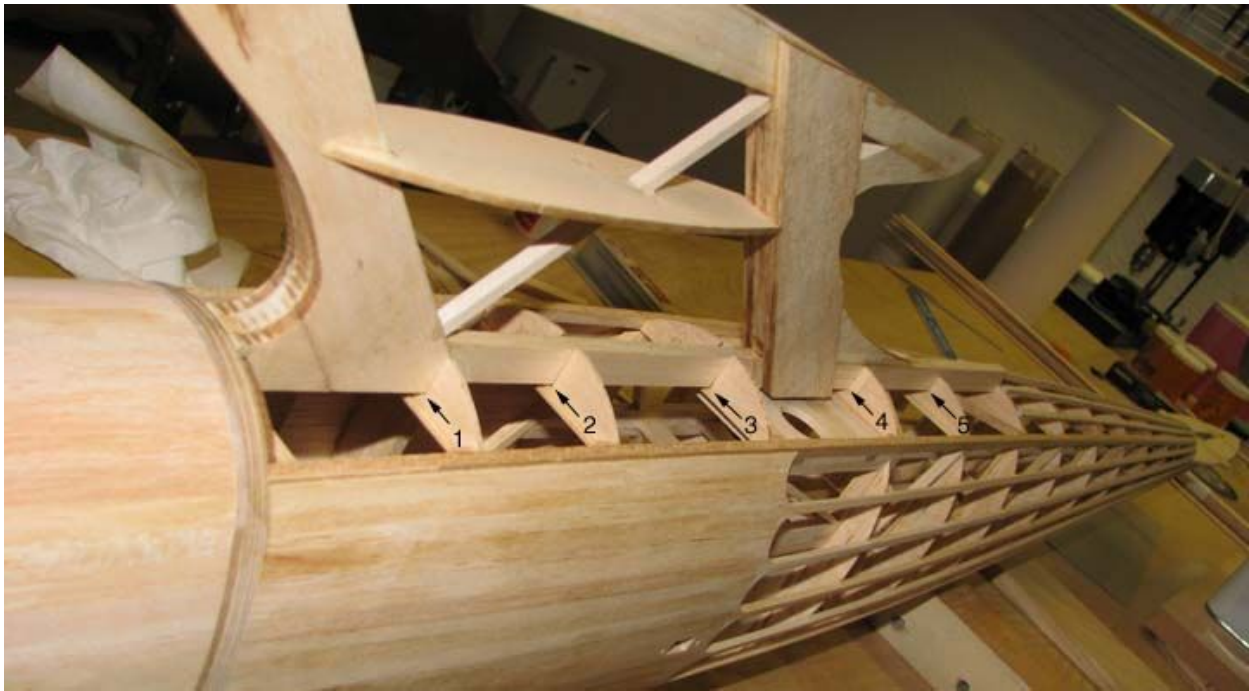
In the picture below, the pylon's lower frame member fits down onto the bottom of each of the five notches, insuring the proper incidence alignment. This a testimony to the accuracy of the laser cut parts.

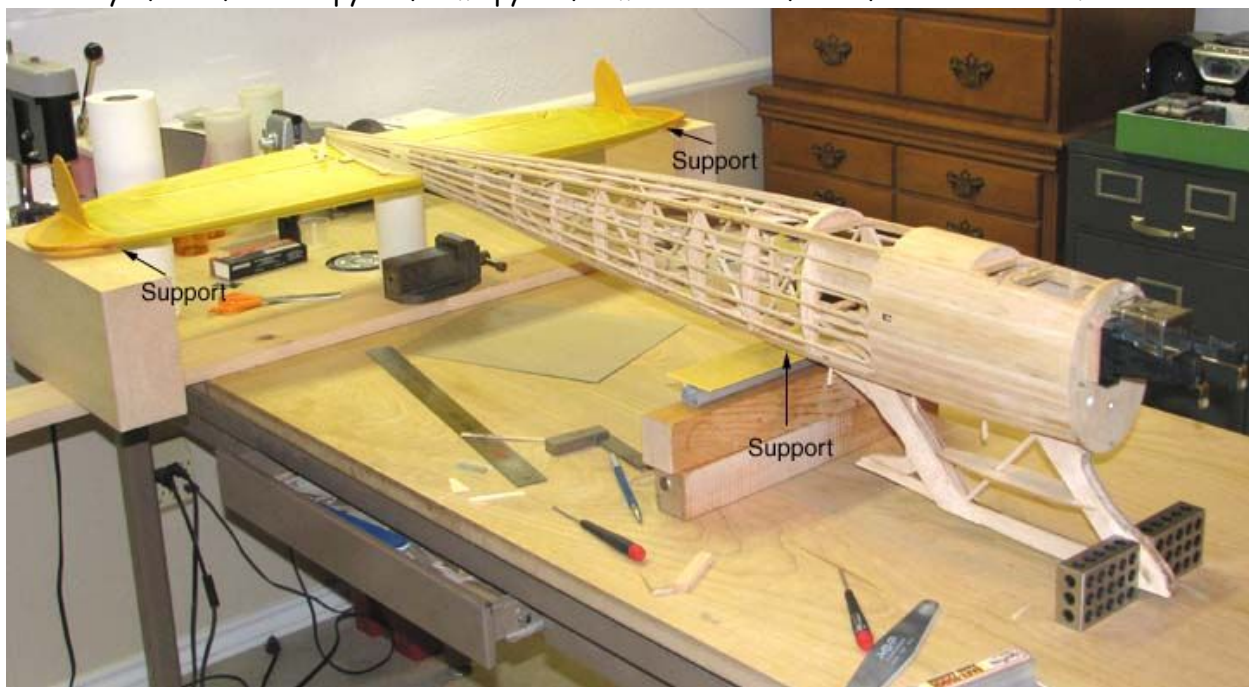
In order to align the pylon frame vertically, the stab was attached to the fuselage, which was inverted on the work table and supported in three places. The pylon frame does not contact the work table as shown below. The stab was supported parallel to the top of the work table and two steel squares were used to check the perpendicularity of the forward pylon frame to the surface of the work table.

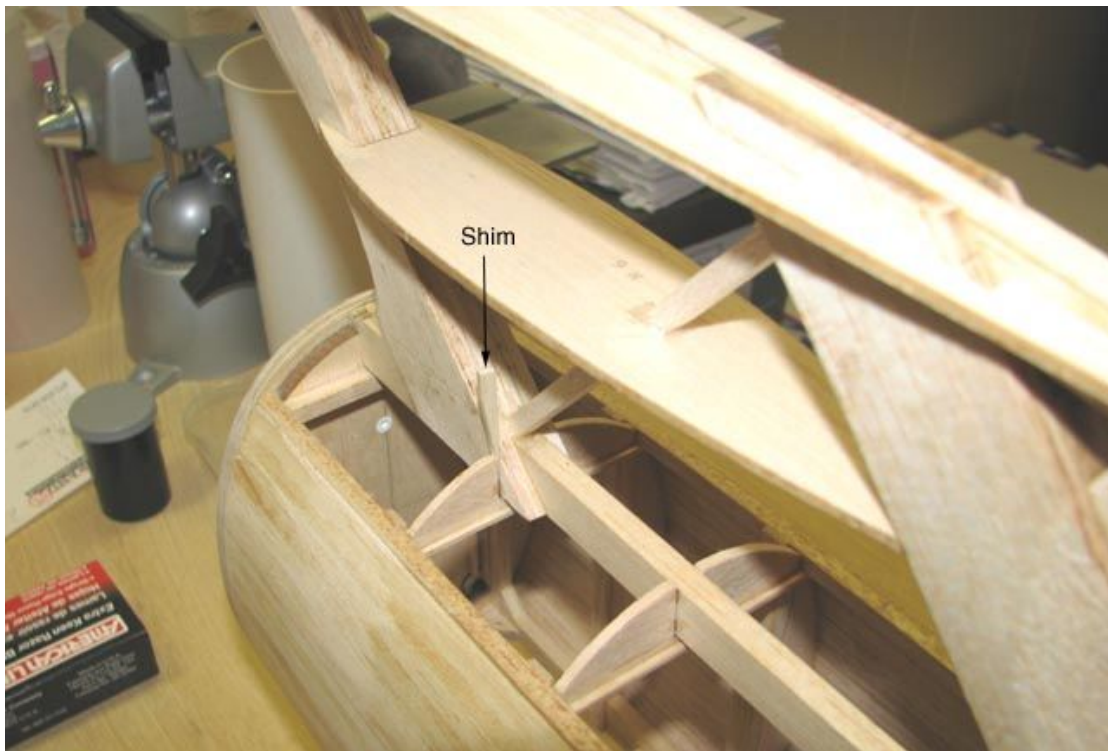
Only slight shimming was required to align the pylon vertically as shown below.

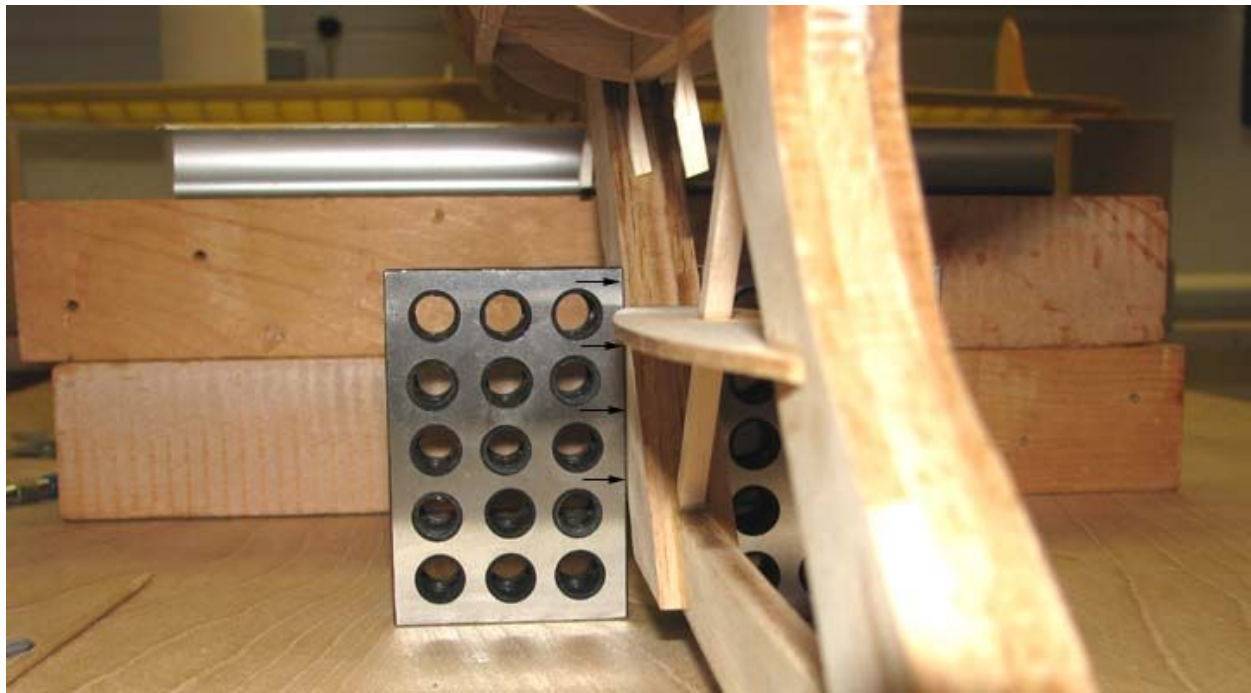
A second perpendicularity check was made with the steel squares on the rear pylon frame to the surface of the work table. In the picture below, notice the rear pylon frame contact all along the steel square's vertical surface as the arrows show.

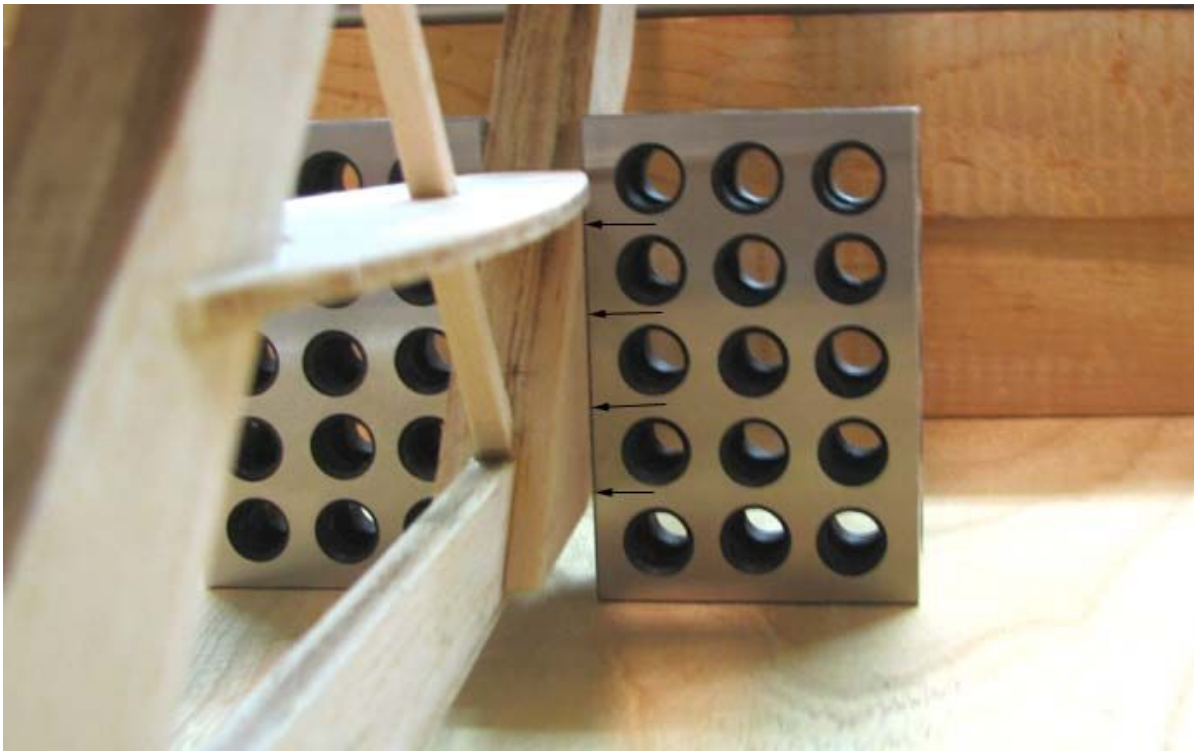
In the picture, the other side of the rear pylon frame also contacts all along the steel square's vertical surface as the arrows show.

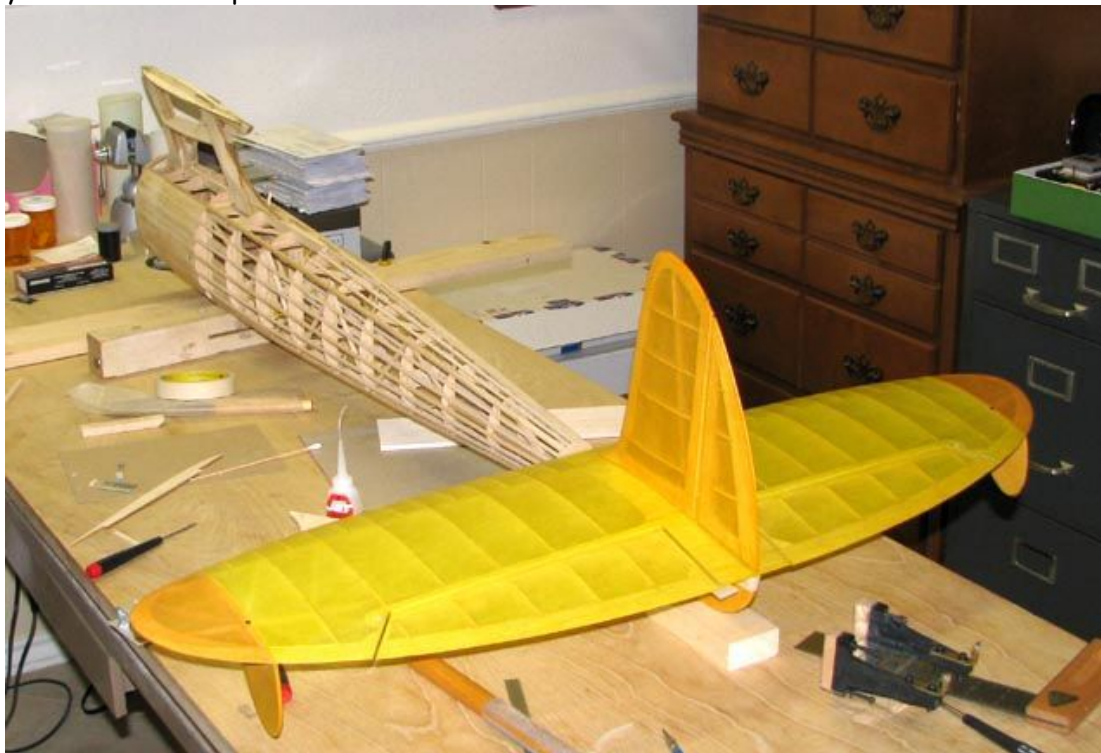
The picture below shows the pylon frame tacked glued in place on the fuselage structure. Notice that the top rib has been installed on the pylon frame. The bottom pylon rib will not be installed until the fuselage planking around the pylon frame is completed.

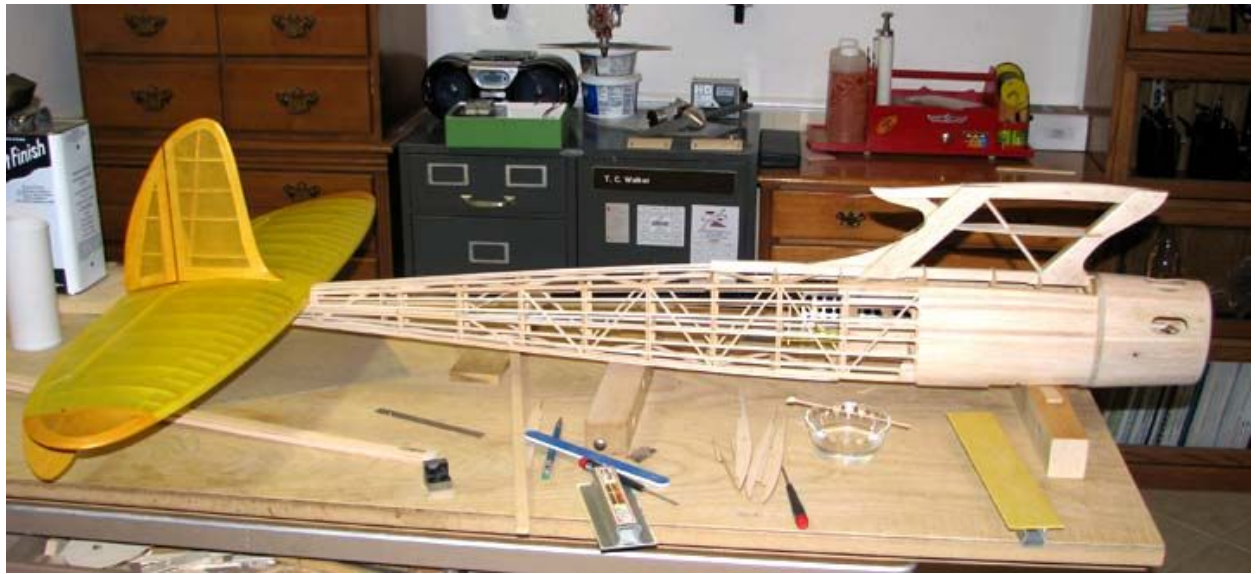
I will close with this picture of the fuselage with the tail, pylon, and cowl in place.....Tandy
