From: ["Tandy C. Walker" <tandyw@flash.net>](mailto:Tandy C. Walker <tandyw@flash.net>)
To: [Undisclosed-Recipient:](#)
Date: 5/8/2009 3:11:51 PM
Subject: 93 Sailplane Lining the Access Hatches

Comet Sailplane Project

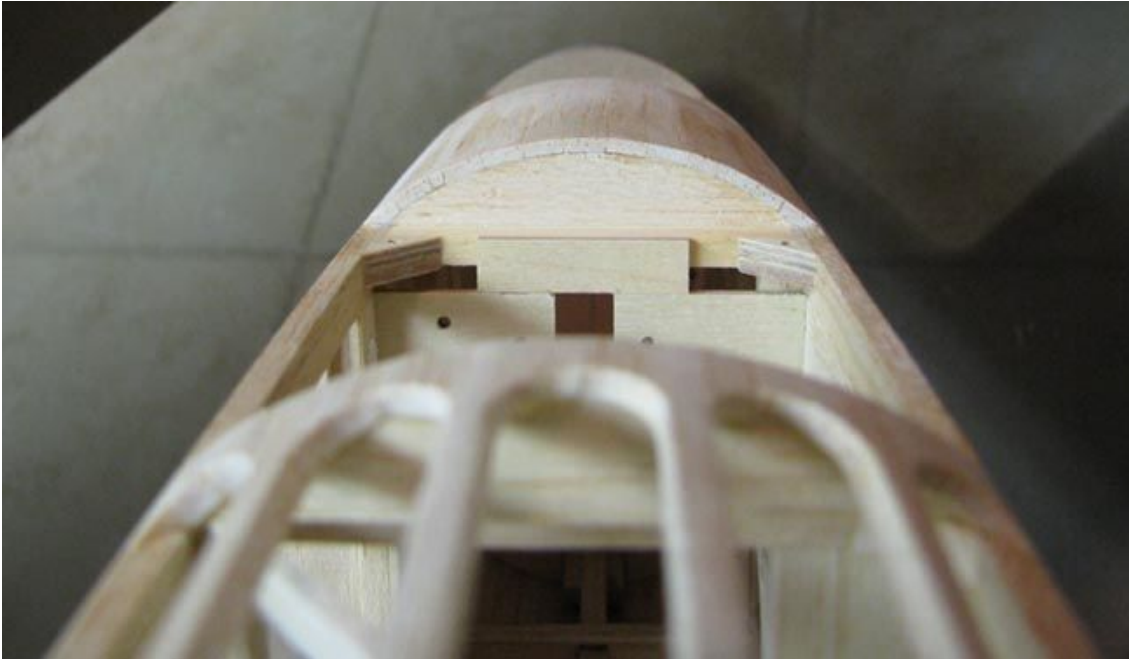
I decided to take a break from working on the pylon this morning and do something a little different. Installing and removing equipment in and out balsa hatch openings always takes it toll on the edges with lots of dents and dings. So I use 1/64" plywood to line the ends of the hatch openings to protect the edges as well as the ends of hatch covers themselves. The picture below shows the front face of aft hatch opening used to install and access the radio equipment. Notice the ends of the barrel planking strips around the top of the cover's balsa bulkhead.

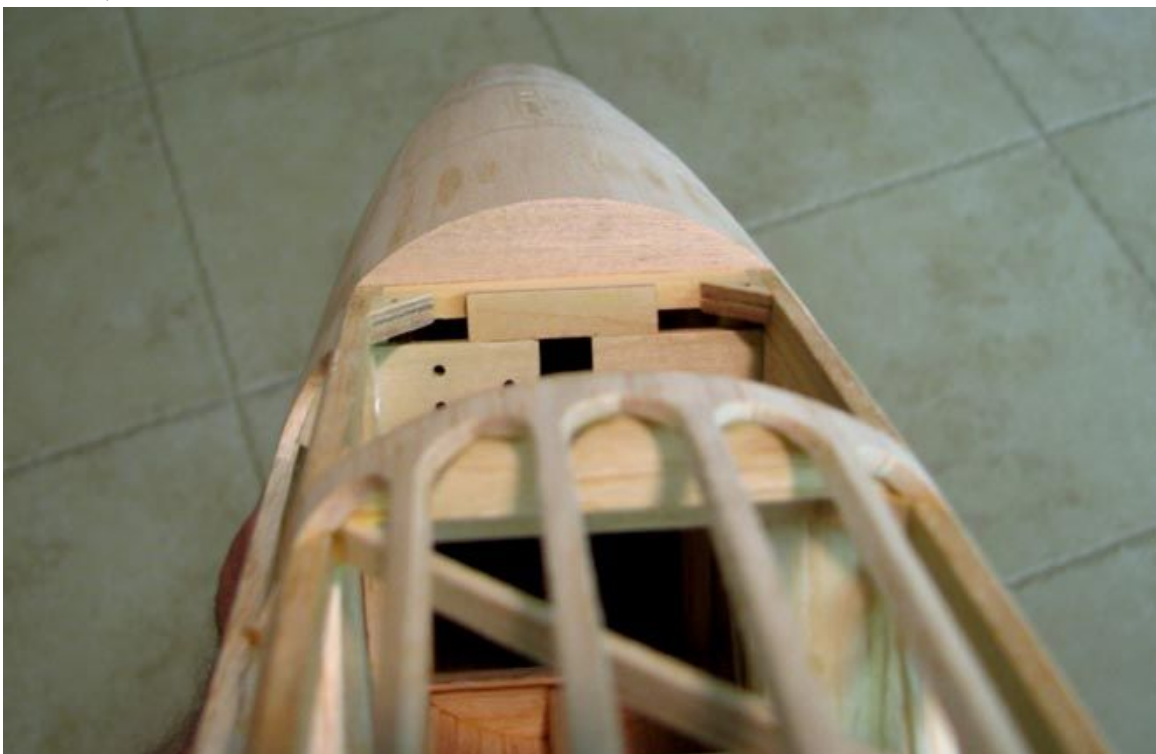
In this picture, you see the piece of 1/64" plywood that has been glued to the front face, trimmed, and sanded to contour.

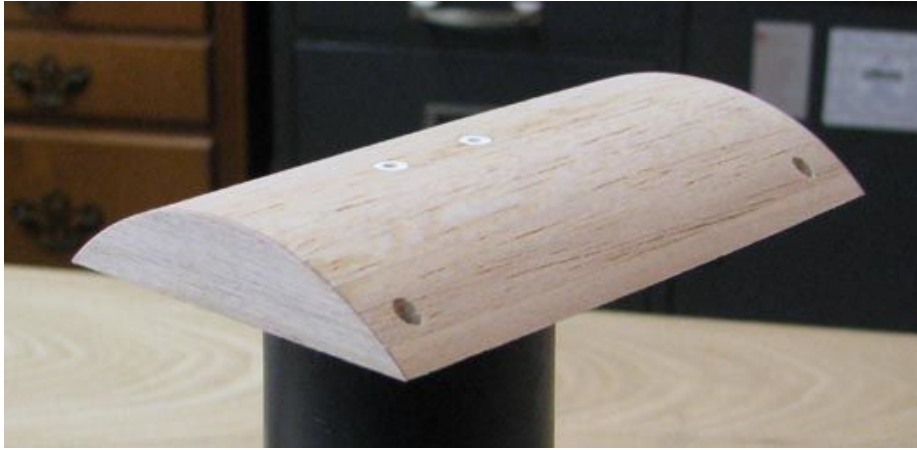
This particular shot shows the front end of the forward hatch cover also lined with 1/64" plywood.

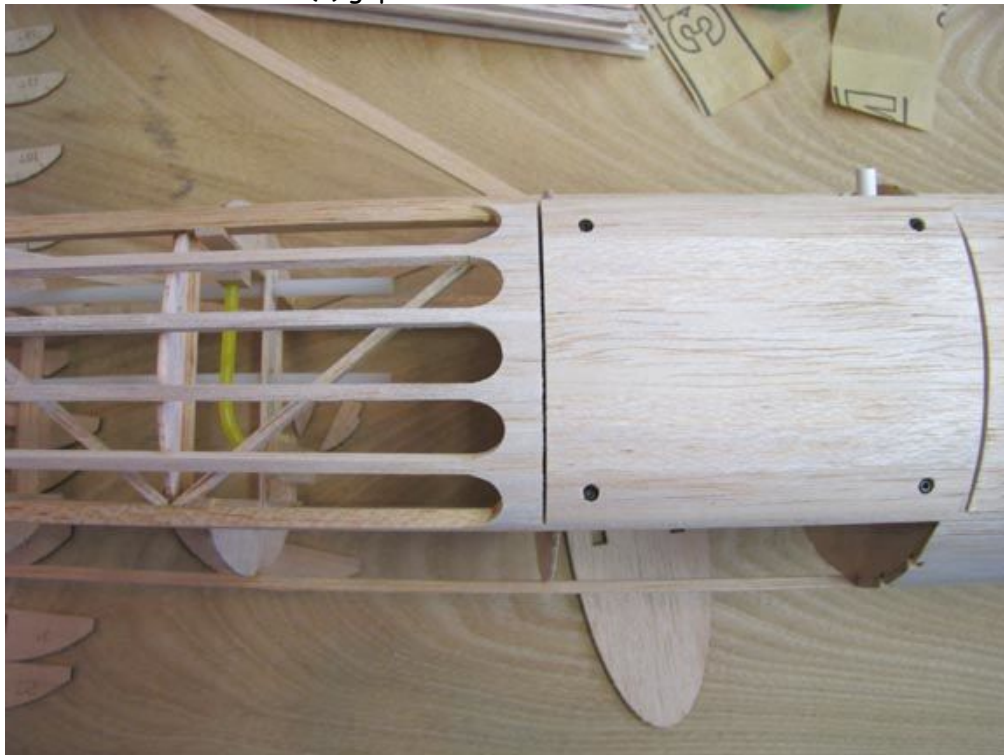
Going back to Report No. 39, the picture below showed how the stringers tied into forward planking using fillets on either side. Notice the 1/32" (+) gaps on either end of the aft hatch cover.

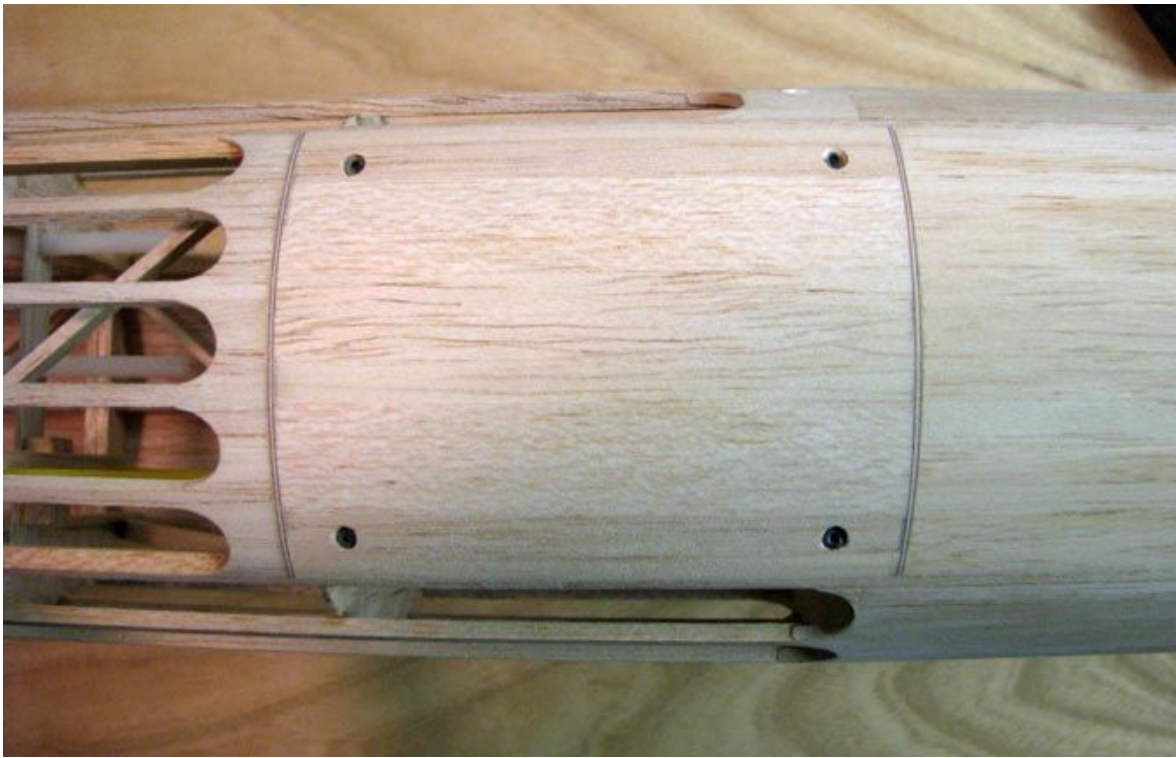
Here you see aft radio hatch installed after both the opening and cover have been lined on both ends, which nicely fill the two gaps.

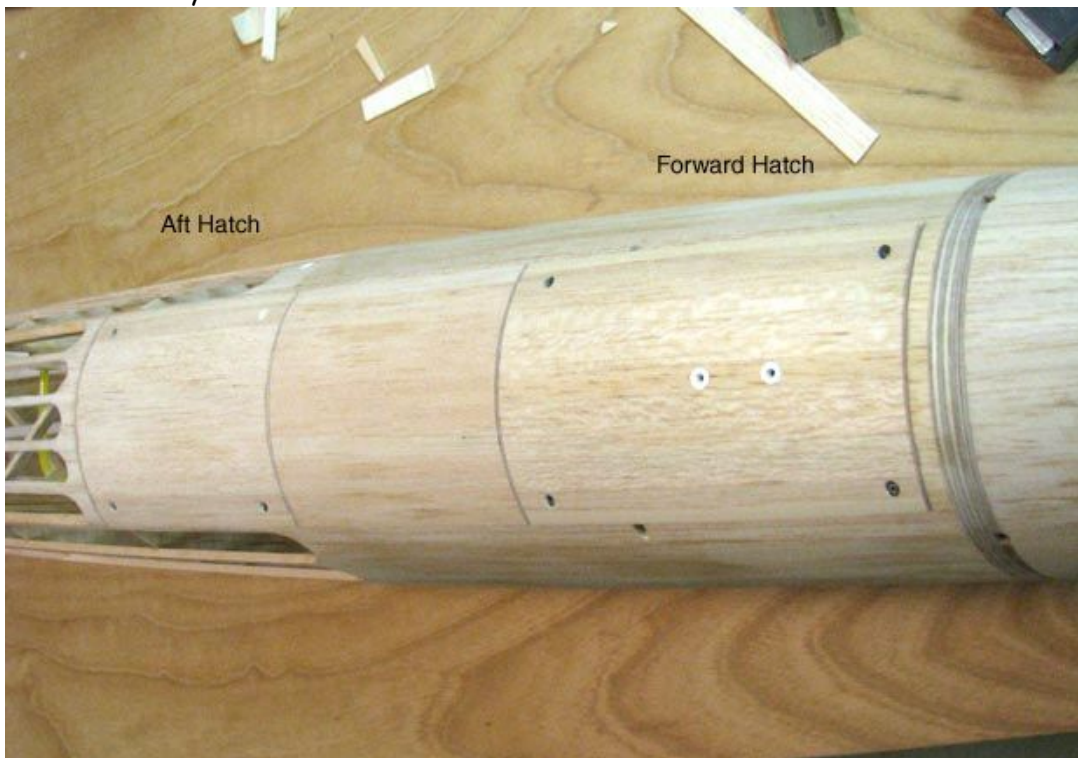
Finally, this shows both the fore and aft hatch covers installed completing the bottom of the Sailplane fuselage.....Tandy
