From: ["Tandy C. Walker" <tandyw@flash.net>](mailto:tandyw@flash.net)
To: [Undisclosed-Recipient:](#)
Date: 8/3/2009 12:57:46 PM
Subject: 143 Sailplane Resolution to a Potential Vibration Problem

Comet Sailplane Project

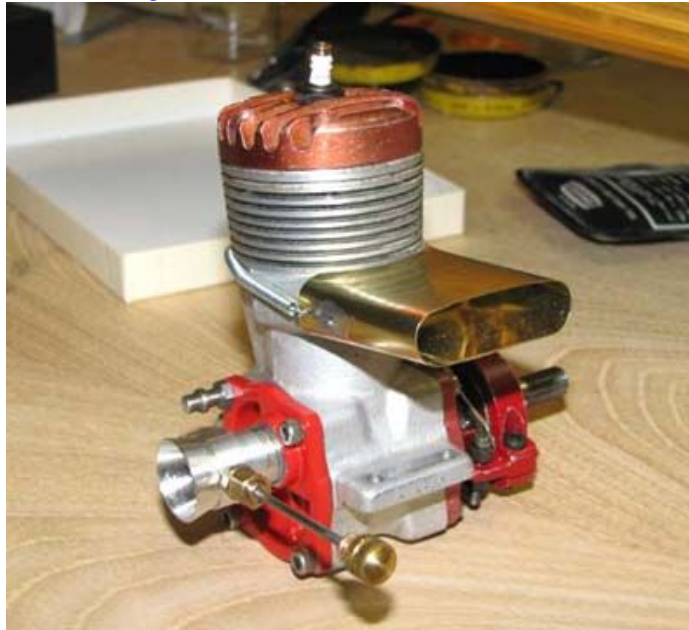
When my friend Jerry Burk saw the picture below of the knurled brass knob soldered to the unsupported stem of the needle valve, he e-mailed me back the following comment:

The needle valve looks very good, but the large weight at the end of the NV might cause a harmonic vibration at some RPM.

Once again, this feed back pointed out a problem I hadn't even considered. With the McCoy's high RPM, there is high probability of this occurring. The approach I used to resolve this issue was to support the needle valve stem out at the cowl surface. To do this, I selected a medium size piece of black neoprene fuel tubing. Since the neoprene tubing was a little large to go through the aluminum tube in the cowl, I cut one end off on the bias, put a dab of after run oil on the tubing, and forcefully pulled it through the aluminum tube in cowl with a pair of hemostats as shown below.

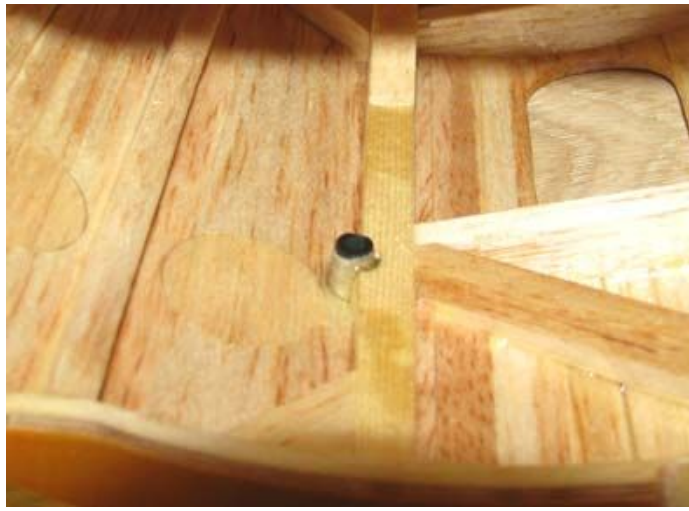
I left about an 1/8" sticking out inside the cowl as shown below.

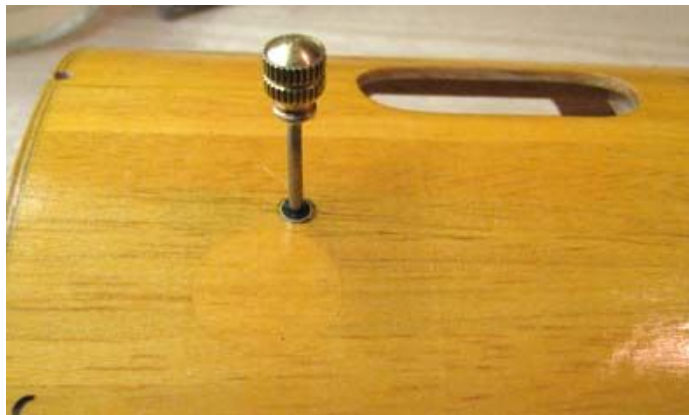
This compressed the neoprene tubing down to the point that the stem of the needle valve would not slide through the hole in the center of the neoprene tube. So I used increasing drill bit sizes to ream the hole out until I could push the needle valve stem through the hole in the tubing as shown below. The stem fits snugly inside the neoprene tubing, which should dampen out and prevent any harmonic vibration from occurring in the needle valve.

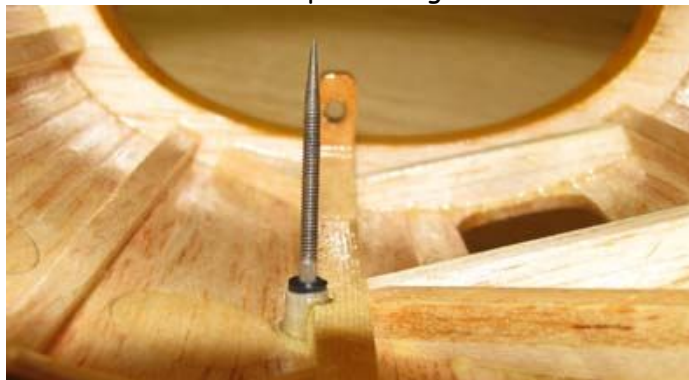
This is a view of the needle valve protruding inside the cowl.....Tandy
