Subject: 75 Lancer 850 - Joining the Two Sides (Part 4)

Report No. 75
 New Cyclone Lancer 850
 February 28, 2018

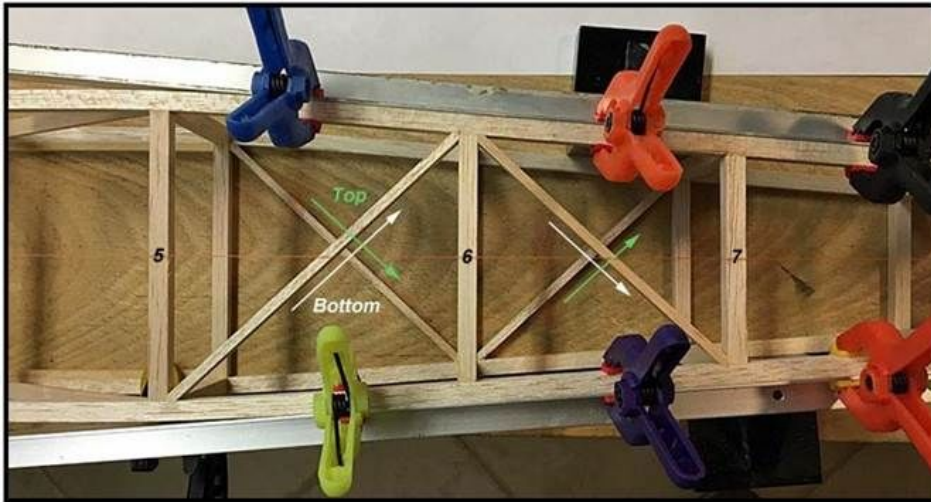
The fuselage's 1/4" sq. longerons have to start bending behind Sta. 5 and then straighten out behind Sta. 6. In yesterday's report No. 74, you saw the two sets of 1/8" X 1/4" diagonals used to lock the curve portion of the top and bottom longerons in place in the picture below.
