From: ["Tandy Walker" <rdb435021@icloud.com>](mailto:rdb435021@icloud.com)
 To: ["Tandy Walker" <rdb435021@icloud.com>](mailto:rdb435021@icloud.com)
 Date: 4/6/2018 2:32:46 PM
 Subject: 106 Lancer 850 - Vertical Tail Construction (Part 3)

Report No. 106
New Cyclone Lancer 850
April 6, 2018

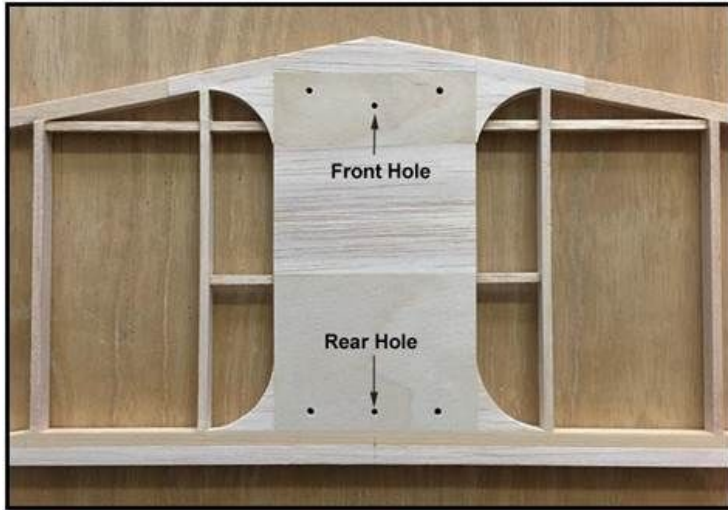
The two No. 44 holes in the center of the front and rear stab plywood plates shown below are for retaining the fin in the stab's slot on top.

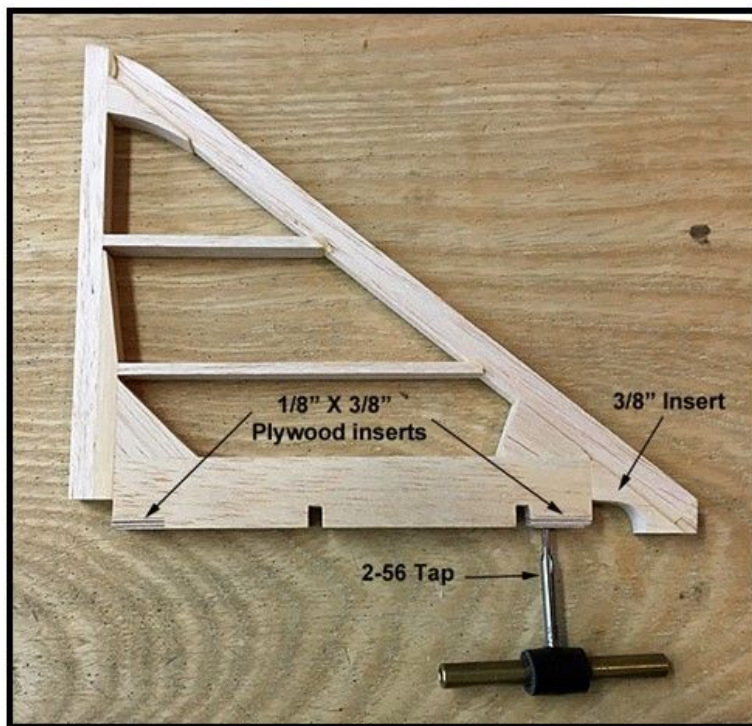
The fin's base was inserted in the stab slot and the location of the two holes were marked on the bottom of the base. Two 1/8" X 3/8" plywood inserts were drilled and threaded with 2-56 threads. The fin's base was notched on the bottom and the two inserts were glued in place as shown below. Notice the 3/8" balsa insert glued in front of the fin's base to fill in under the leading edge.

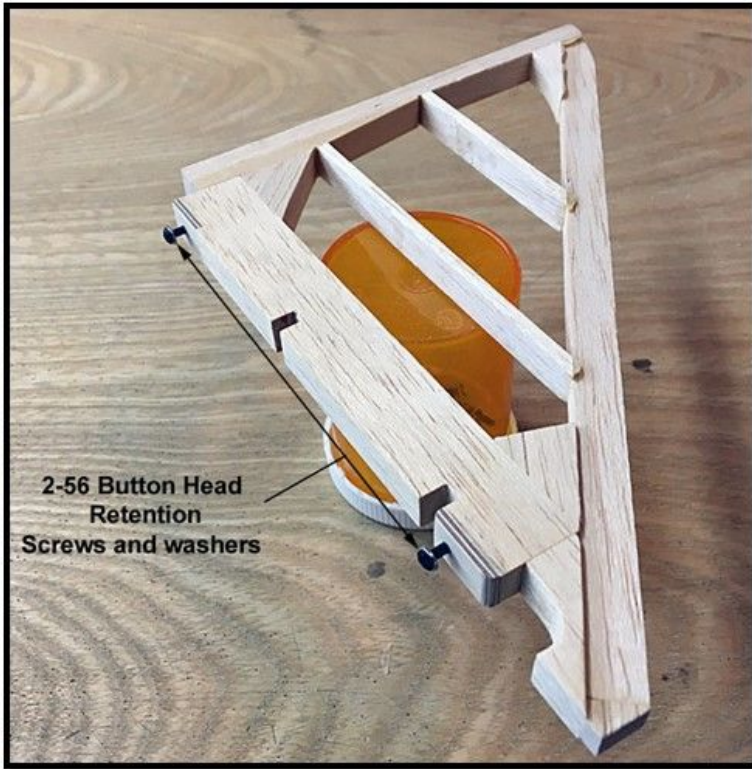
The two 2-55 button head screws shown below are used to secure the fin in the stab's top center slot.

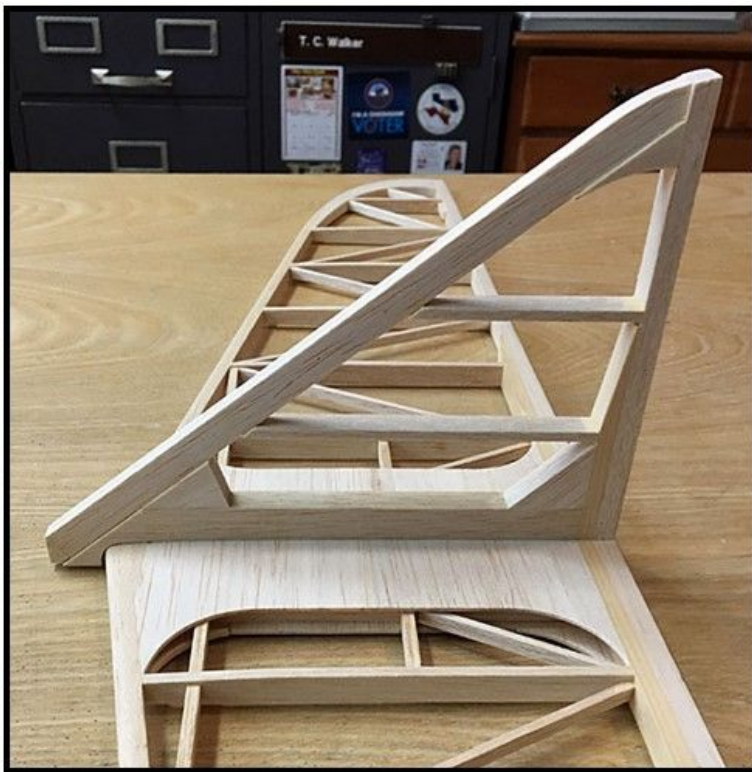
This picture shows the fin's fit in the stab slot.

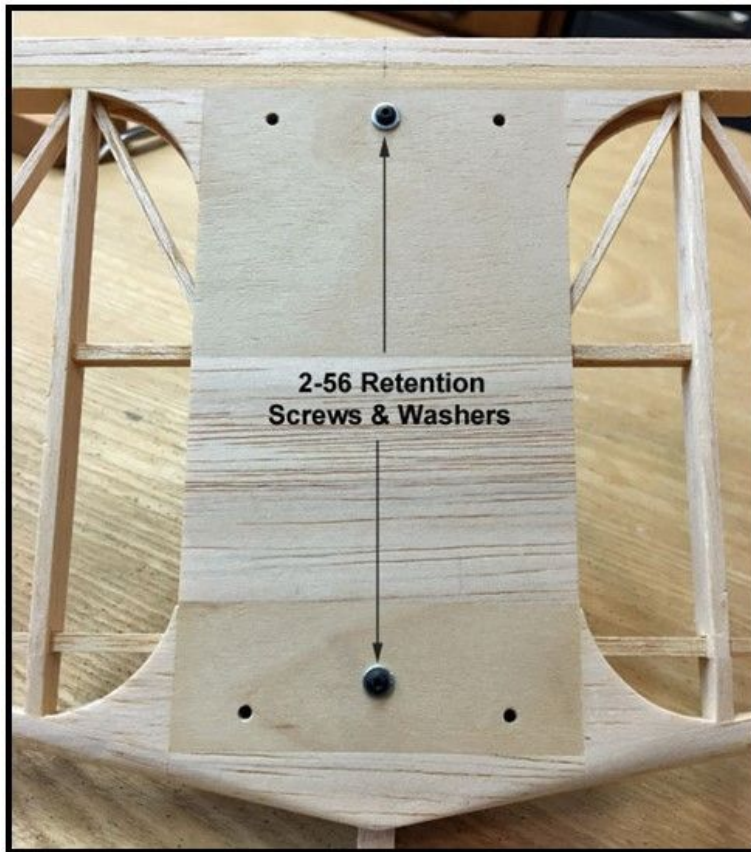
This bottom view shows the two screws securing the fin to the stab.

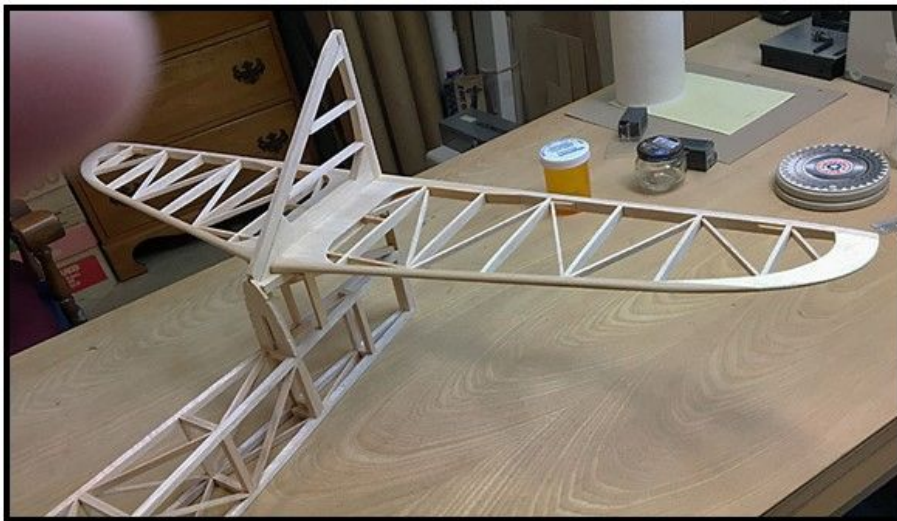
The fin/stab assembly was attached to fuselage's stab platform for a trial fit.

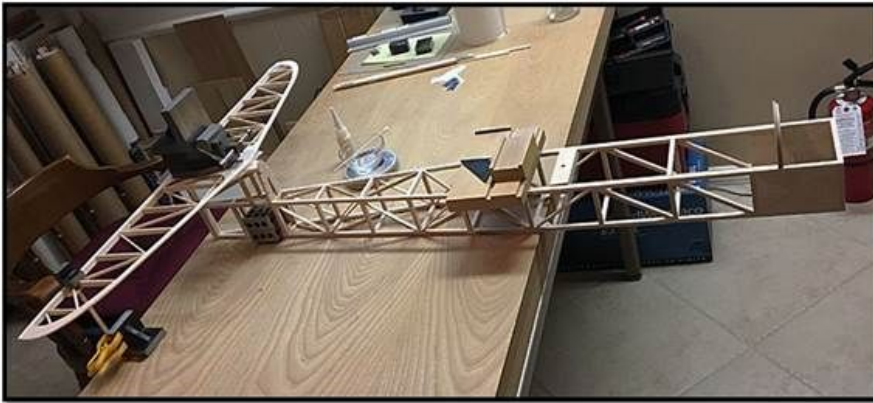
The fuselage was again weighed down on the work table as shown below and the distances of the two stab tips above the work table were remeasured to verify that they were still equal (and they were).

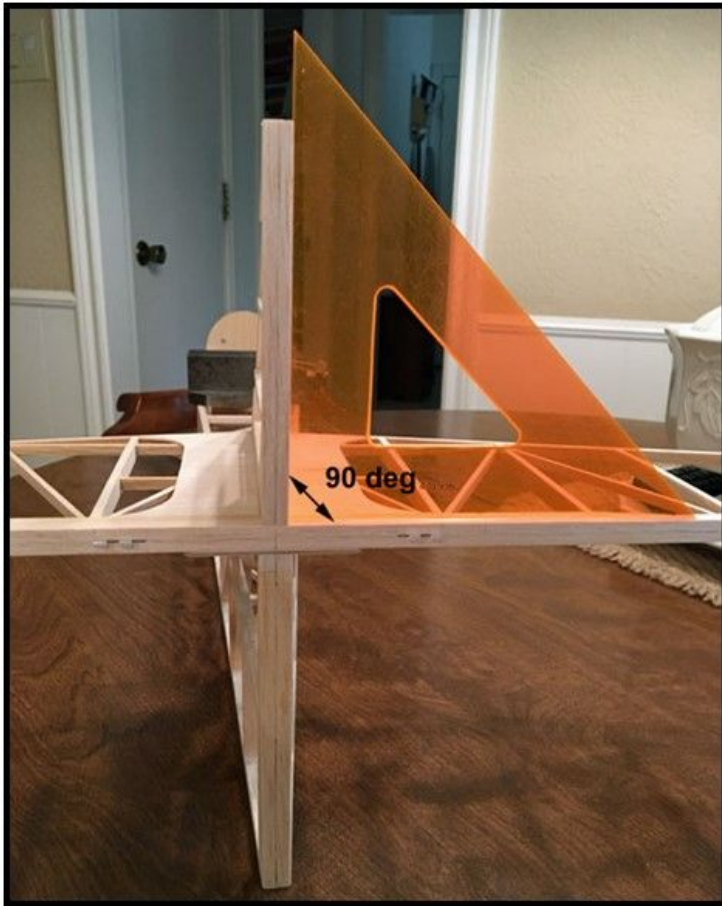
Next the fuselage was placed the heavy flat maple dinette table and weighted down. The orange triangle shown below was used to verify that the fin was perpendicular to the stab (and it was).
