From: Tandy C. Walker [tandyw@flash.net]
Sent: Wednesday, January 27, 2010 5:08 PM
To: Undisclosed-Recipient: ;@smtp103.sbc.mail.mud.yahoo.com
Subject: 50 Speed 400 Cloudster - Construction the Cloudster's Cowl Frame

Speed 400 Cloudster Project

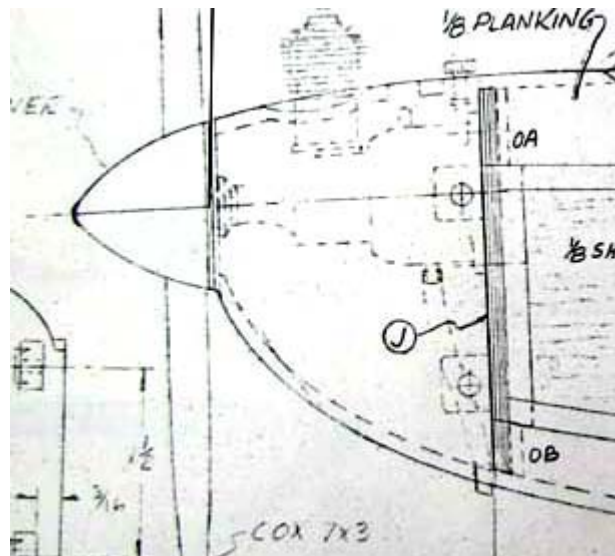
The Jim Adams plan has a sculptured cowl that fairs into the back of a spinner as shown below.

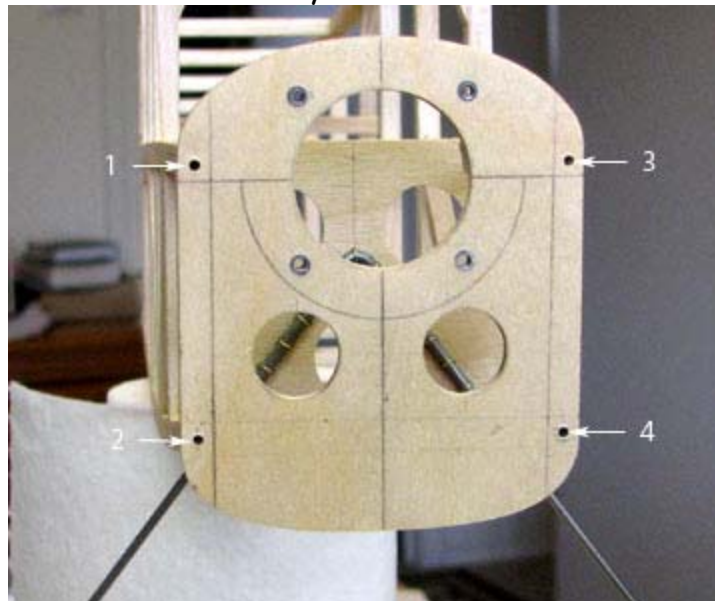
After several concept considerations for constructing a cowl, an approach finally emerged. Four 1/16" holes were carefully hand drilled into the firewall as shown below.

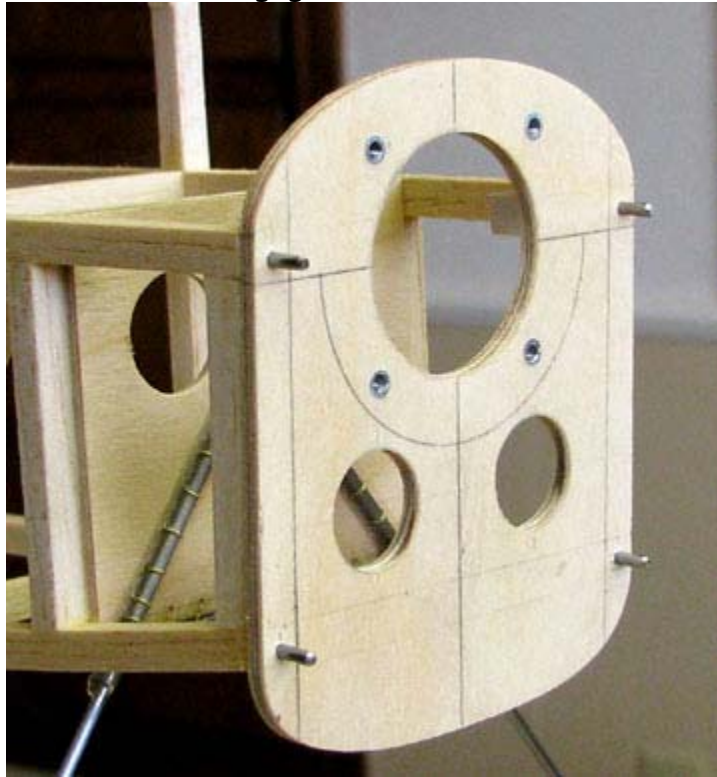
Four $\frac{7}{16}$ " lengths of $\frac{1}{16}$ " piano wire were cut and inserted into the holes in the firewall. The length of these cowl alignment pins allow the pins to protrude out of the front face of the firewall $\frac{3}{16}$ " to engage the rear face of the cowl sides.

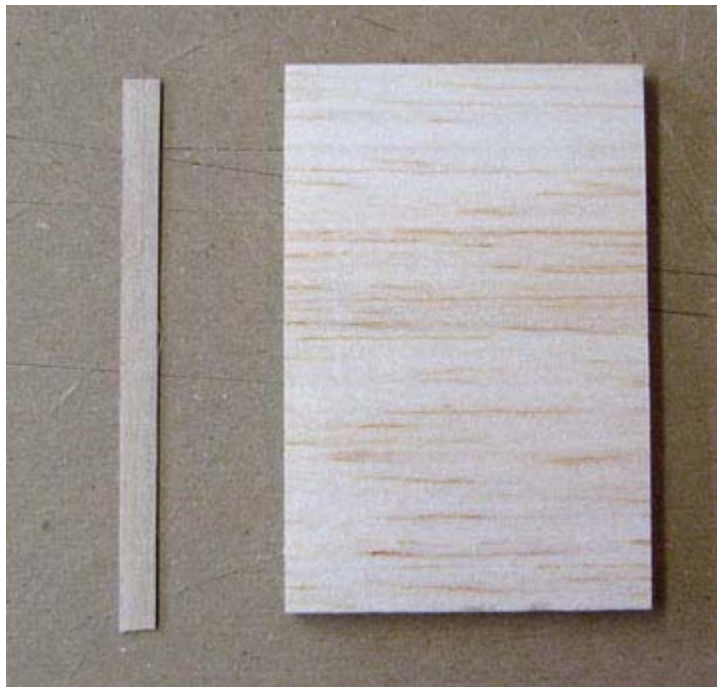
Next, a 3" wide sheet of $\frac{3}{16}$ " medium soft balsa sheet was cut to length for the cowl side shown below. A $\frac{3}{16}$ " wide strip was cut from $\frac{1}{64}$ " plywood, which is also shown below.

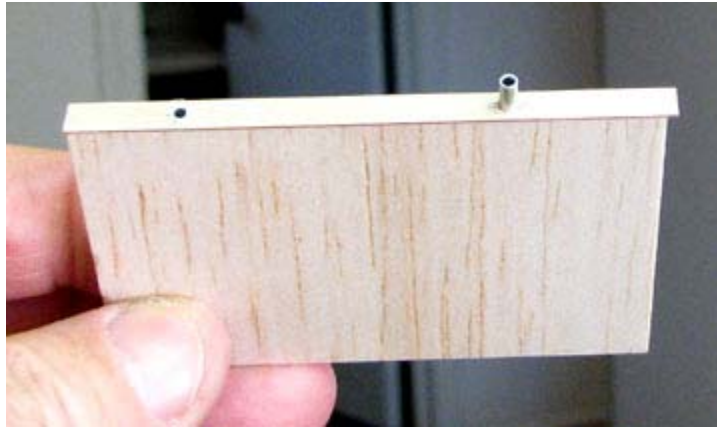
The strip of plywood was glued to the rear edge of the 3/16" balsa sheet. This protects the balsa edges from getting all dented up. The two holes were marked to align with the cowl pins and then drilled 3/8" deep. An aluminum tube with 1/16" I.D. was cut to length and inserted into the hole as shown below.

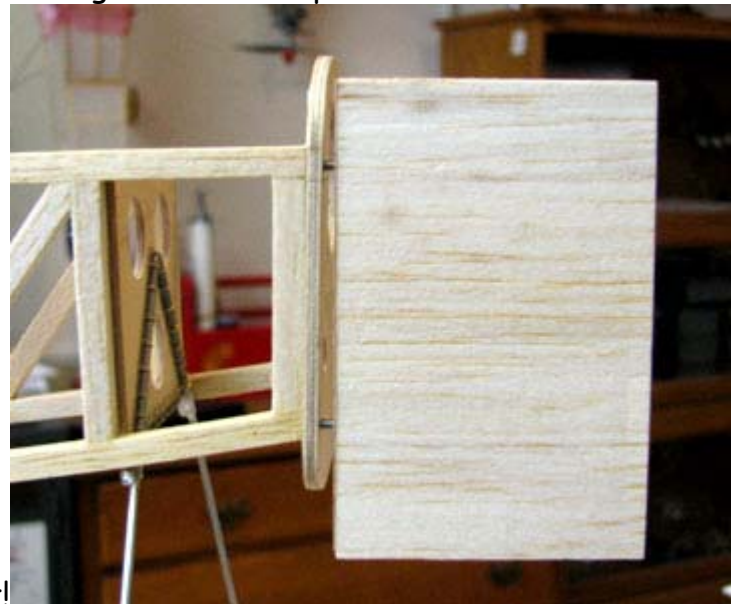
A trial fit was performed to check the alignment of the pins with the holes as shown

below. Thank goodness, they did fit!

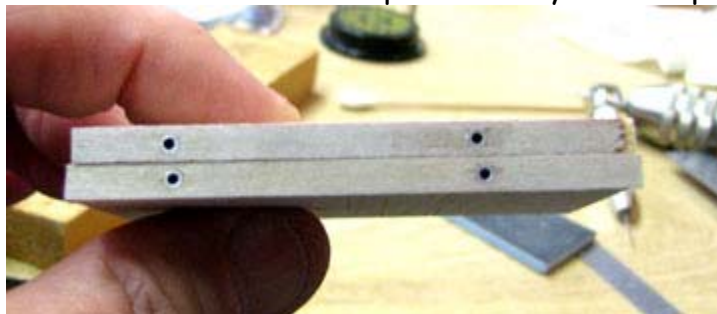
The aluminum tubes were removed and then permanently CA's in place as shown below.

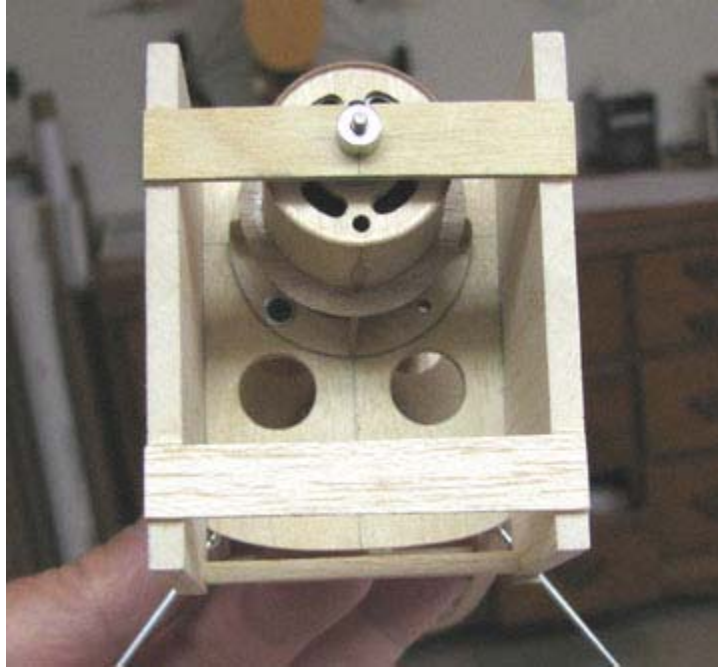
A strip of 1/16" plywood was drilled out for the Speed 400 motor shaft. This plywood

strip was forced down against the front of the cowl sides and held down with a 3/32" wheel collar as shown below. Even though the fuselage sides taper in at the front, the cowl sides were positioned perpendicular to the firewall and CA's to the plywood strip. In addition, a second balsa strip was added on the front of the cowl sides to jig the cowl sides straight. Notice that a balsa brace was also added between the cowl sides on the bottom back near the firewall to further hold the cowl sides straight.

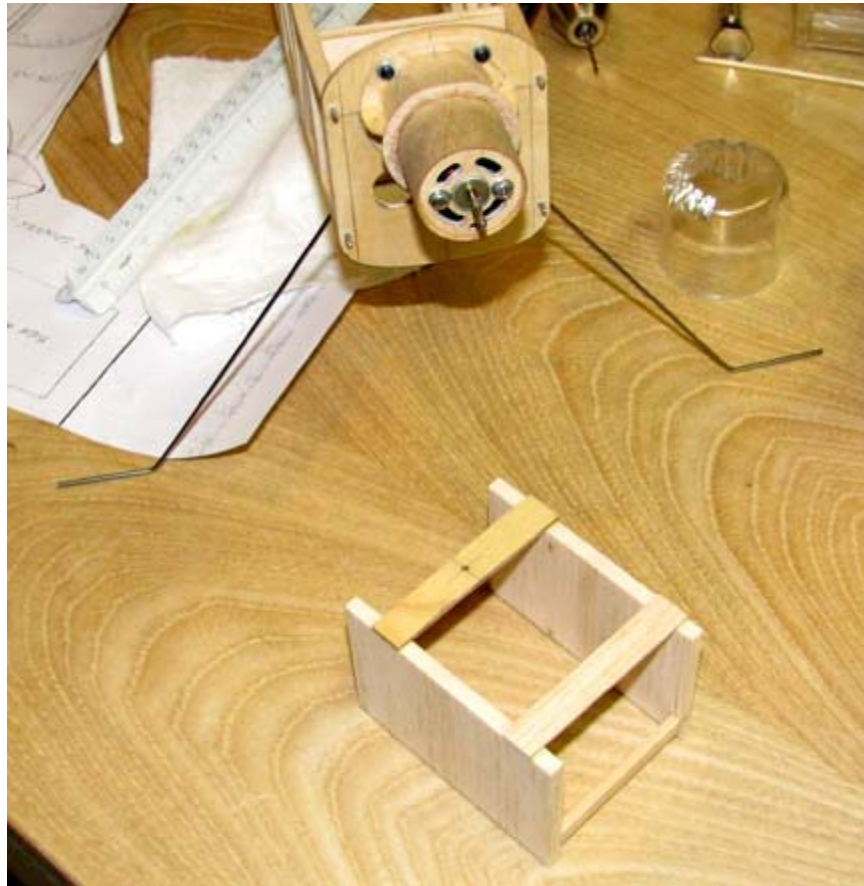
Once dry, the wheel collar was taken off and the cowl frame was removed from the fuselage as shown below.

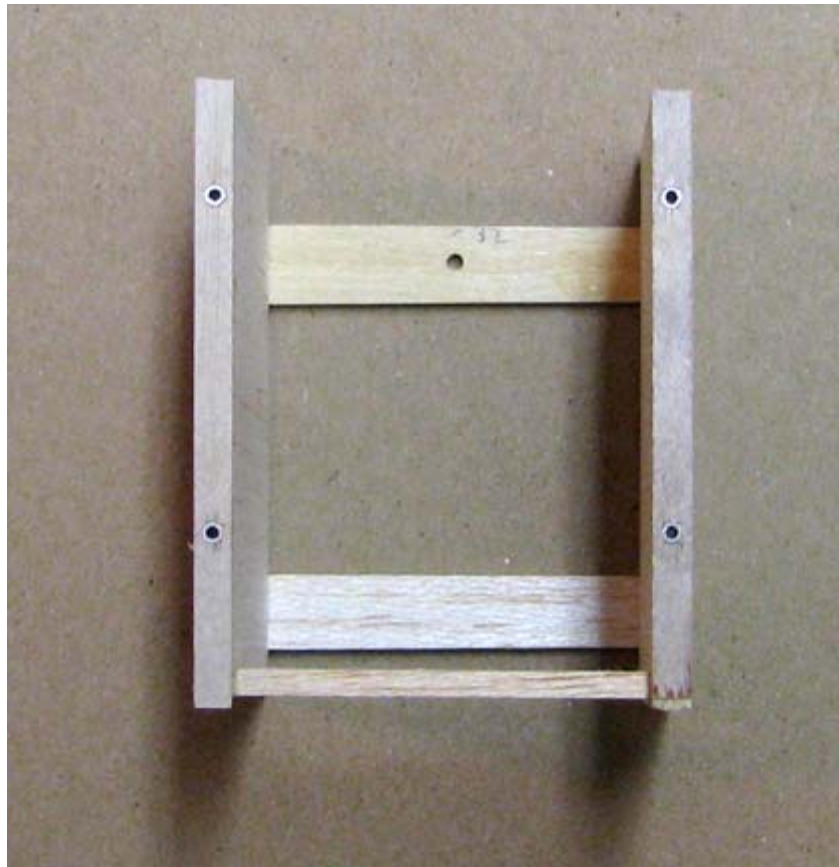
The cowl frame was turned over and this picture taken to show the four lined holes to receive the four cowl alignment pins. The reason the cowl sides are kept parallel is that any and all balsa rectangular blocks can be easily glued to the inside faces of the cowl sides.
