**From:** Tandy C. Walker [tandyw@flash.net]  
**Sent:** Saturday, January 30, 2010 10:40 AM  
**To:** Undisclosed-Recipient: ;@smtp103.sbc.mail.mud.yahoo.com  
**Subject:** 51 Speed 400 Cloudster - Different approach to the Cowl Frame

*Speed 400 Cloudster Project*

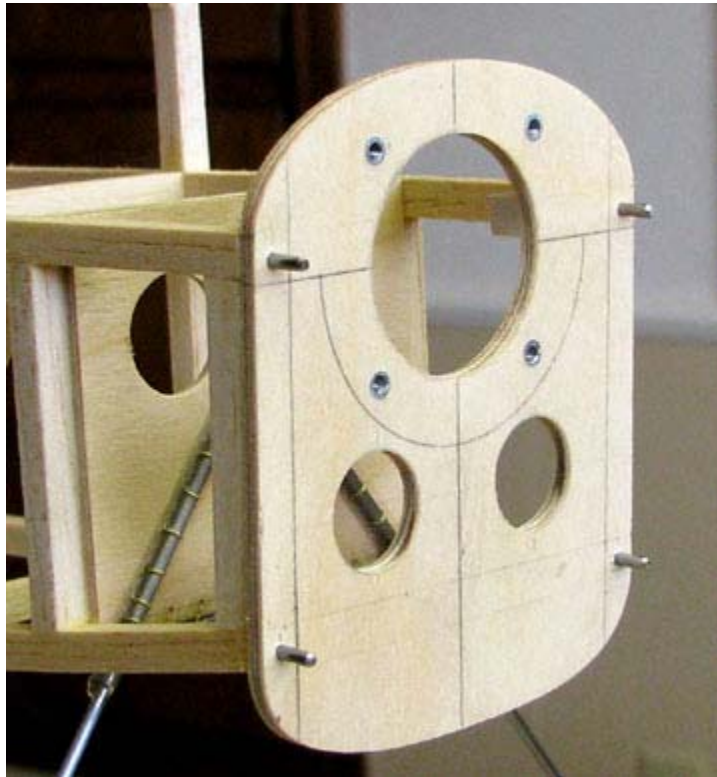
Three mistakes were made on the first cowl frame in Report No. 50: (1) the 7/16" cowl alignment pins shown below were too long, (2) the 3/8" aluminum tube liners for the cowl pins went into the cowl sides too far, (3) the cowl sides were made perpendicular to the firewall instead of parallel to the fuselage sides. Once the cowl was blocked in and carving and trimming of the sides started, the ends of the four embedded aluminum tube liners would quickly be exposed because they extend out too far and are too close to outside surface of the cowl.

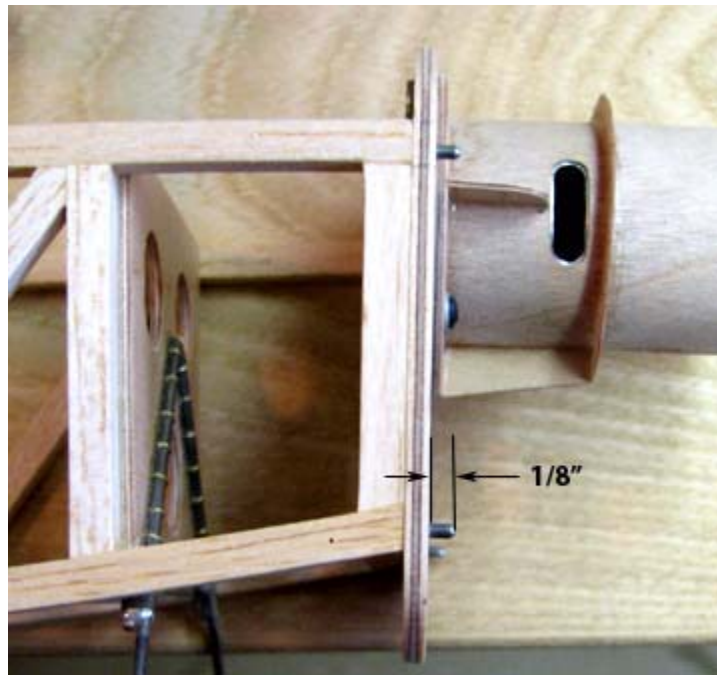
To correct this problem, first the cowl alignment pins were shortened to 1/8" as shown below. After all, these pins only need to be long enough to engage the back face of the cowl sides.

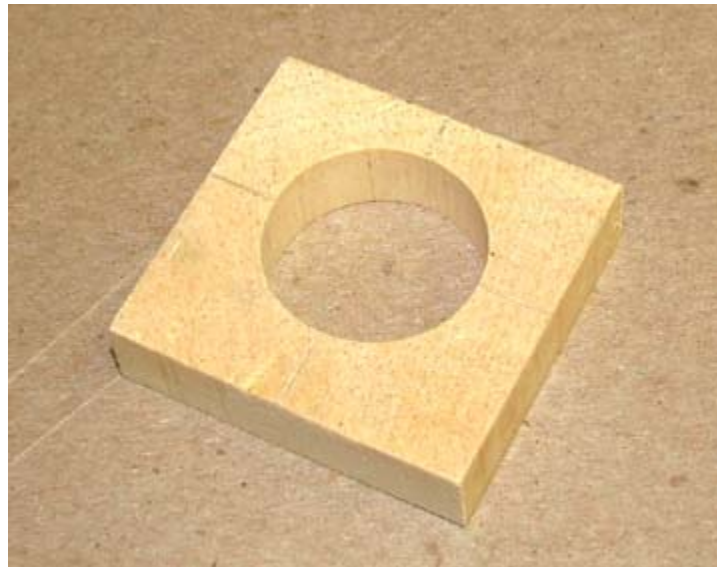
This is where the approach to the cowl frame changes. A 1/2" length of balsa was cut off the end of a 2" X 2" soft balsa block. The front and rear cross grain face were sanded smooth. Then a hole was cut out in the block as shown below and sanded so as to slip snugly over the front end of the cylindrical motor mount. Notice the end grain of this cowl nose block.

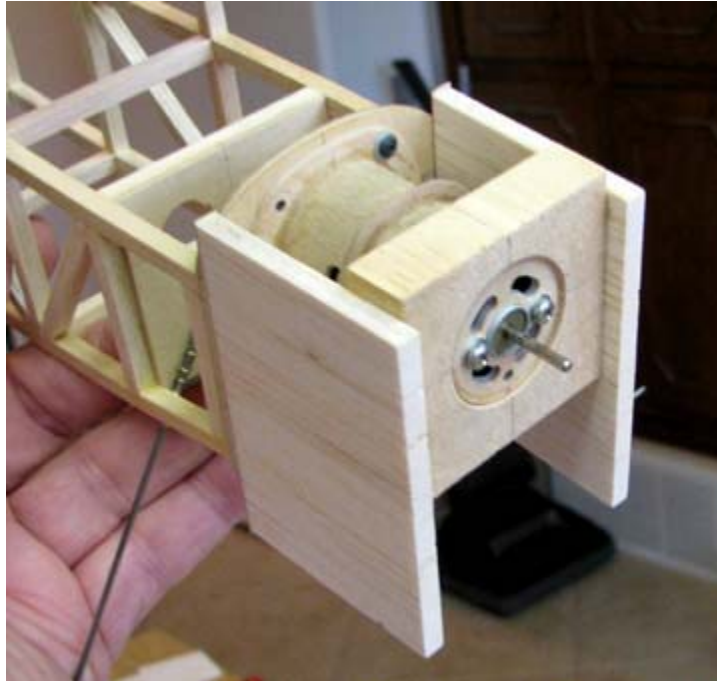
Then two new cowl sides were made using the procedure in Report No. 50, except the rear faces of the sides were beveled so that the cowl sides were parallel with the fuselage sides instead of being perpendicular to the firewall. The vertical side edges of the cowl nose block were carefully trimmed and sanded so that the cowl sides that are parallel with the fuselage sides were also tangent to nose block. Once this was done, the nose block was slipped over the motor tube, the new cowl sides were pushed onto their

respective alignment pins, and the two cowl sides were glued to the nose block with aliphatic glue as shown below. This approach insures an almost perfect alignment fit of the cowl to the firewall.

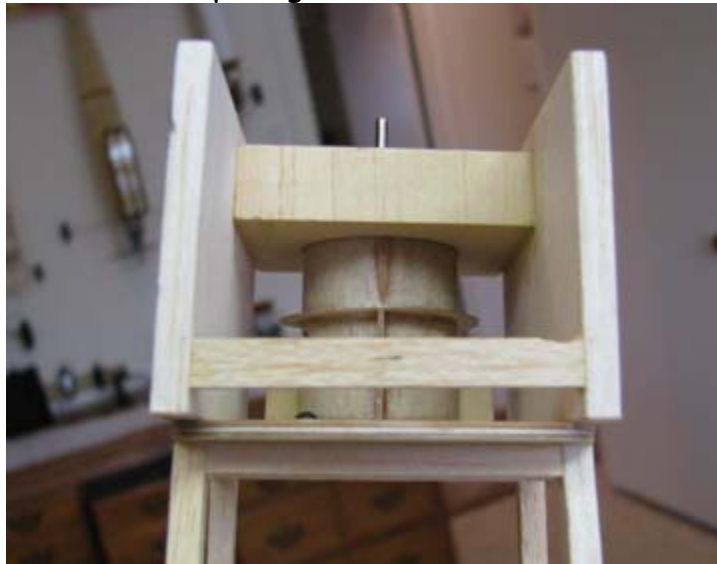
A temporary balsa brace was also added between the cowl sides on the bottom back near the firewall to hold the cowl side spacing until this can be blocked in with balsa.
