From: ["Tandy C. Walker" <tandyw@flash.net>](mailto:tandyw@flash.net)  
To: ["Walker, Tandy C." <tandyw@flash.net>](mailto:tandyw@flash.net)  
Date: 3/25/2009 3:37:32 PM  
Subject: 62 Sailplane Cowl Retention Brackets Mounting

### *Comet Sailplane Project*

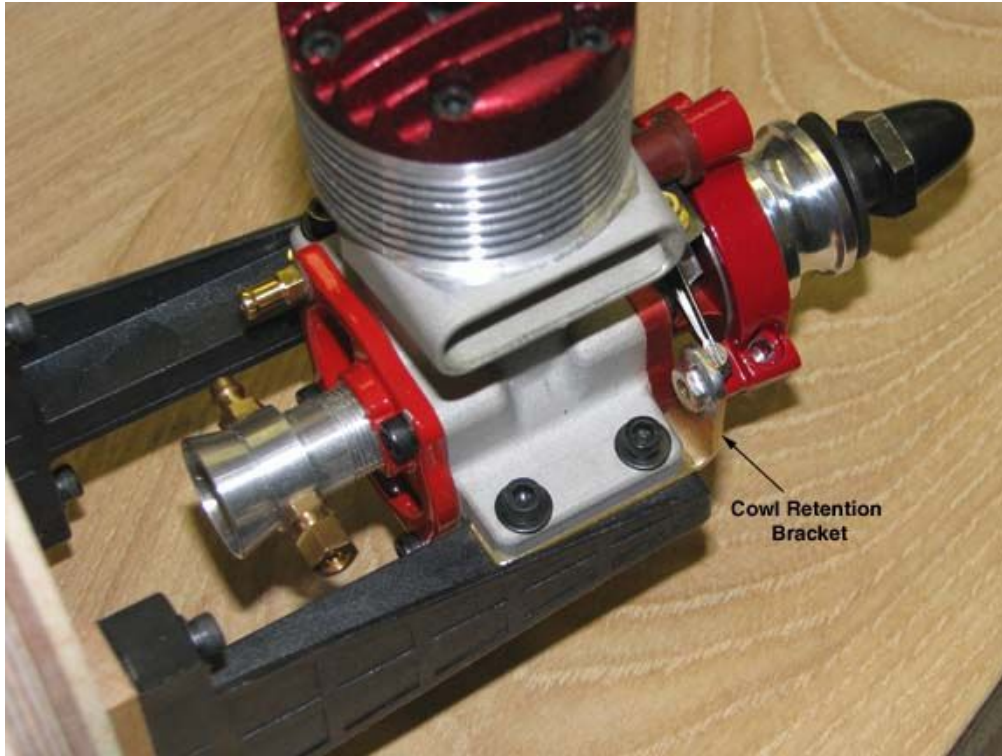
Once both cowl retention brackets were completed, they were installed between the McCoy 60's mounting lugs and the composite motor mounts for the trial fit shown below. This report will now discuss the design and implementation of the two internal structural assemblies used to retain the cowl on the fuselage.

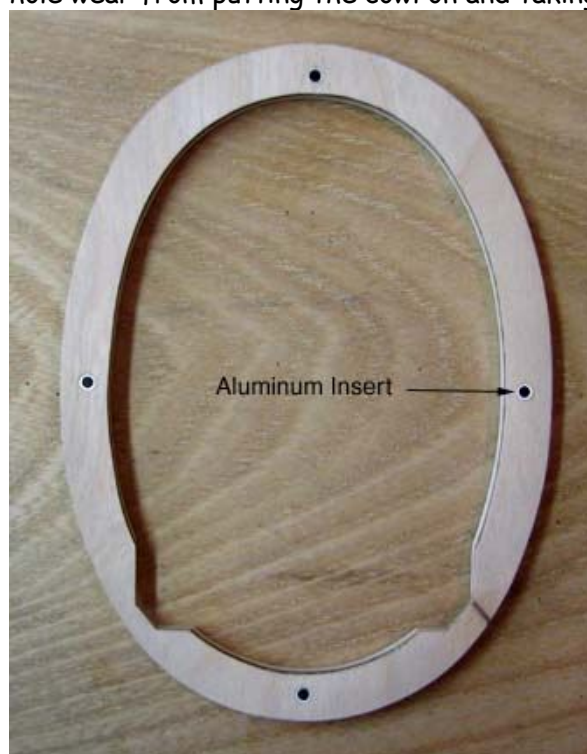
In the picture below you see the backside of the rear cowl bulkhead. The cowl rear bulkhead has been notched out at the bottom to clear the motor mounts and aluminum inserts have been installed in each of the four alignment holes to prevent hole wear from putting the cowl on and taking it off.

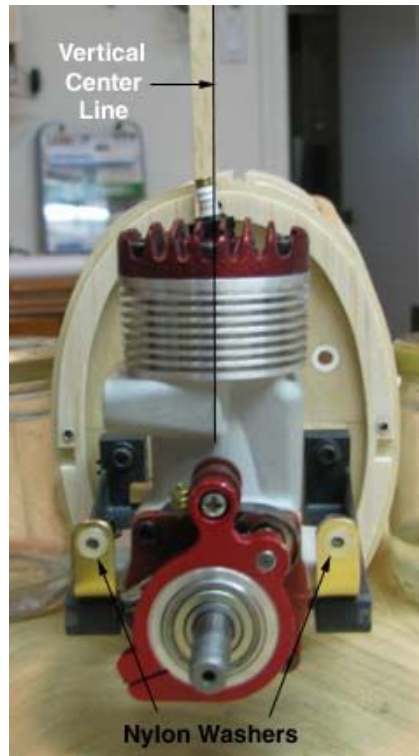
The picture below was taken from the front of the engine to show several things:

- (1) With the rear cowl bulkhead installed on the four centering pins, a vertical balsa strip has been attached to the firewall for the purpose of aligning the cowl front bulkhead.
- (2) Two 3/16" X 1/4" notches have been made in the in the 1/8" balsa rear bulkhead overlay for the cowl attachment structure.
- (3) A nylon washer has been CA'd to the front face of each of the cowl's brass retention brackets for cushion.

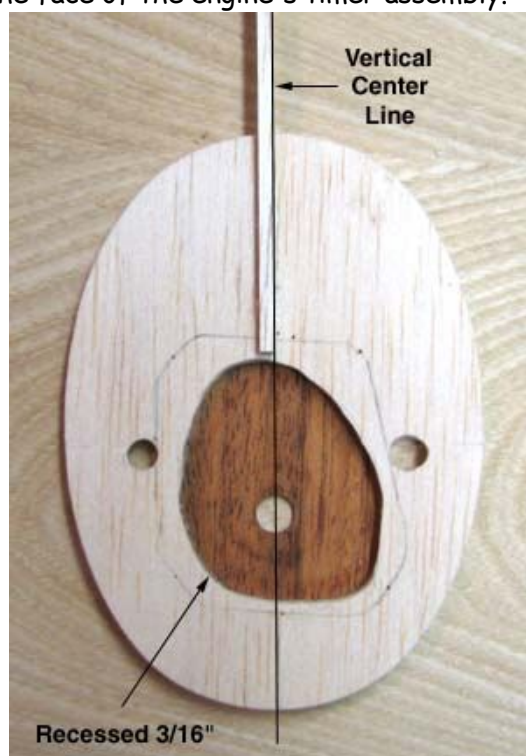
The backside of the front cowl bulkhead is shown below along with its attached vertical balsa strip for the purpose of alignment with the vertical strip on the firewall. Notice that the 3/16" thick bulkhead has been cut out to clear the McCoy's timer assembly and a piece of 1/16" plywood has been glued to the front face of the bulkhead. The purpose is to mount this bulkhead on the crankshaft of the engine such that the front face of the bulkhead is coplanar with the face of the engine's timer assembly.

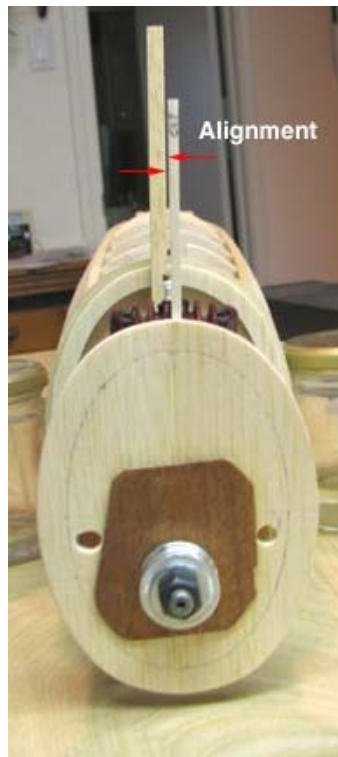
This picture shows how the alignment of the cowl's front bulkhead with the firewall was accomplished. Notice that the McCoy's prop spool was removed, the cowl's front bulkhead slipped onto the crankshaft and over the timer assembly, then the prop spool, and a nut was used to tighten the prop spool against the front bulkhead. The cowl's front bulkhead is now jugged in place and aligned to the cowl's rear bulkhead on the fuselage's firewall.

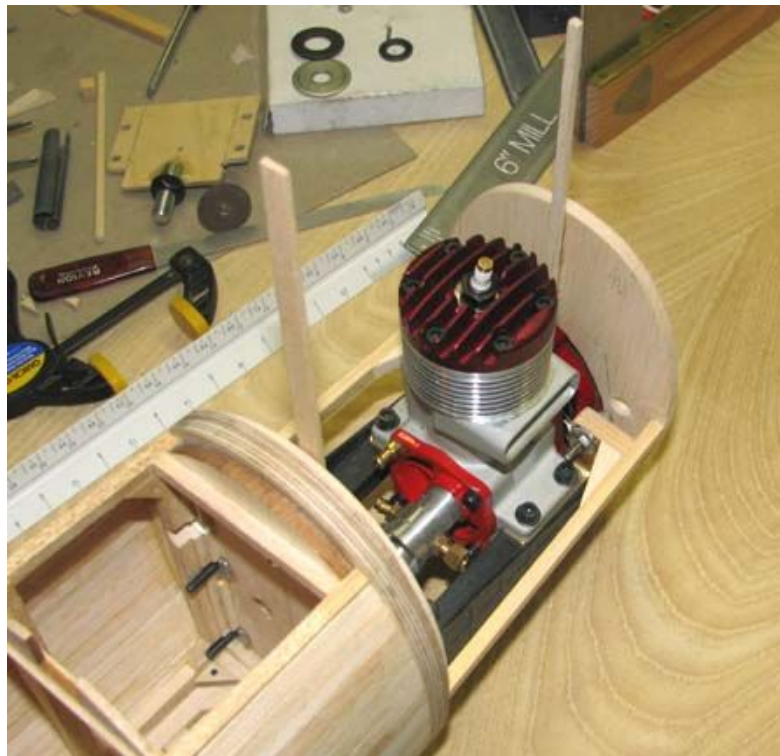
A hole for a 4-40 screw was drilled in a 1/4" square spruce piece. This spruce piece was screwed to the cowl brass retention bracket as shown below. A strip of 3/16" X 1/4" spruce was cut to length to fit snugly between the front and rear bulkheads. The 1/4" square spruce piece was then marked and cut to length so that the 3/16" X 1/4" strip of spruce made contact with it when put in place. The two spruce pieces were then glued together in place in the jig set up. The screw was removed and a 1/4" balsa triangle was glued in to reinforce the structural assembly. Finally the spruce assembly was glued to both the front and rear cowl bulkheads as shown below.

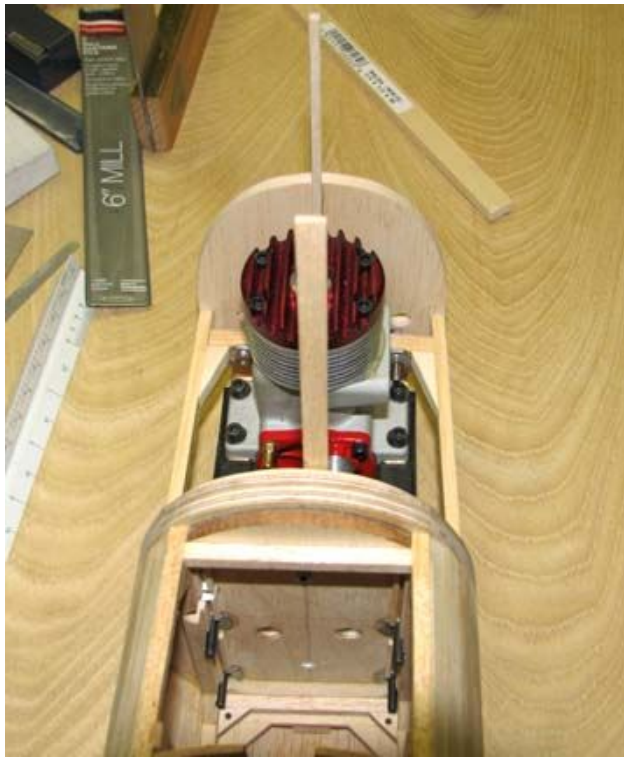
This picture looking forward shows both the left and right spruce assemblies glued in place.
