Subject: 108 Sailplane Integrating the Right Wing Tip Panel with the Right Inner Panel

### *Comet Sailplane Project*

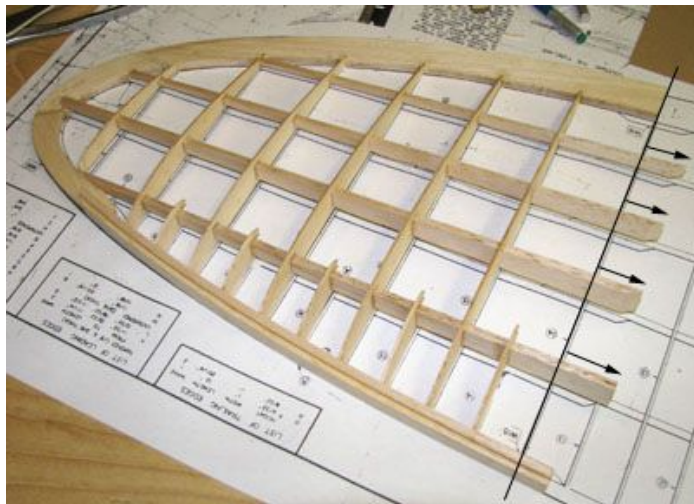
As shown below, the ends of the four spars extend out beyond a line through the ends of the leading and trailing edges where the polyhedral break takes place. This presents a challenge on how to bevel the slopes on the ends of the leading and trailing edges because you can not just block up the tip of the tip panel to the desired height and sand the bevel in.

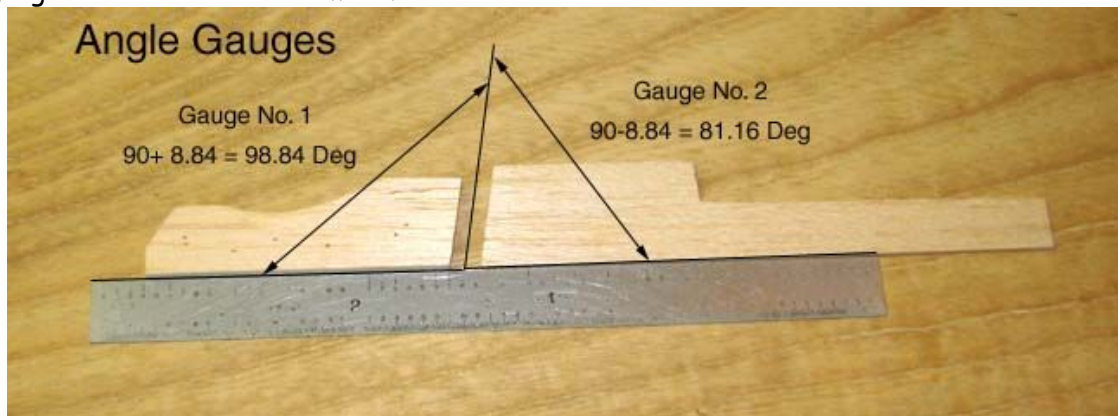
The total polyhedral angle is 17.687 degrees. The leading and trailing edges of both the inner and tip panels are beveled at  $17.687/2$  or 8.844 degrees. To assist in setting up and measuring the slope of the bevel, the two angle gauges shown below were made.

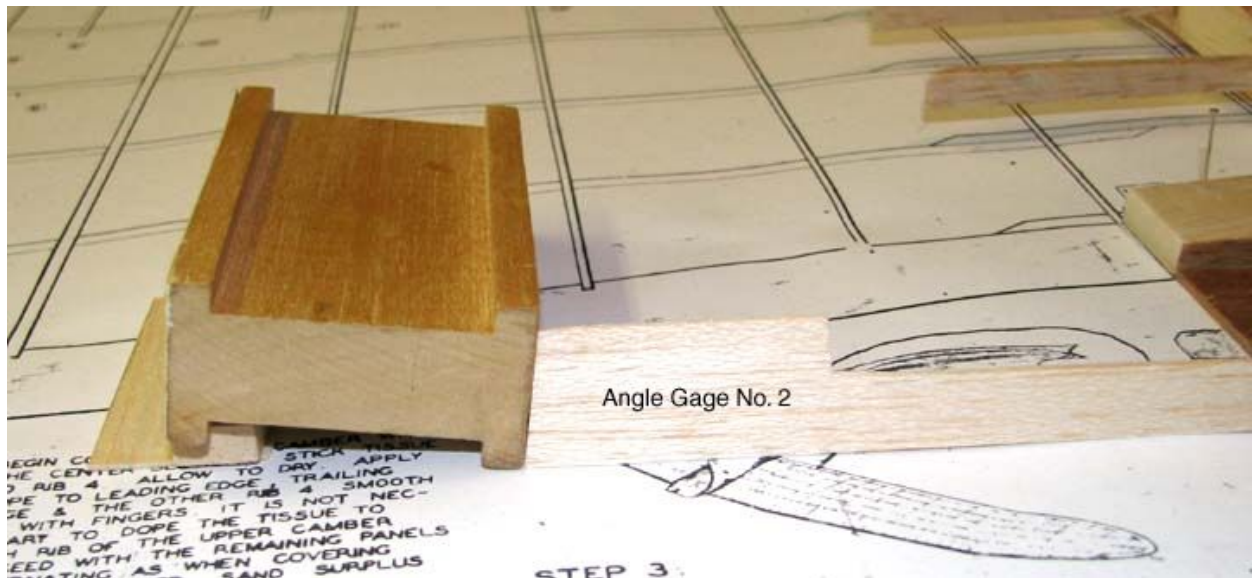
The slide of my bar sander was blocked to fit the slope of Angle Gauge No. 2 as shown below.

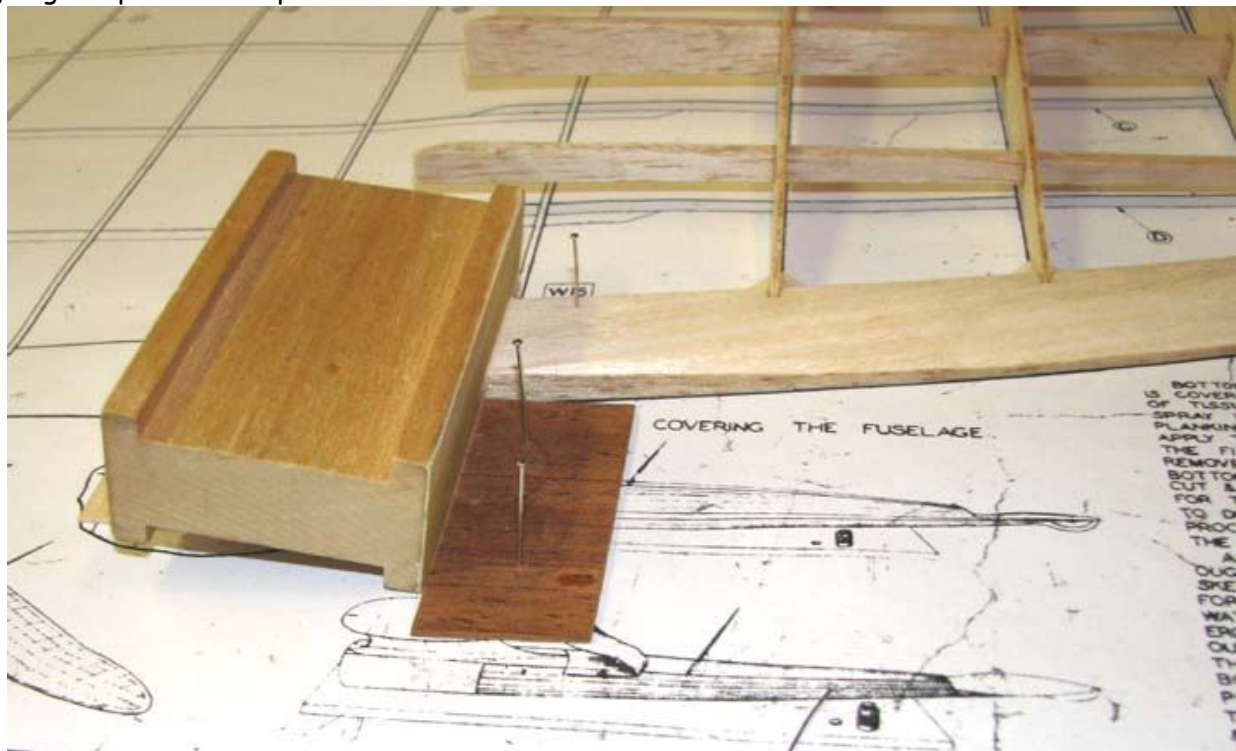
A piece of 1/16" plywood was pinned down as a sanding fence behind the trailing edge as shown below. The outside edge of the plywood was also beveled. The slide of the blocked up bar sander is gasped with both hands and carefully move it back and forth against the trailing edge and sanding fence until the desired trailing edge slope has been produced as shown below.

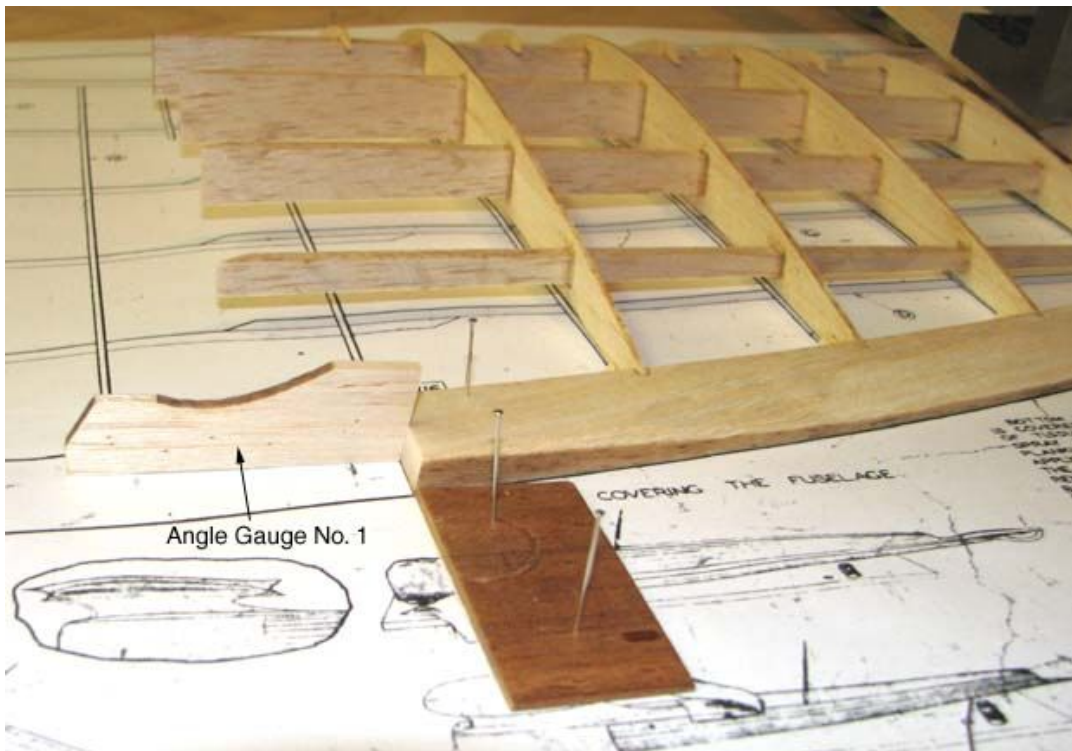
The beveled slope of the trailing edge was then checked with the Angle Gauge No. 1 as shown below.

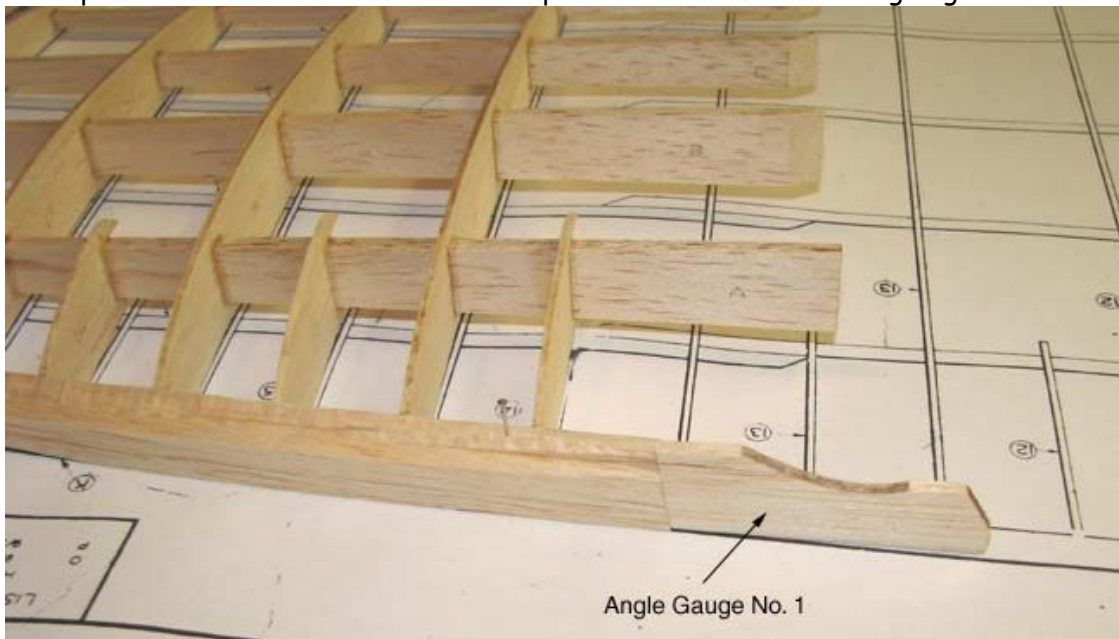
The same procedure was used to bevel the slope on the end of the leading edge as shown below.

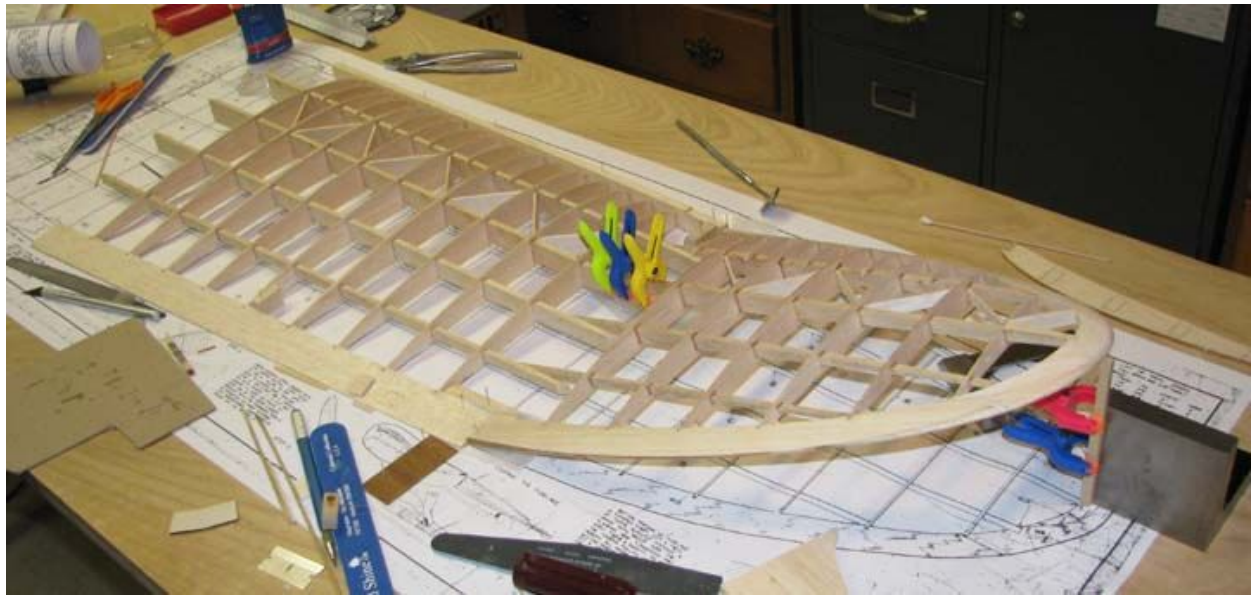
This procedure was also used to bevel the leading and trailing edges of the inner panel. Then the wing's right tip panel was jugged up to the inner panel with a rise of 4-3/8" and the leading and trailing edge joints were glued first with Elmer Carpenter's aliphatic glue and let dry. More Elmer Carpenter's aliphatic glue was then worked down in between the second from the front spar overlap and clamped to let dry as shown below. Then the right wing half was removed from the work table the three remaining spar overlaps were glued and clamped in the same manner.....Tandy
