From: ["Tandy Walker" <rdb435021@icloud.com>](mailto:rdb435021@icloud.com)
To: ["Tandy Walker" <rdb435021@icloud.com>](mailto:rdb435021@icloud.com)
Date: 1/8/2018 2:23:47 PM
Subject: 31 Lancer 850 - Straight Trailing Edge

New Cyclone Lancer 850

January 8, 2018

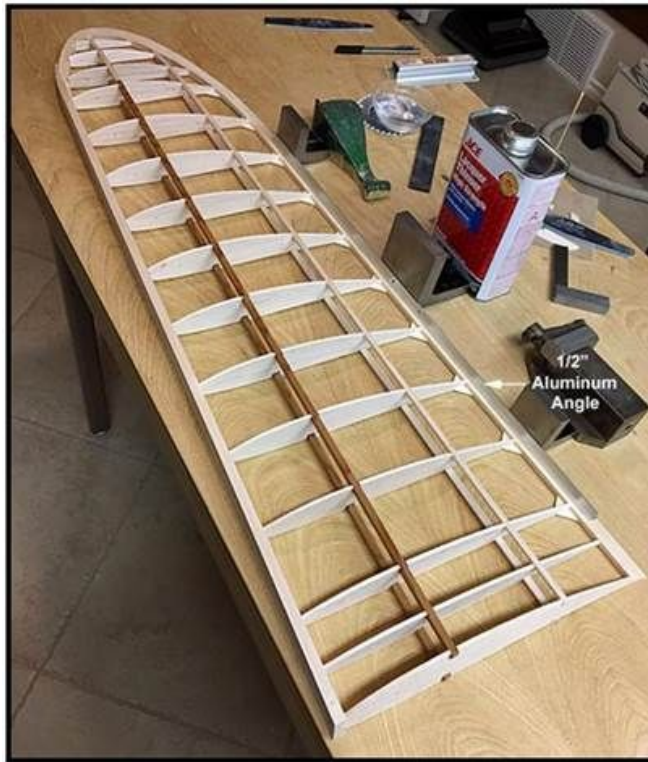
You may recall that yesterday twenty 1/2" gussets cut out of 3/32" sheet balsa were glued in on either side of each rib using aliphatic glue as shown below. This was to strengthen the rib joints at the trailing edge. A 1/2" aluminum angle was placed on top of the trailing edge and weighted down with three steel block squares while the glue on the dried overnight to try and remove the waviness in the trailing edge.

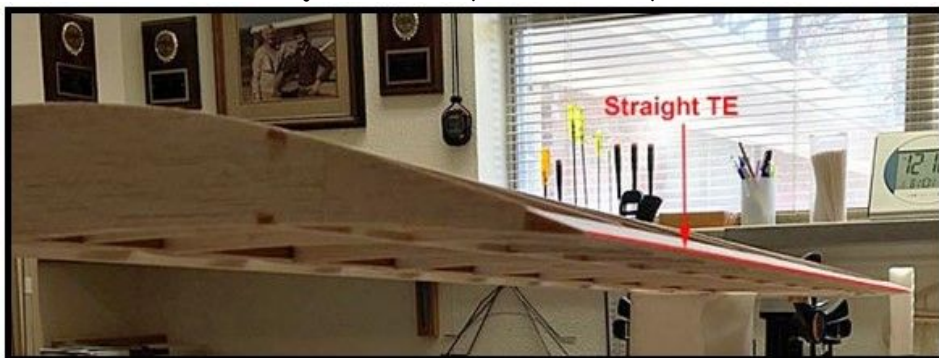
This morning the picture below was taken to show you how straight the trailing edge came out after the glue on the gussets dried overnight. I plan to also put in diagonal bracing between the trailing edge and secondary spars to stiffen the rear portion of the wing even further, but that will be the subject a later report.....Tandy
