From: ["Tandy Walker" <rdb435021@icloud.com>](mailto:rdb435021@icloud.com)
 To: ["Tandy Walker" <rdb435021@icloud.com>](mailto:rdb435021@icloud.com)
 Date: 3/19/2018 3:50:58 PM
 Subject: 88 Lancer 850 - Horizontal Tail Construction (Part 5)

Report No. 88
New Cyclone Lancer 850
 March 19, 2018

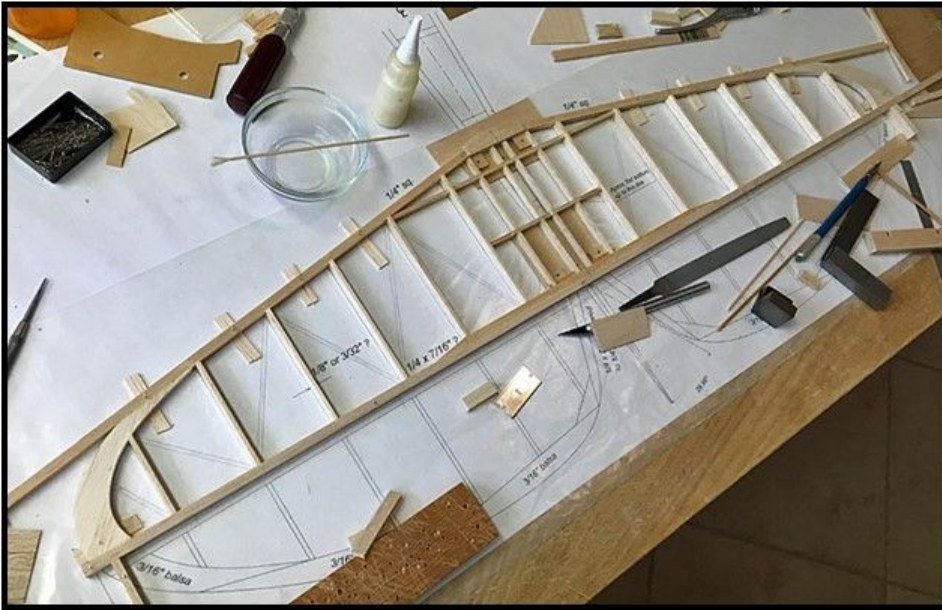
This morning Sue and I worked out at the fitness center. When we got home we moved all of our temperature sensitive plants out of the garage onto the patio now that the weather has finally warmed up here. I cleaned up the garage, replaced the left rear yellow turn signal bulb on Sue's PT Cruiser, and then it was time for lunch. After lunch I finished framing up the stab this afternoon as shown below. Notice that the diagonal bracing was left out. This will be added in after the stab frame is removed from the plan in order to get the correct vertical centering.

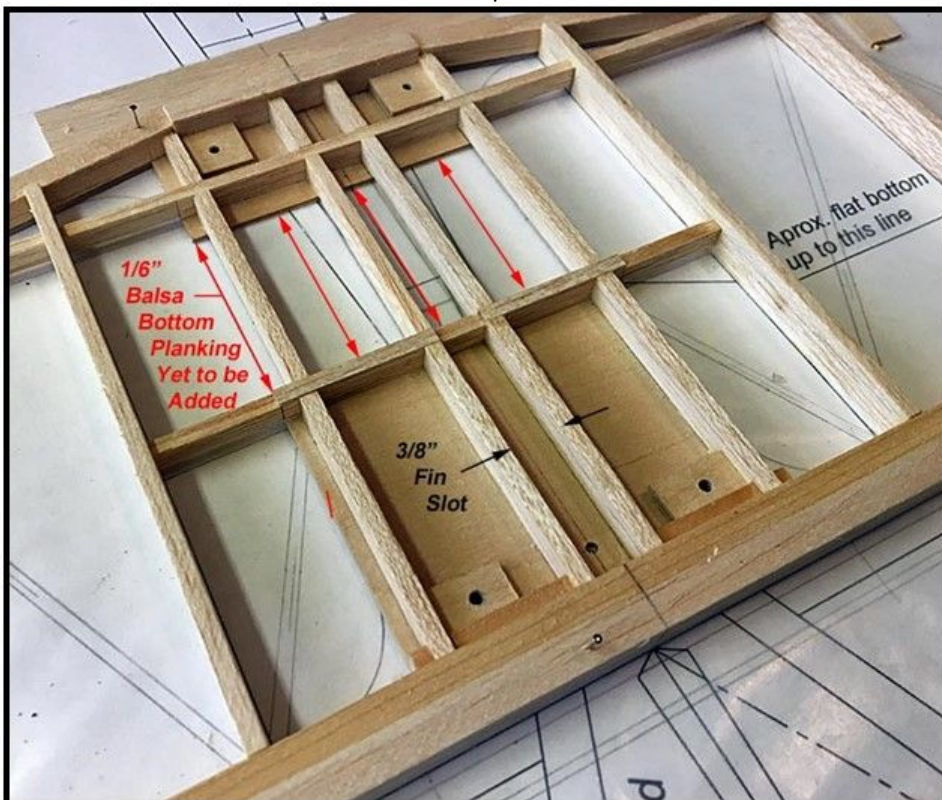
This close up of the stab's center section shows the stab's 3/8" fin slot formed by the two 1/8" central ribs. Notice that the center section of the 1/16" bottom balsa planking will also be added in after the stab frame is removed from the plan.

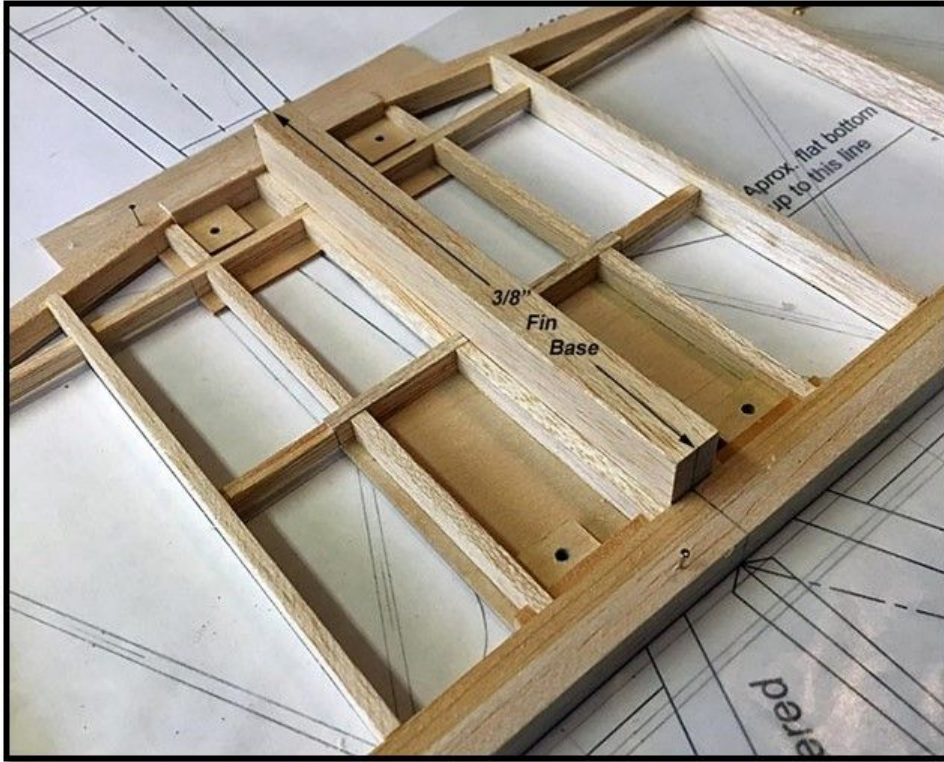
This shows the trial fit of the of the 3/8" fin base in the stab's center slot.....Tandy
