Subject: 155 Sailplane Spraying Klass Kote on Sailplane's Wing

### *Comet Sailplane Project*

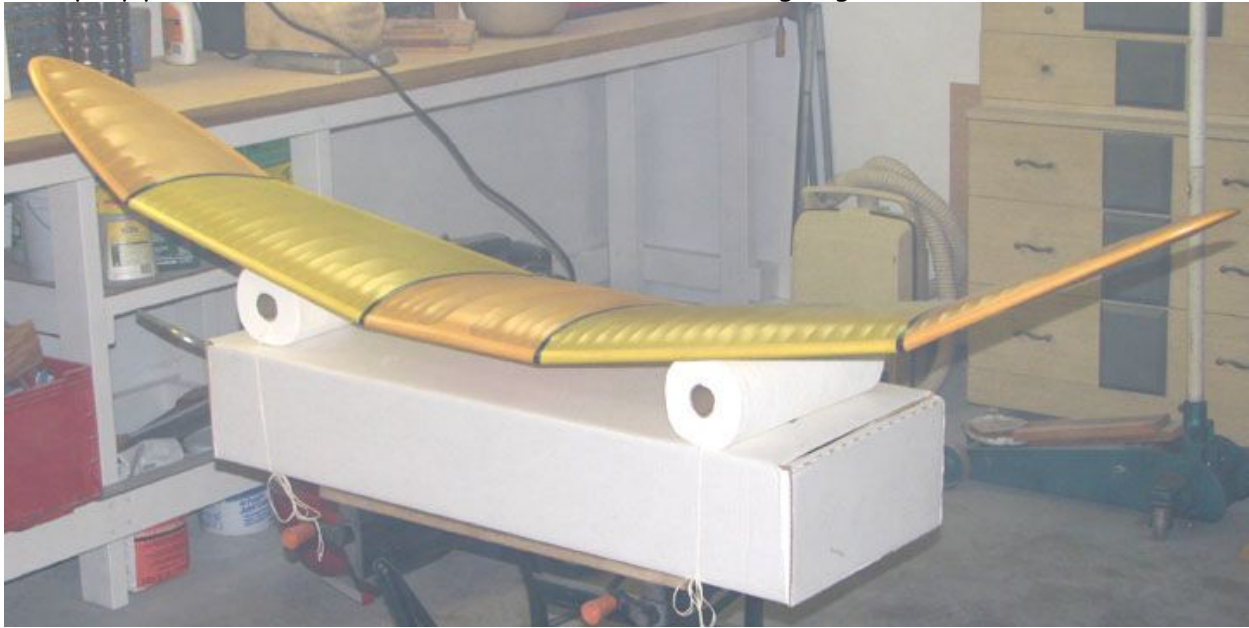
This afternoon I made up an all new mix of satin Klass Kote and shot the bottom of the wing around 1:30 p.m. Later on this afternoon, I decided the wing would be dry enough to spray the top. So around 5:00 p.m. I shot the top of the wing. When I had finished spraying the top, I took the picture below before the atomized Klass Kote epoxy particles had settled out of the air in the closed garage.

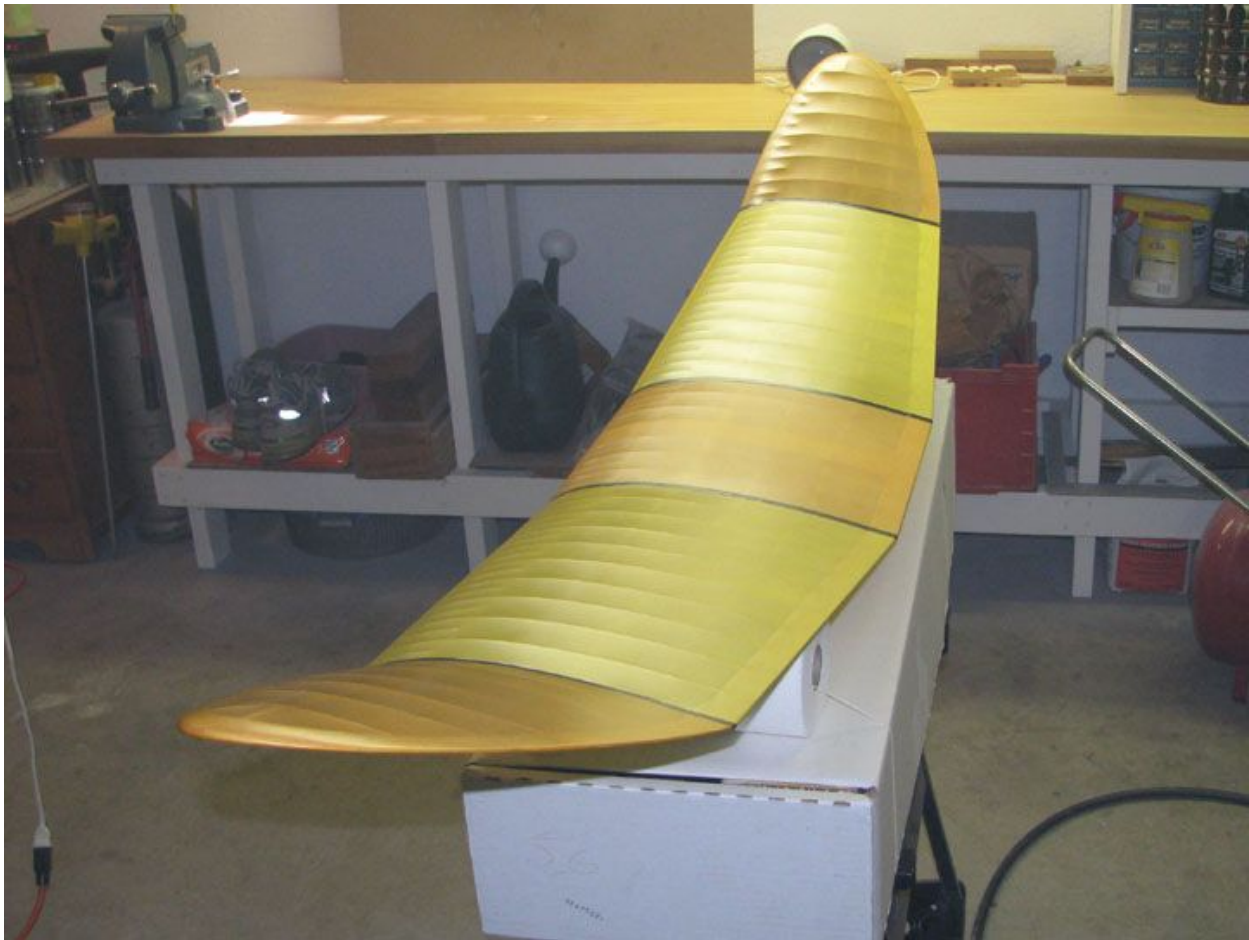
A little later when I went out and checked on how the wing was drying, I took this picture in an attempt to show you the beautifully smooth satin Klass Kote finish on the top of the wing.

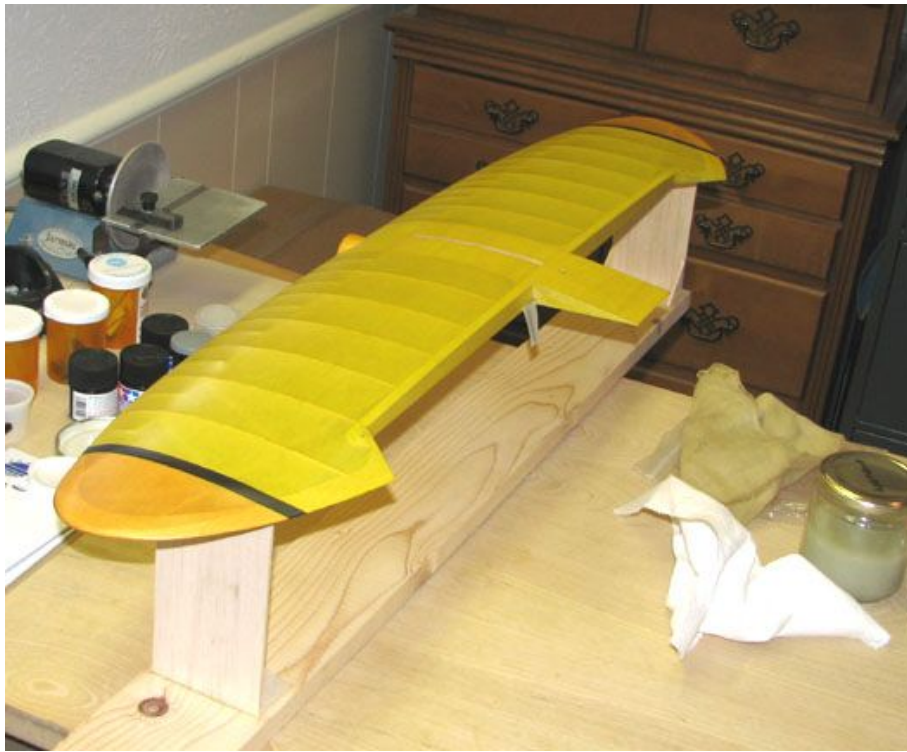
Here is problem I encountered: As late as yesterday evening the dry coat of satin Klass Kote on top of the stab was not as satin as the rest of the model's components #\$\$@&? (it had kind of a shiny or semi gloss sheen). The only thing I can come up with as to why is that the mix had been placed in the refrigerator overnight and it had a little additional thinner added, which by the way according to Nate Dickerson was supposed to be OK.

I kept looking at the top of the stab and debating about what to do for a long time. Since I was never going to accept this miss matched sheen of the top of the stab, I remounted the stab on the second support fixture and resprayed the top of the stab this afternoon in between the time I sprayed the bottom of the wing and the top of the wing. As you can see below, by respraying using the fresh satin Klass Kote I had mixed up for the wing, the satin finish of the top of the stab now matches the rest of the model's components. I will call Nate Dickerson (Mr. Klass Kote) tomorrow and see if he knows what the problem could possibly be.
